Inspection, Analysis, and Recommendations Report Ford Manchester Dam

River Raisin
Manchester, Michigan
EGLE Dam ID No. 391

February 14, 2024
GEI Project No. 2204052

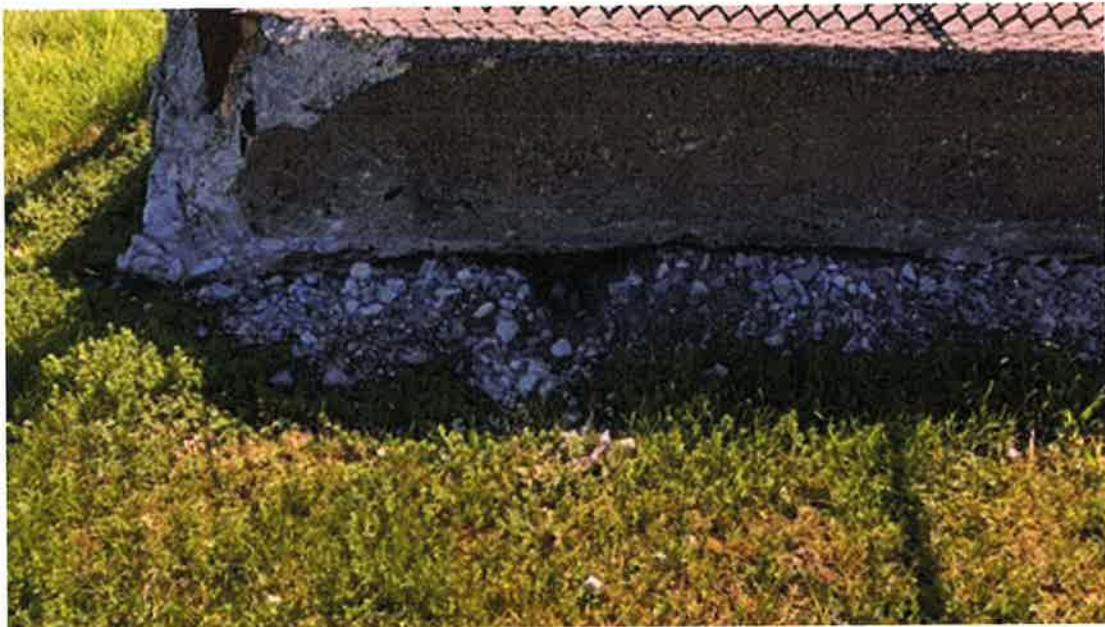
Photo #13 - Burrow observed under spillway concrete at left end of spillway

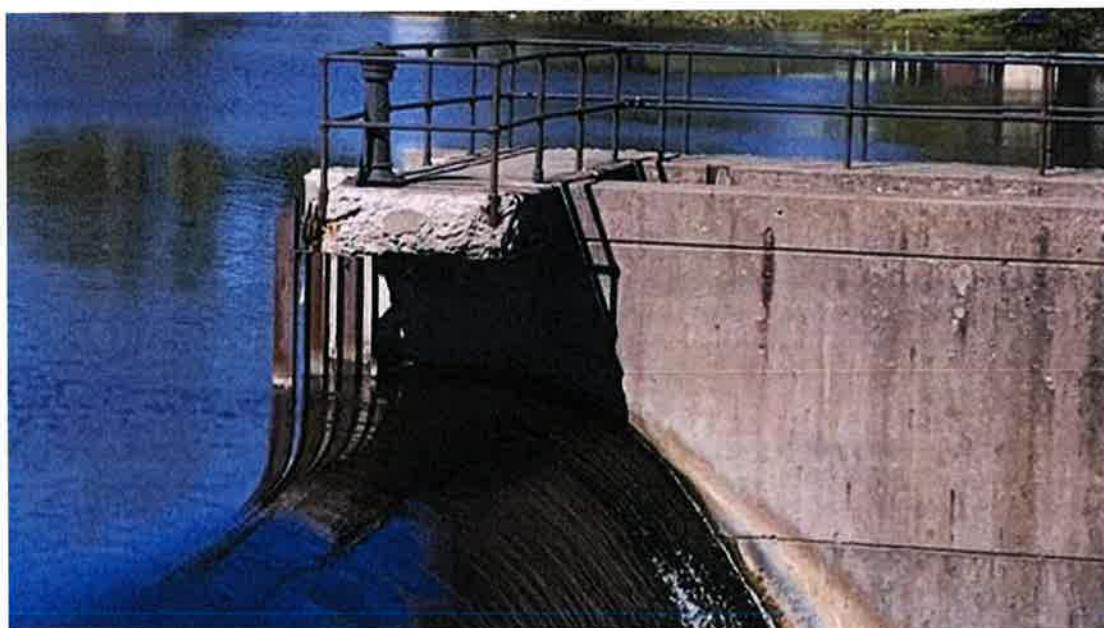
Photo #42 - Spillway left upstream abutment wall. Note concrete deterioration of gate operator deck

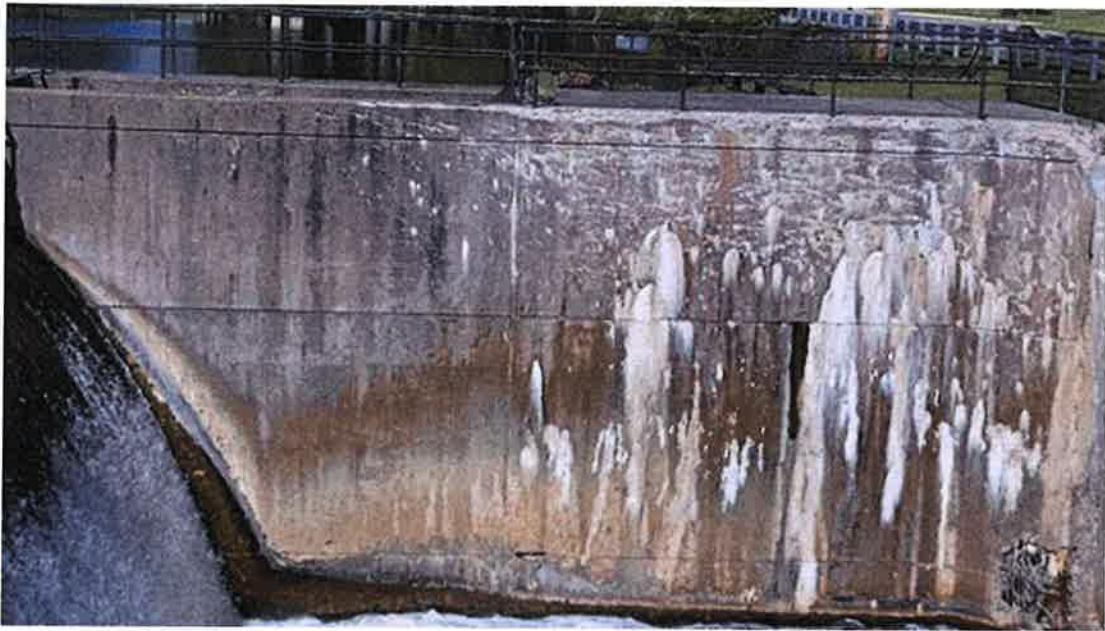
Photo #43 - Left downstream spillway abutment wall. Efflorescence present throughout. Some minor seepage observed at darker area of concrete

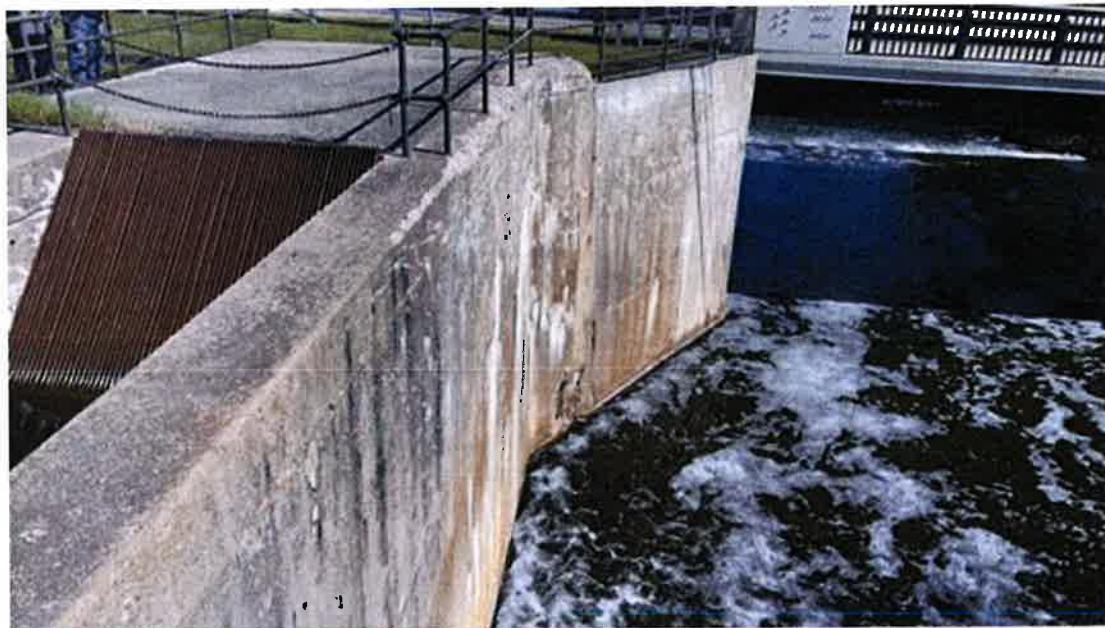
Photo #46 - Left downstream spillway abutment wall. Efflorescence present. Spalling present at the top of the wall. Cracking and loss of concrete observed near the bottom of the wall

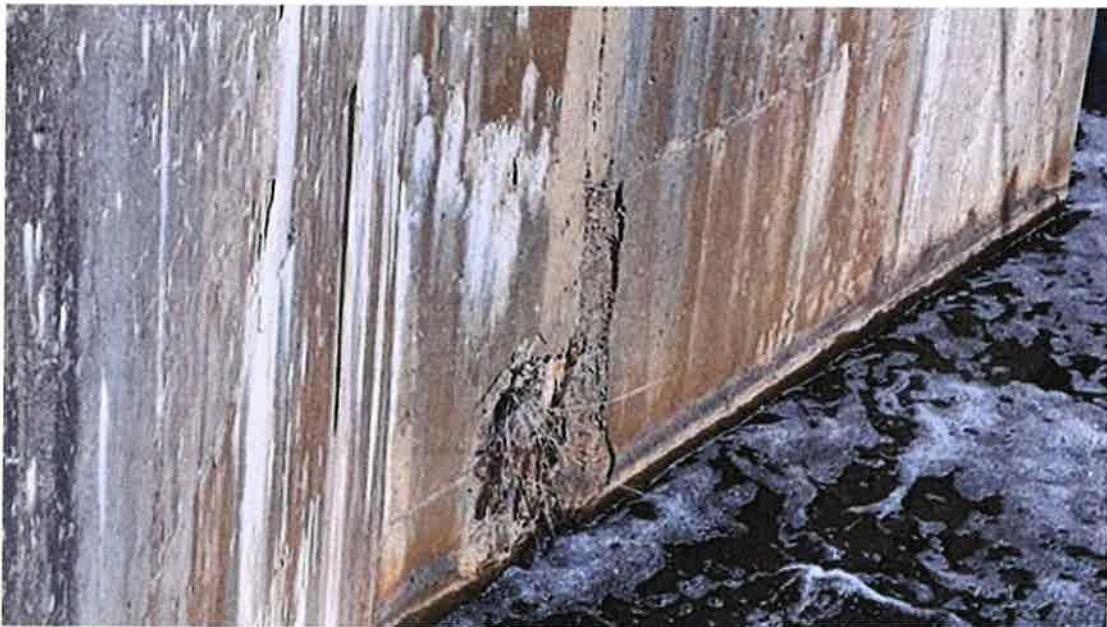
Photo #47 - Cracking and loss of concrete observed near the bottom of the left downstream abutment wall

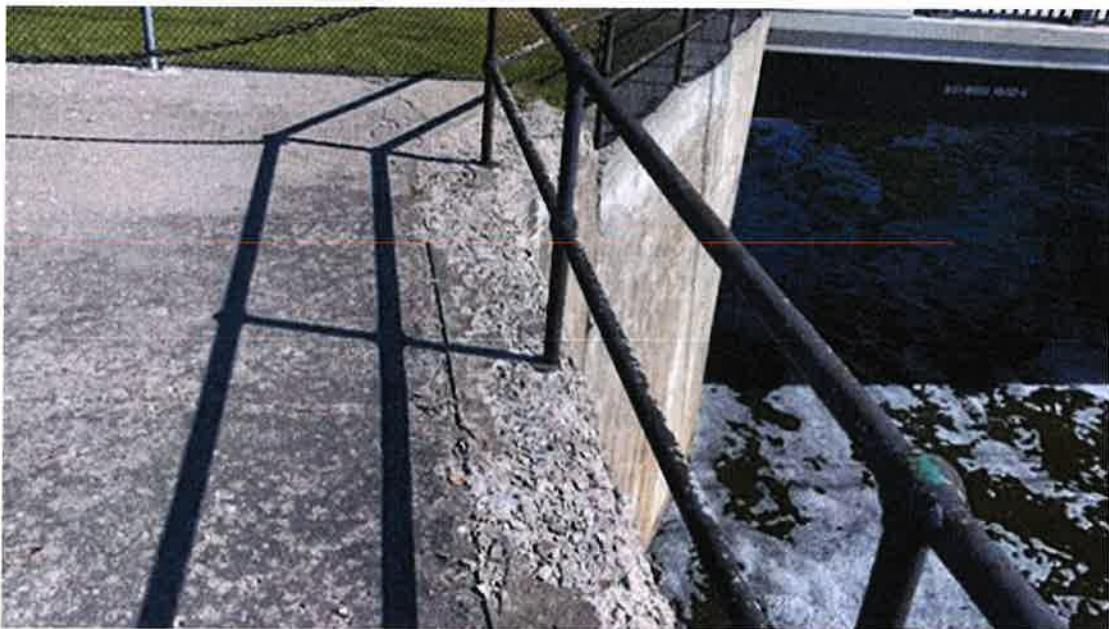
Photo #48 - Spalling on top of left spillway abutment wall

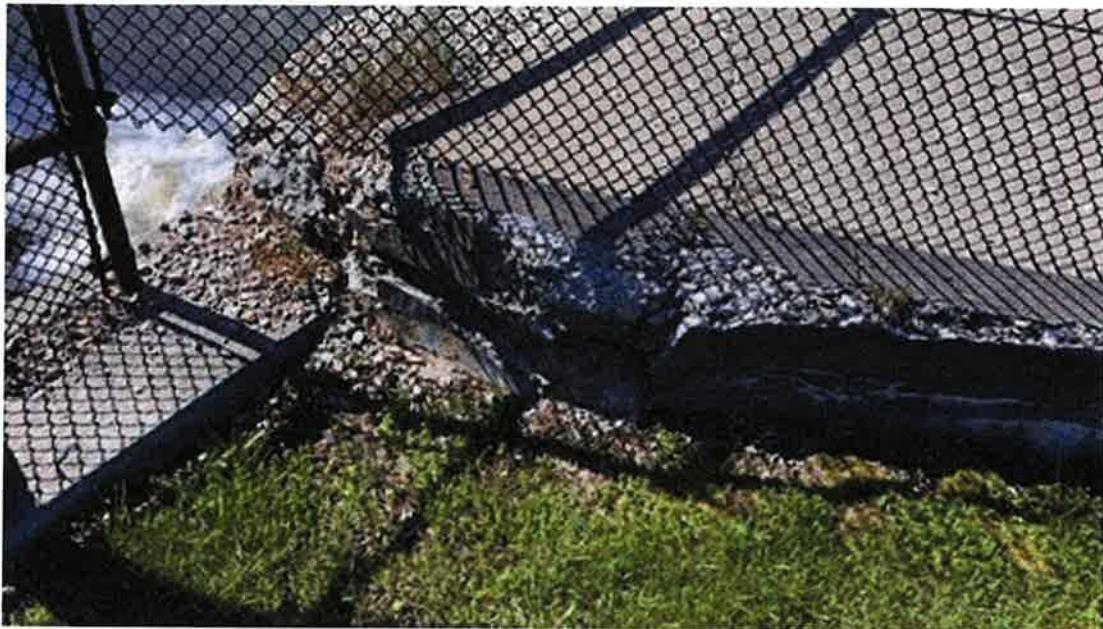
Photo #51 - Concrete deterioration at spillway deck over sluiceway

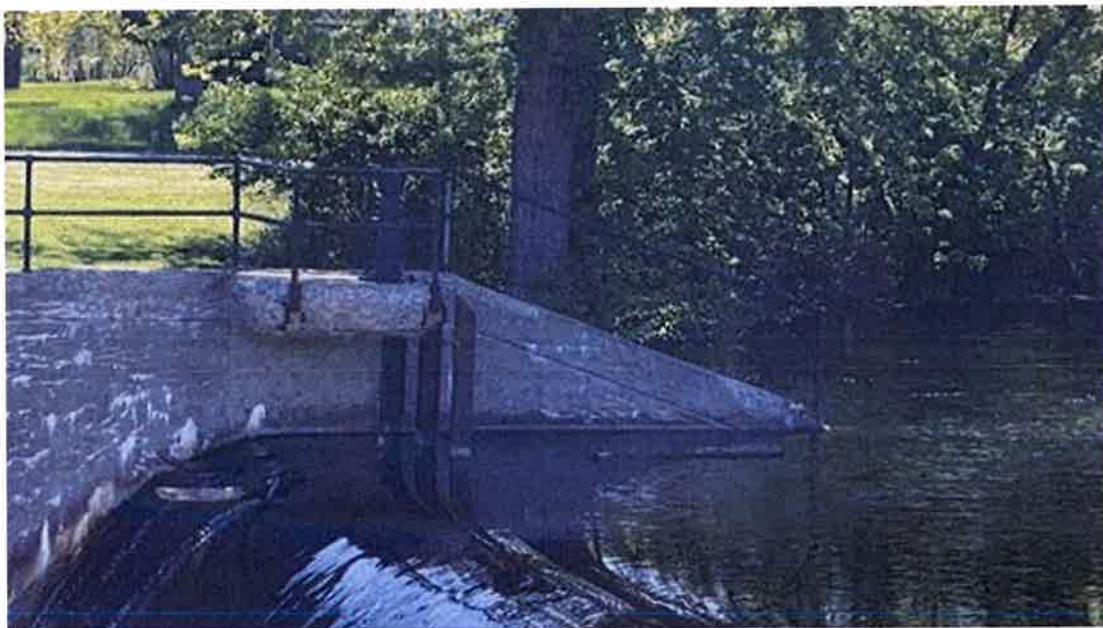
Photo #54 - Right upstream spillway abutment wall. Also note deterioration of gate operator deck

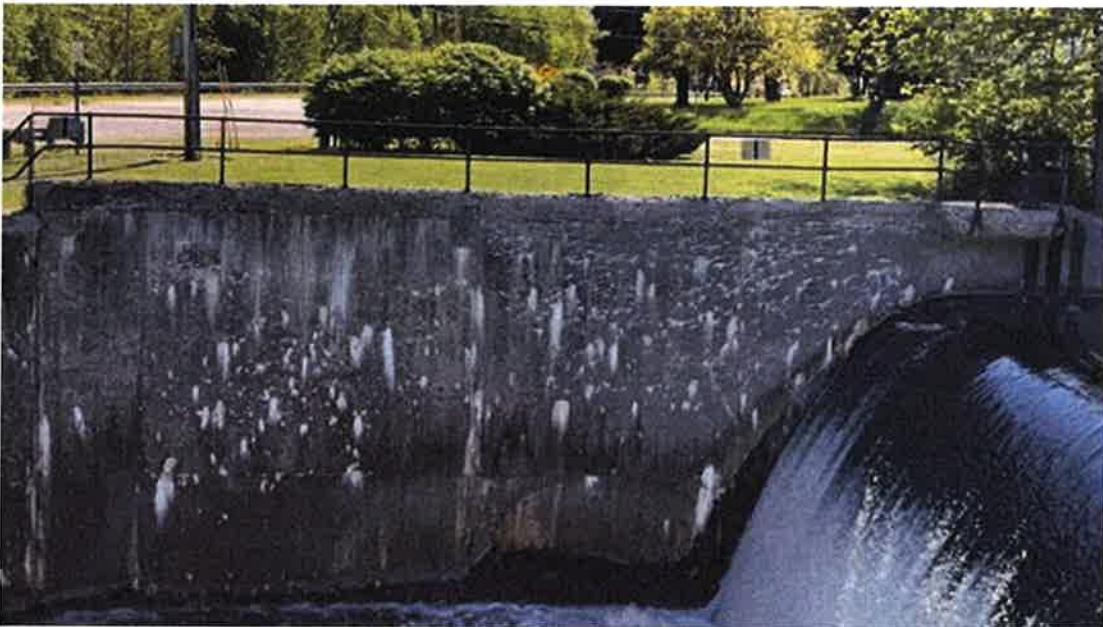
Photo #55 - Right downstream spillway abutment wall. Efflorescence present throughout, spalling present at the top of the wall

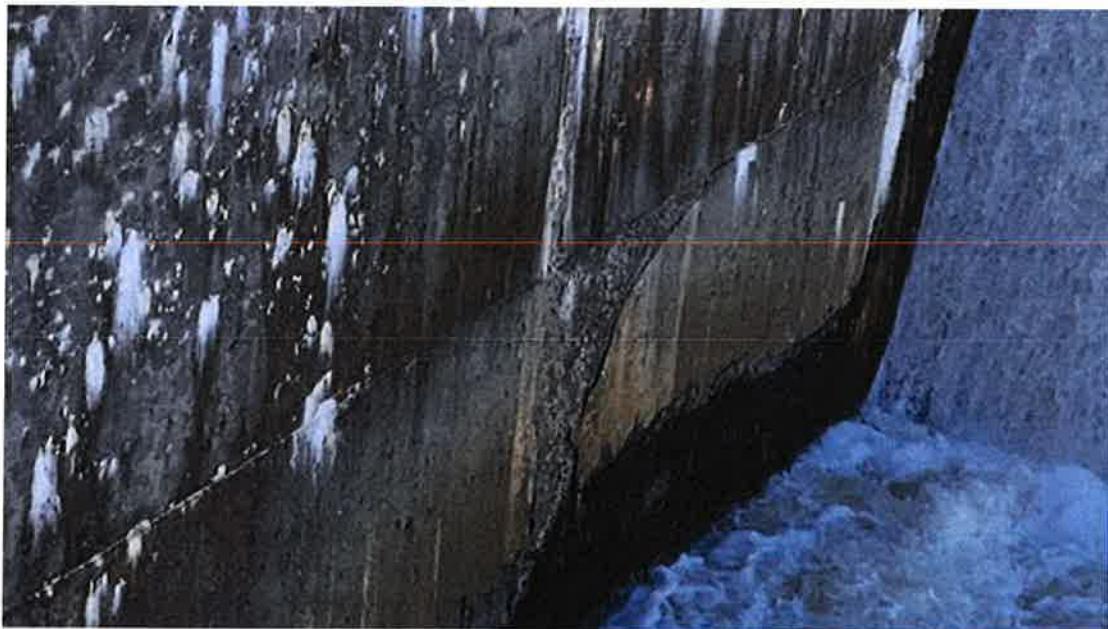
Photo #56 - Concrete delamination on spillway's right downstream abutment wall

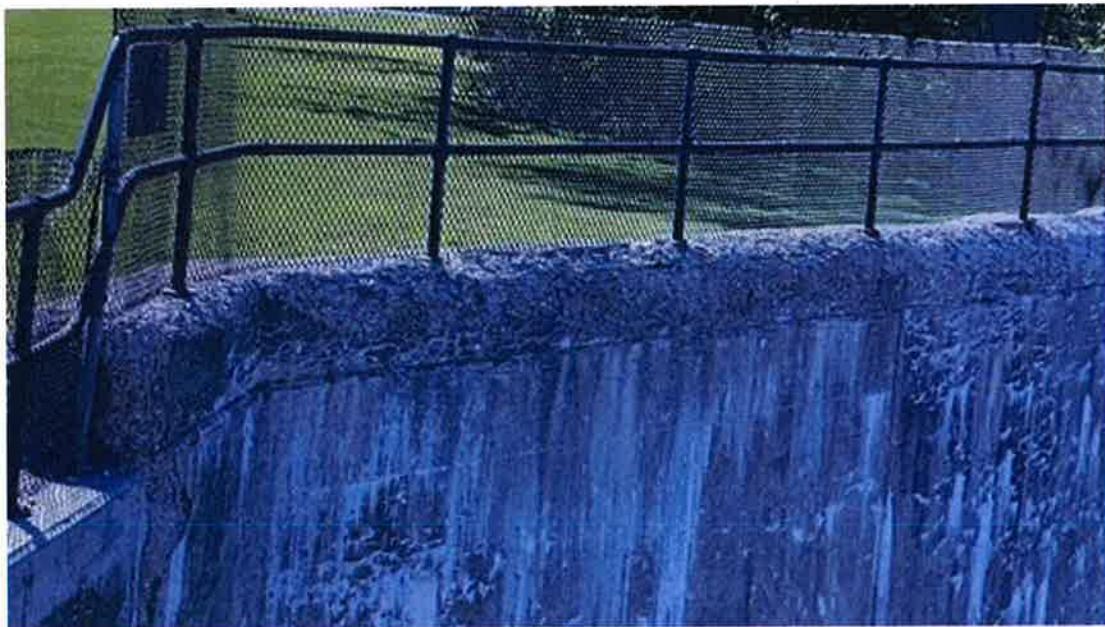
Photo #58 - Spalling on top of the spillway's right downstream abutment wall

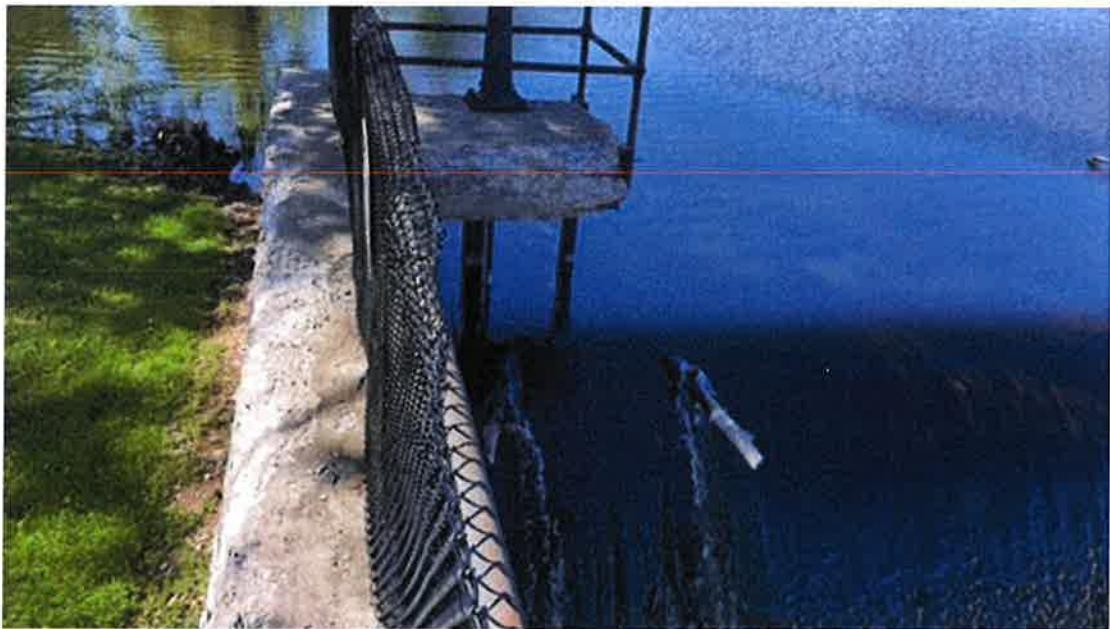
Photo #60 - Spalling on top of the spillway's right downstream abutment wall and gate operator deck

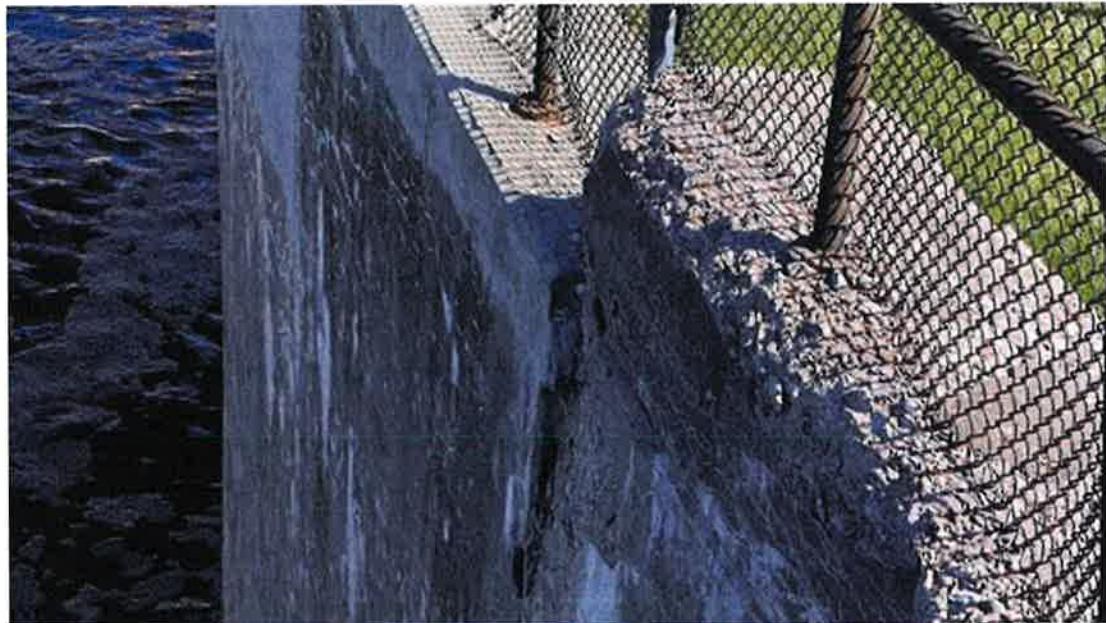
Photo #61 – Concrete deterioration on spillway's right downstream abutment wall

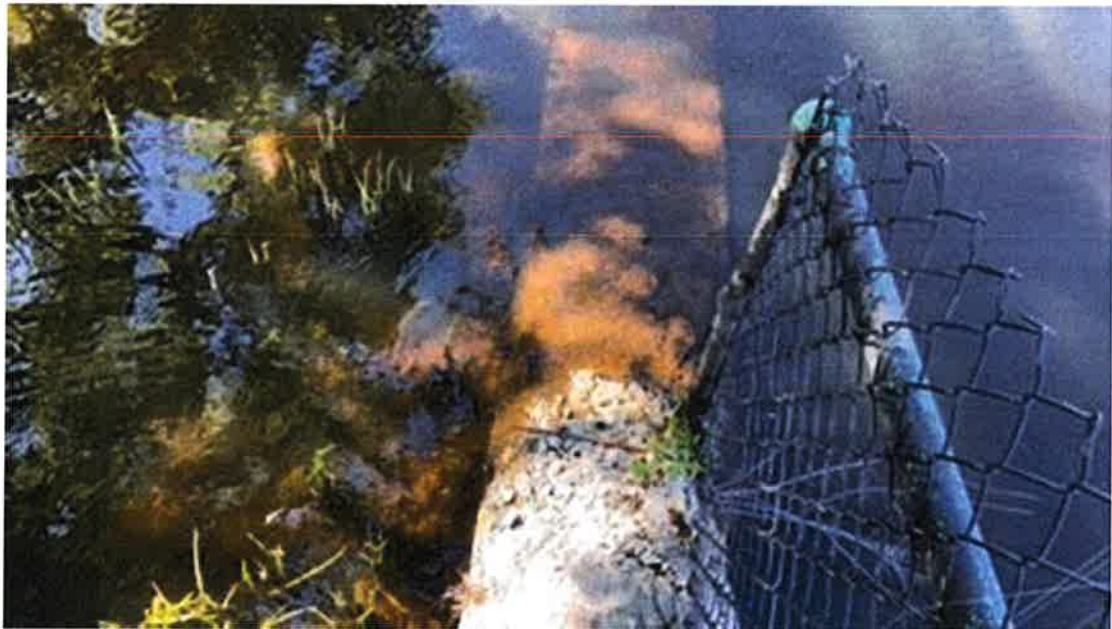
Photo #64 - Top of spillway's right upstream abutment wall. Loss of concrete at waterline

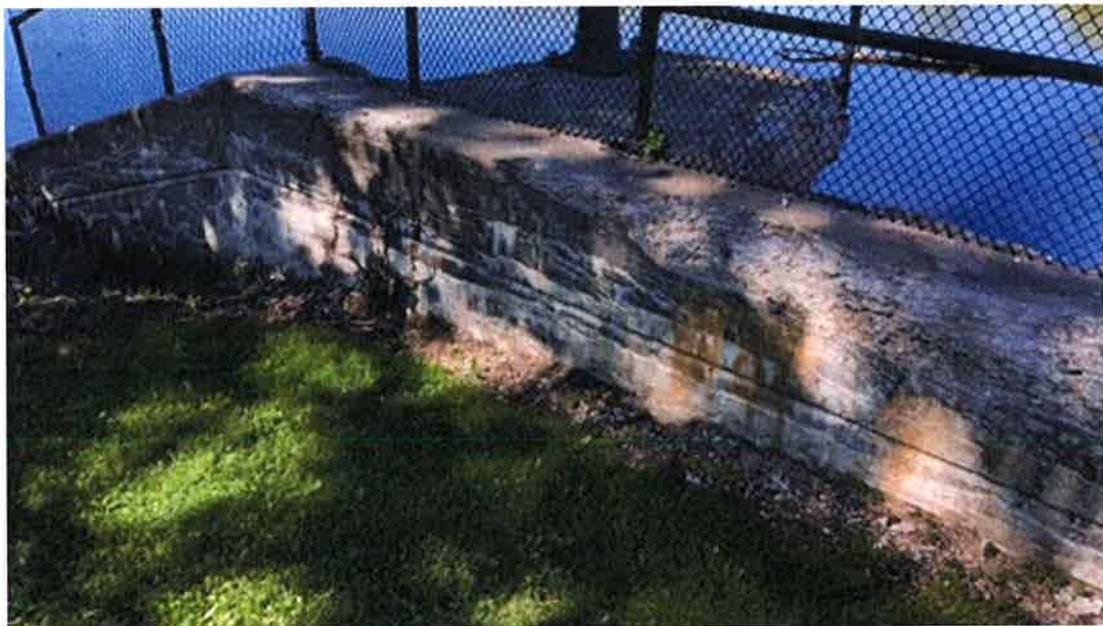
Photo #65 - Spillway right abutment wall right face. Spalling present

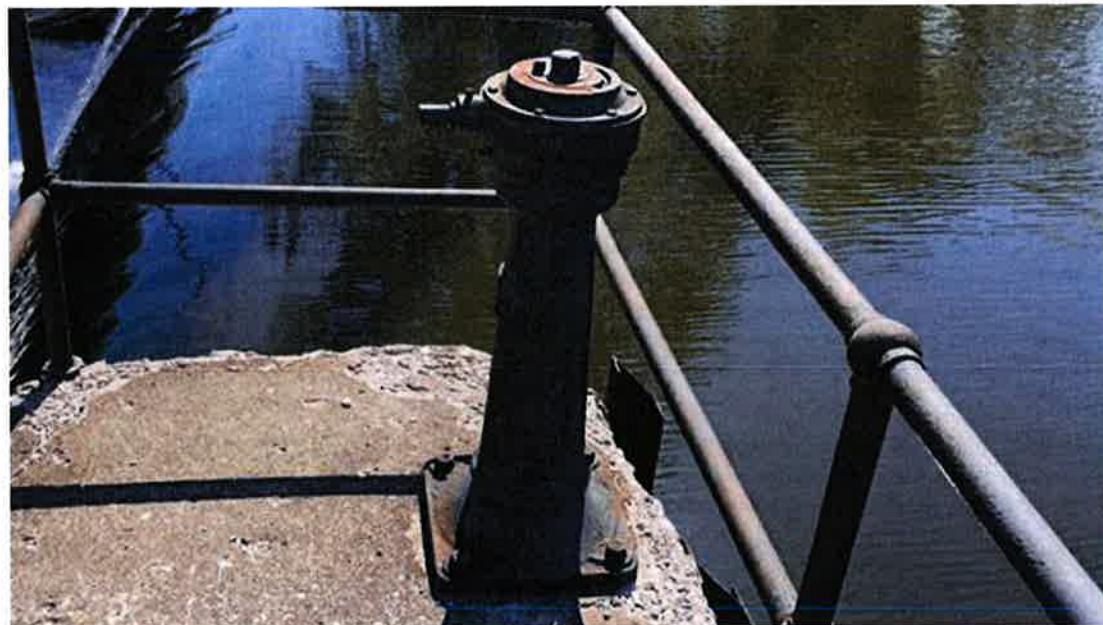
Photo #66 - Left drawdown gate operator. Note severe deterioration of concrete on operator deck

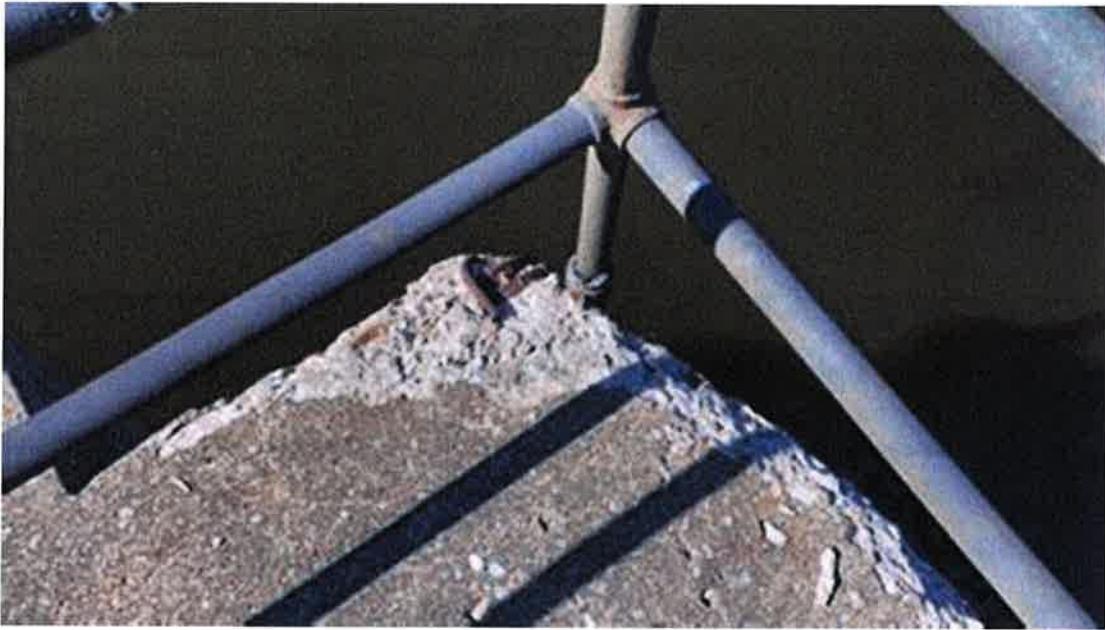
Photo #67 - Spalling, exposed rebar at left spillway gate operator deck. Guardrail connection to concrete is compromised

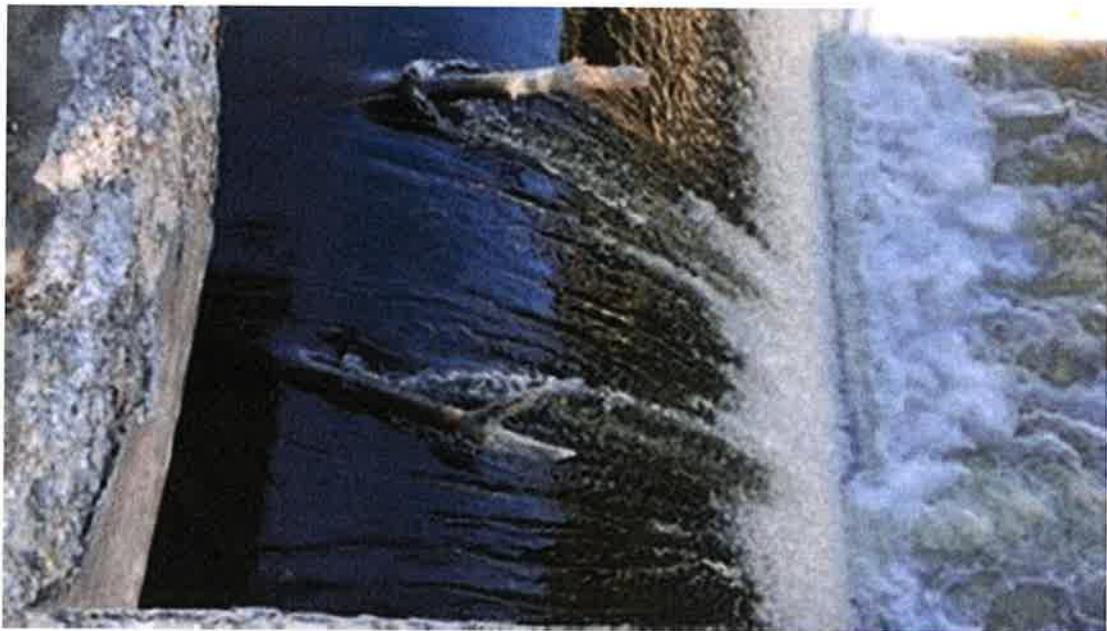
Photo #71 - Spillway crest at right drawdown gate. Drawdown outlet was unable to be observed

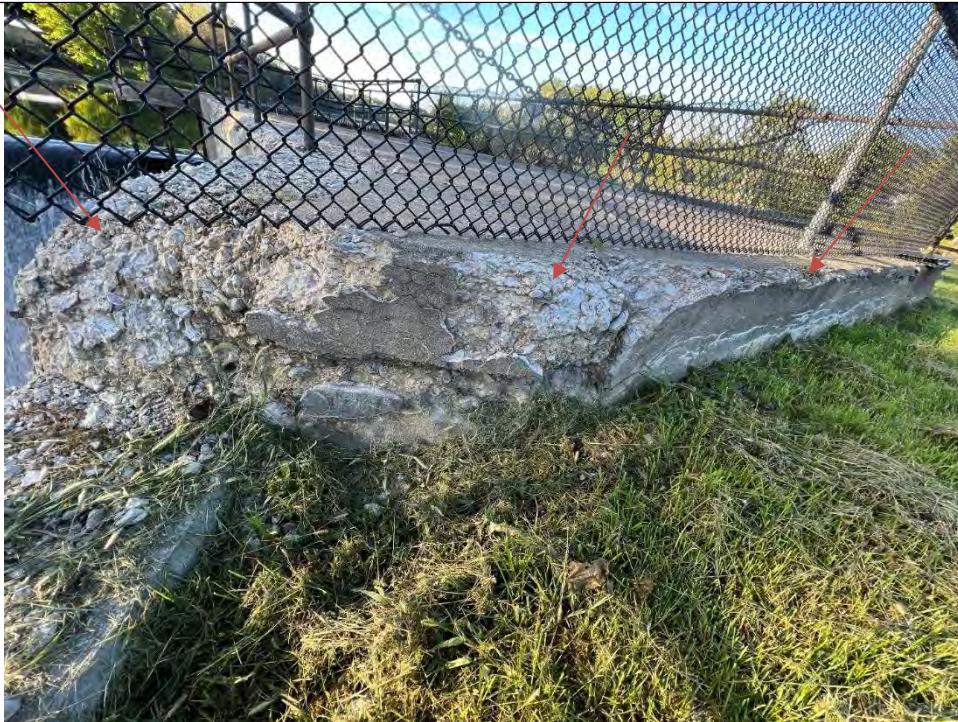
Photo No. 28 – Concrete Deterioration on Downstream Side of Penstock Intake Deck Looking Upstream

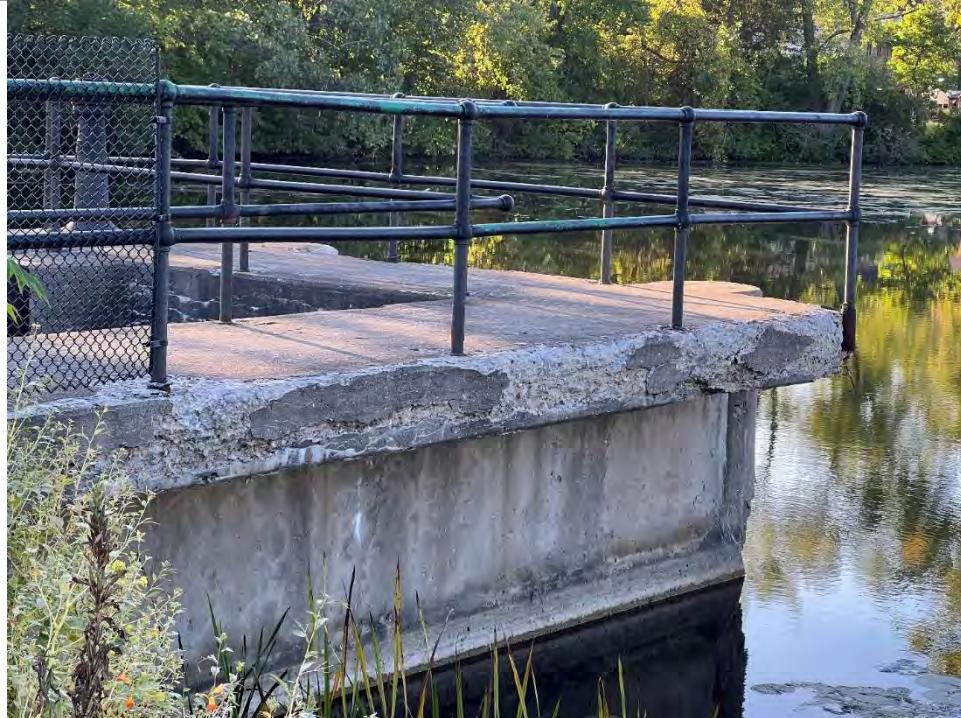
Photo No. 32 – Concrete Deterioration of Left Side of Penstock Intake Deck Looking Right

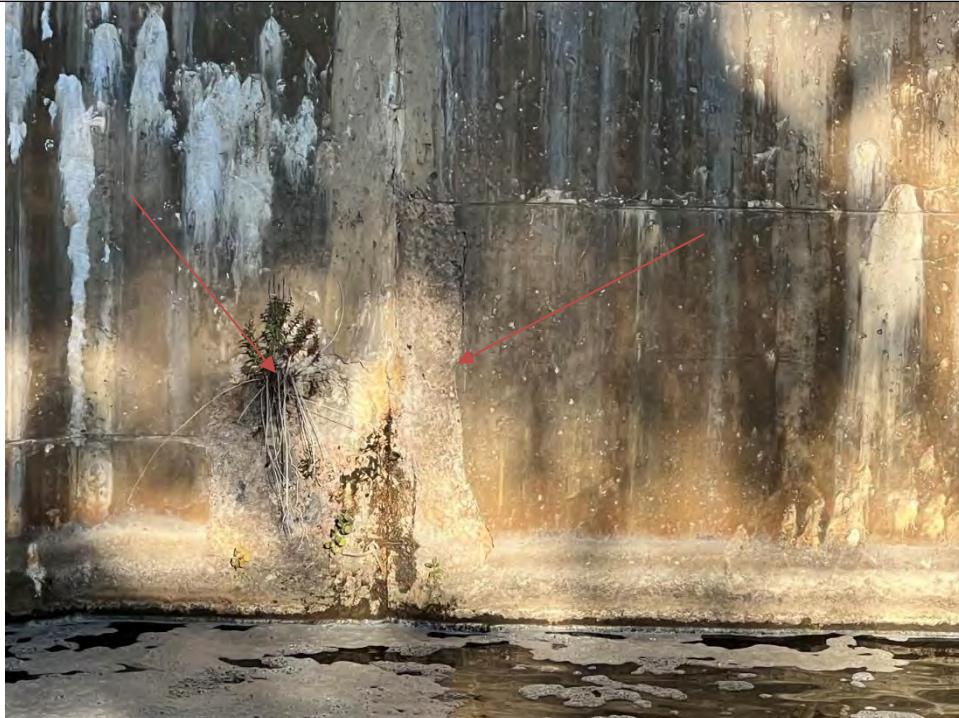
Photo No. 47 – Concrete Deterioration on Downstream Left Wall Upstream of M-52 Bridge Looking Left

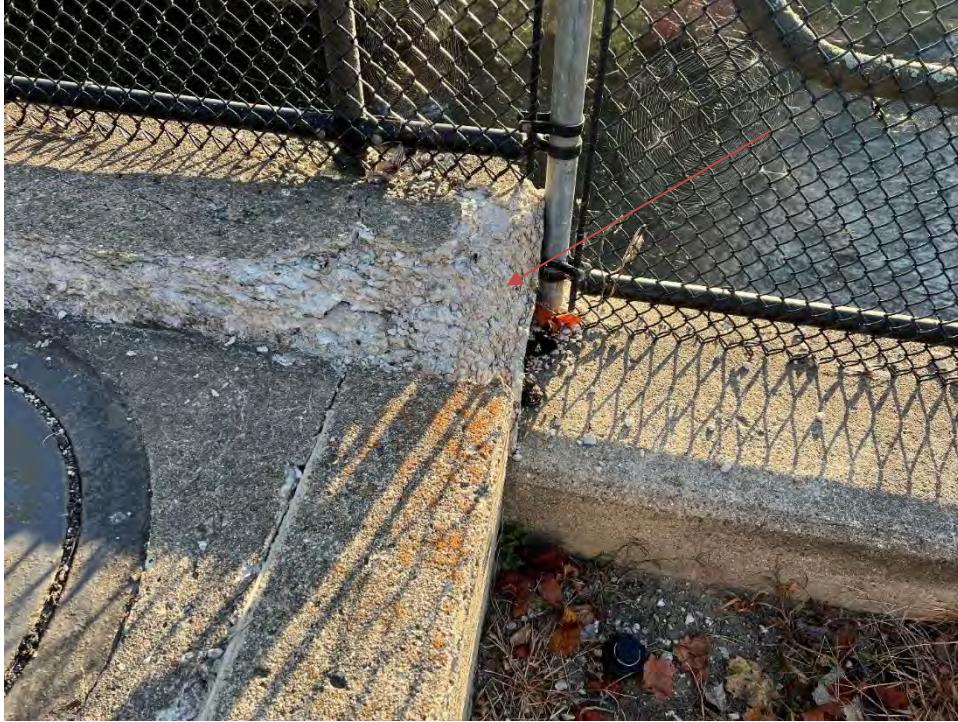
Photo No. 53 – Concrete Deterioration at Top of Downstream Left wall Upstream of Powerhouse
Looking Right

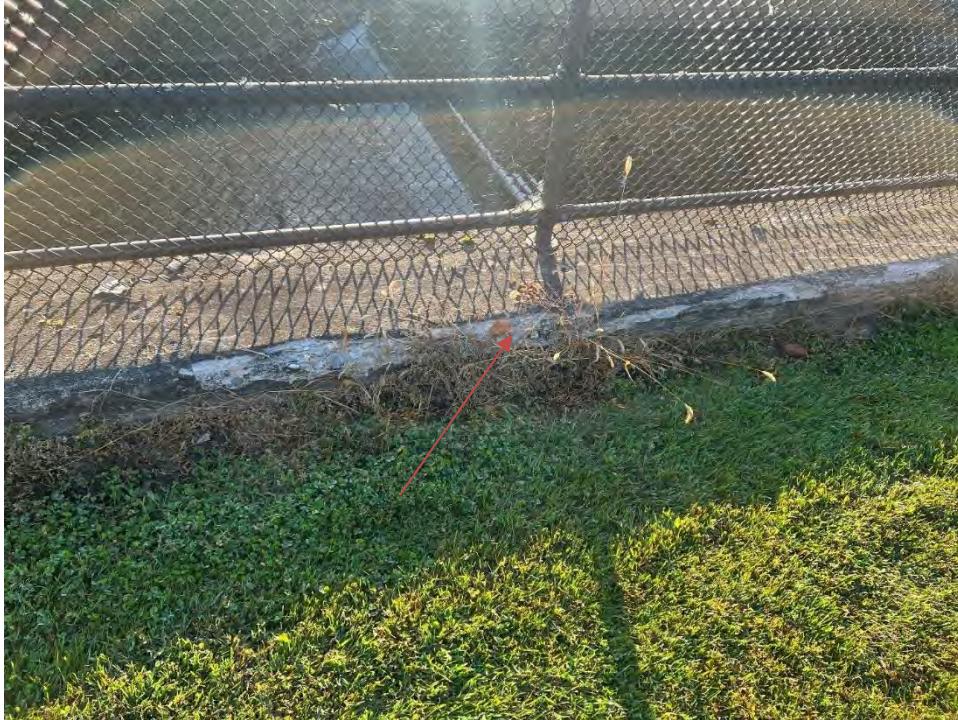
Photo No. 55 – Concrete Deterioration at Top of Downstream Left Wall Downstream of M-52 Bridge
Looking Right

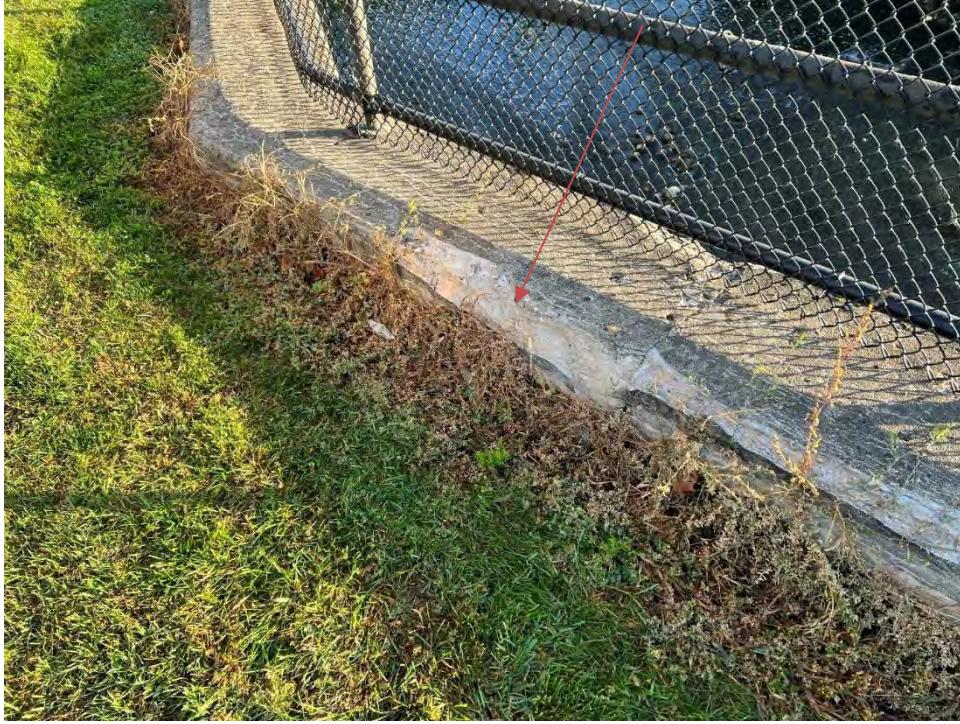
Photo No. 57 – Concrete Deterioration at Top of Downstream Left Wall Downstream of M-52 Bridge
Looking Downstream

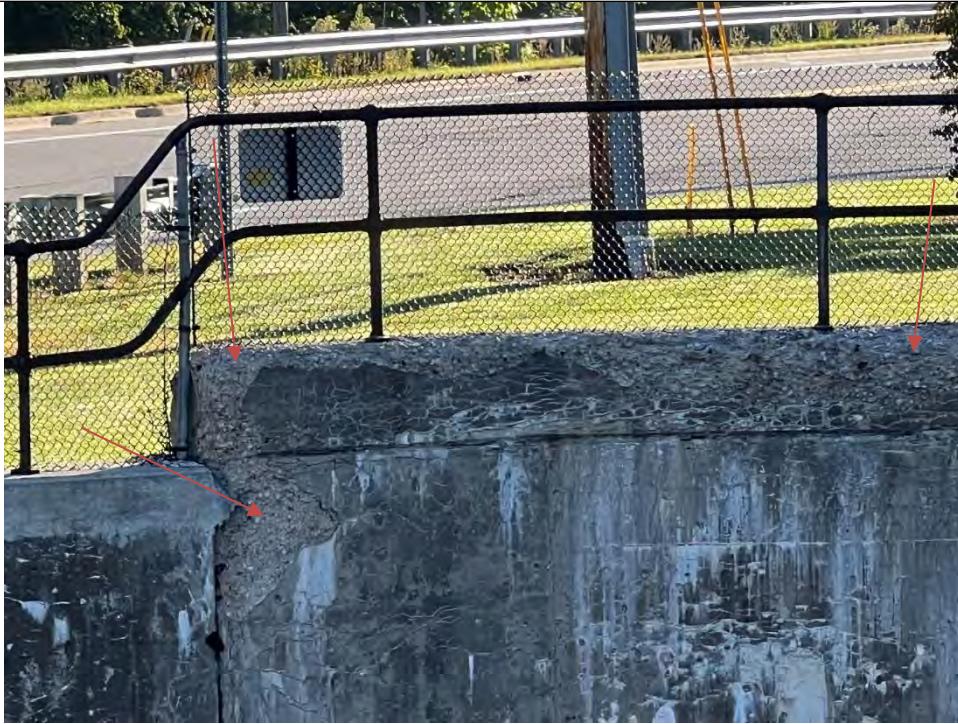
Photo No. 67 – Concrete Deterioration at Top of Downstream Right Wall Upstream of M-52 Bridge
Looking Right

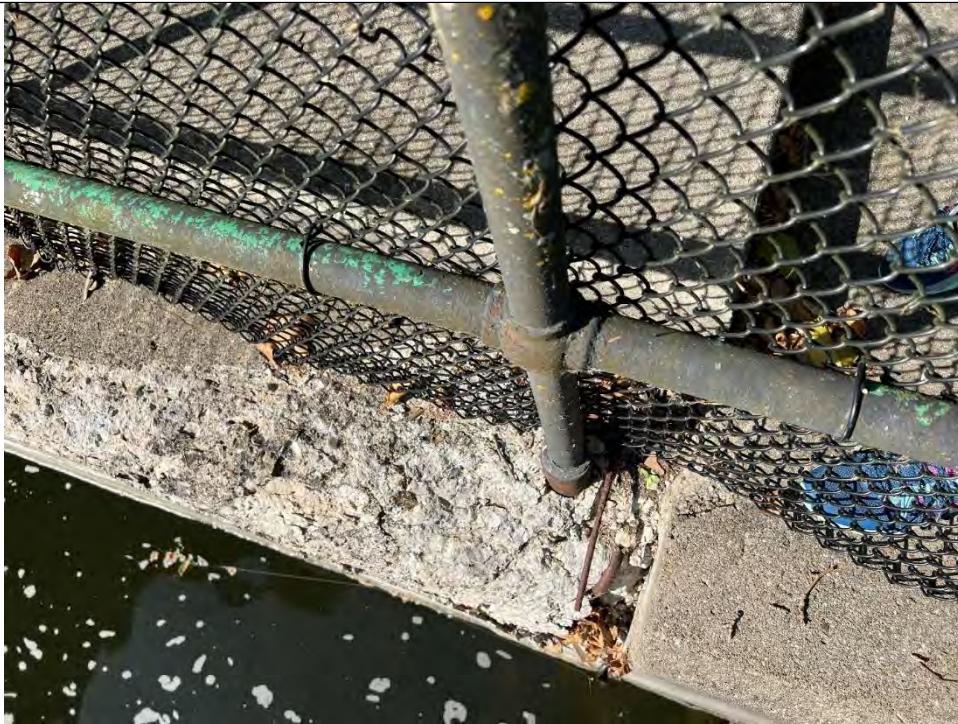
Photo No. 86 – Concrete Deterioration at Top of Seating Area Wall Looking Left

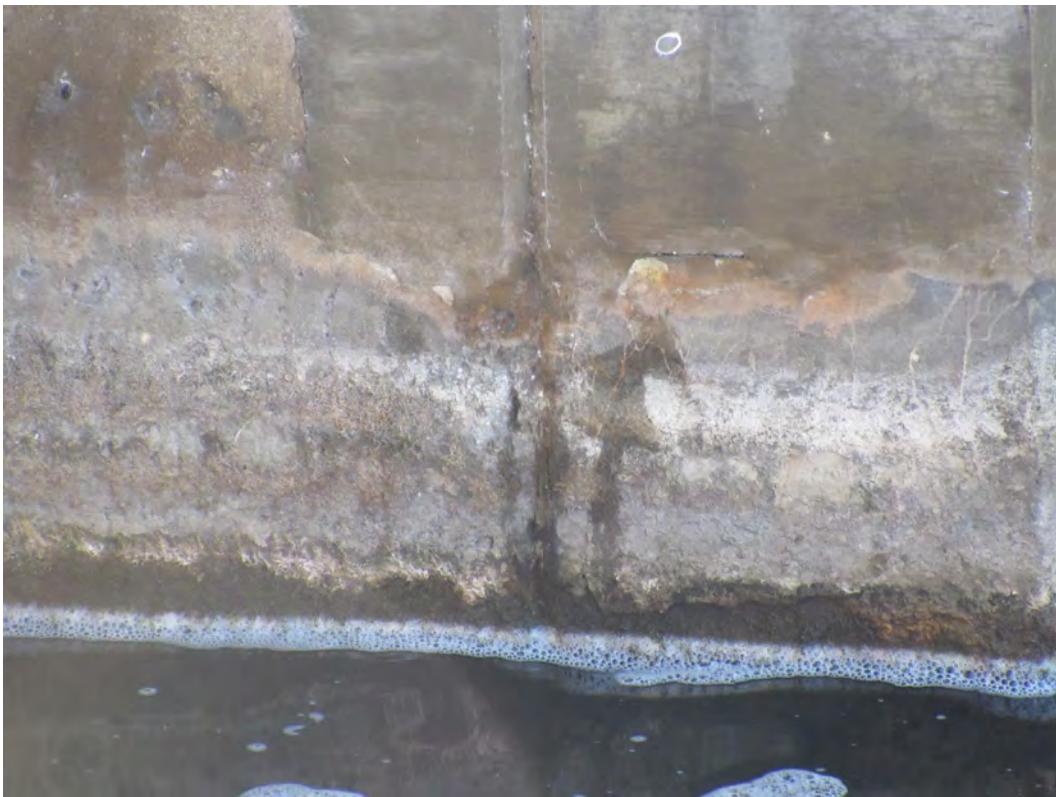
Figure 5 – Downstream, East Wall: Spalling

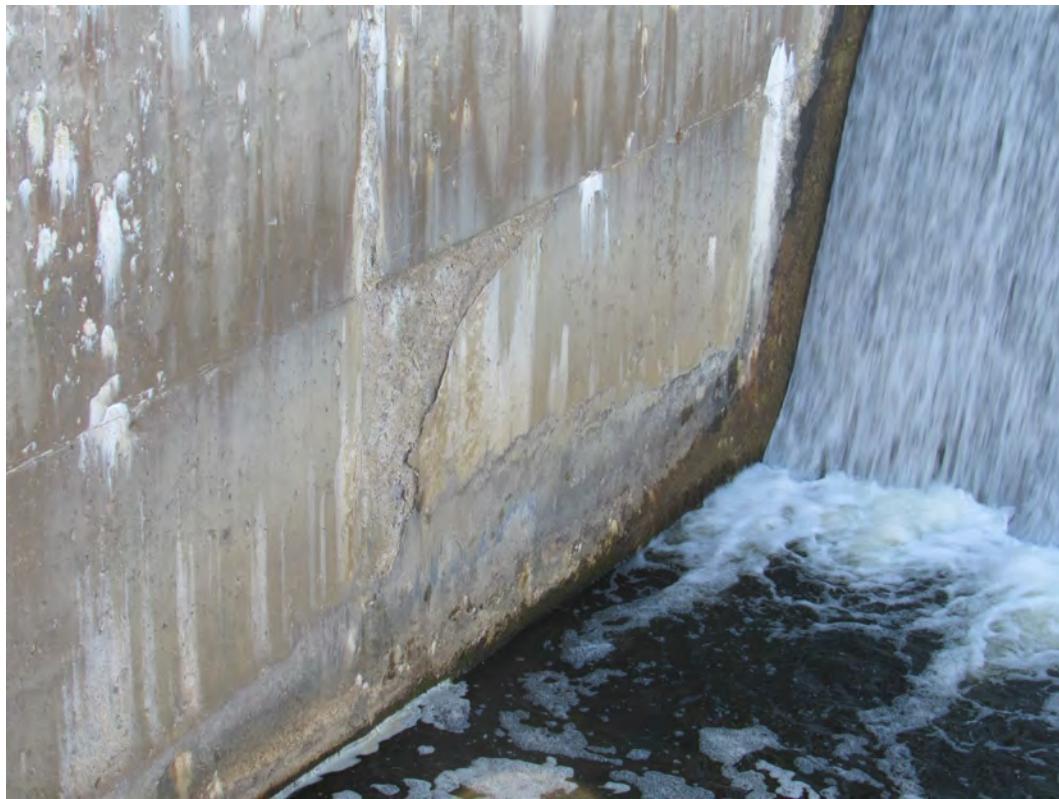
Figure 6 – Downstream, East Wall: Delamination

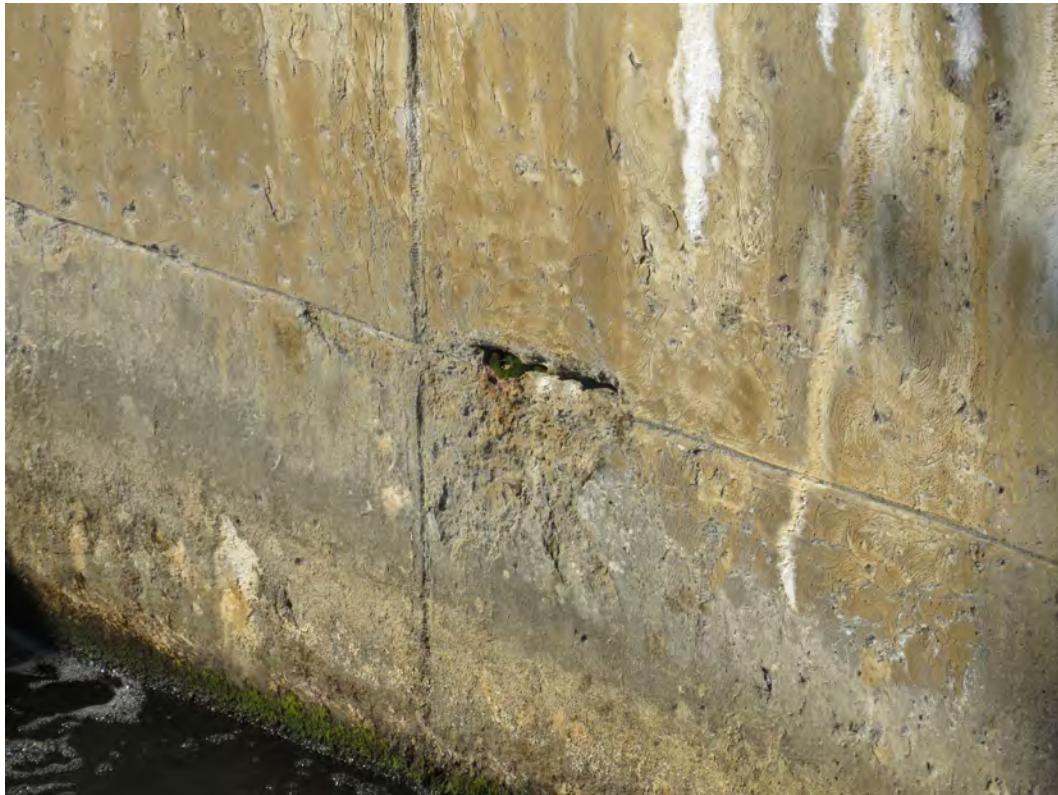
Figure 9 – Downstream, West Wall: Spalling

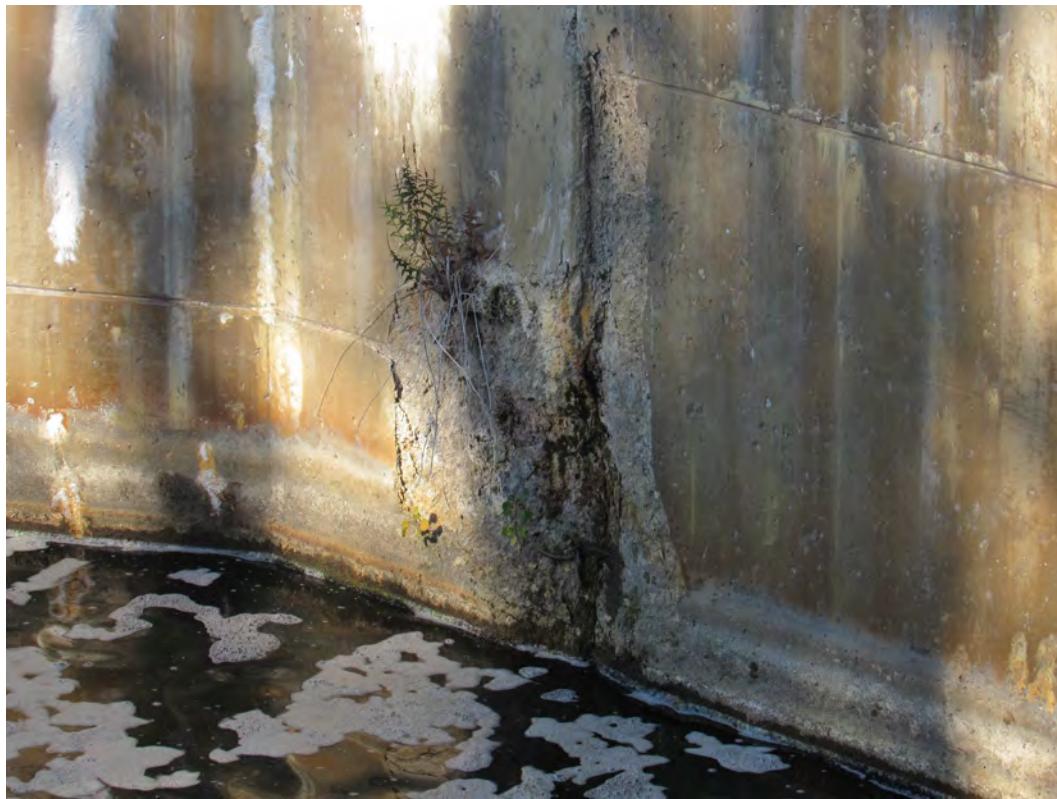
Figure 10 – Downstream, West Wall: Spalling with Exposed Rebar

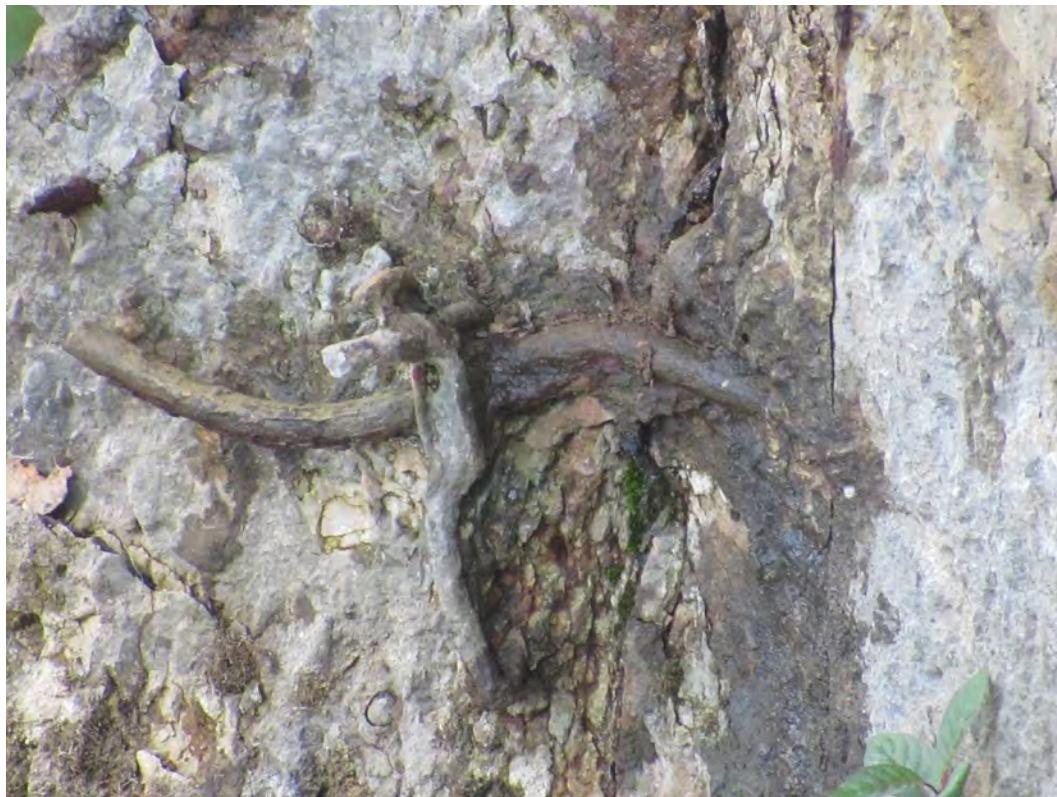
Figure 11 – Downstream, West Wall: Spalling with Exposed Rebar
