Inspection, Analysis, and Recommendations Report Ford Manchester Dam

River Raisin
Manchester, Michigan
EGLE Dam ID No. 391

February 14, 2024
GEI Project No. 2204052

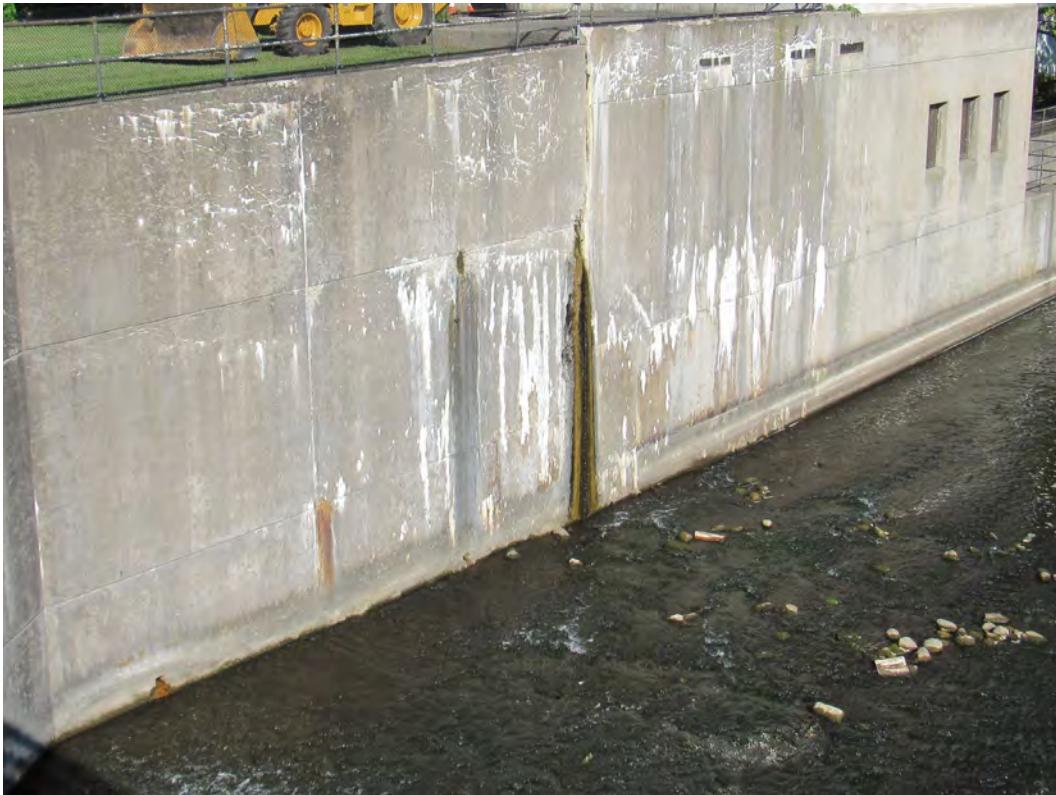
Figure 12 – Downstream, West Wall: Spalled Out Construction Joint

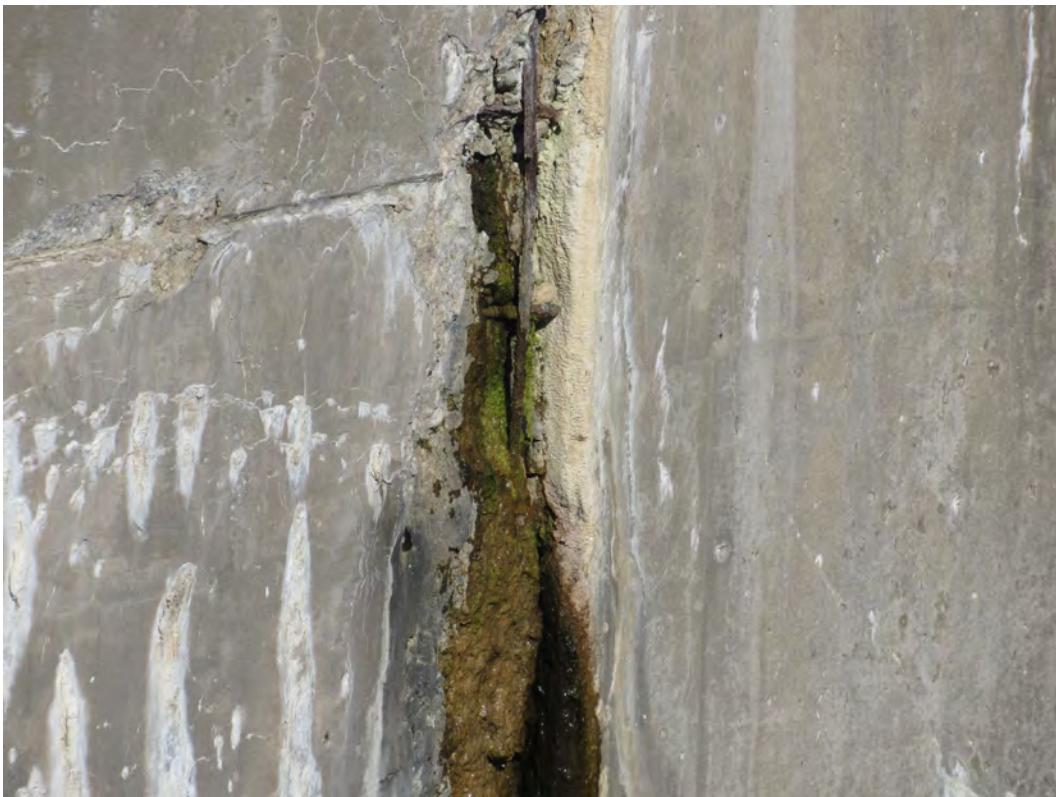
Figure 13 – Downstream, West Wall: Spalled Out Construction Joint: Exposed Rebar

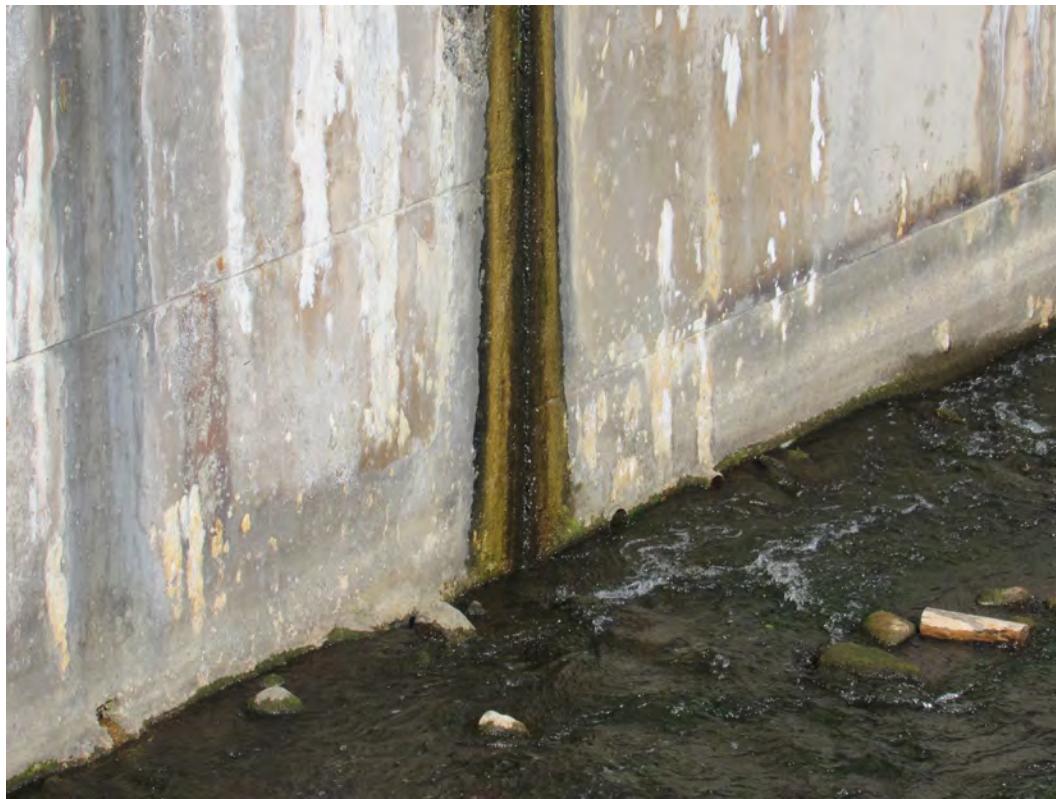
Figure 14 – Downstream, West Wall: Spalled Out Construction Joint

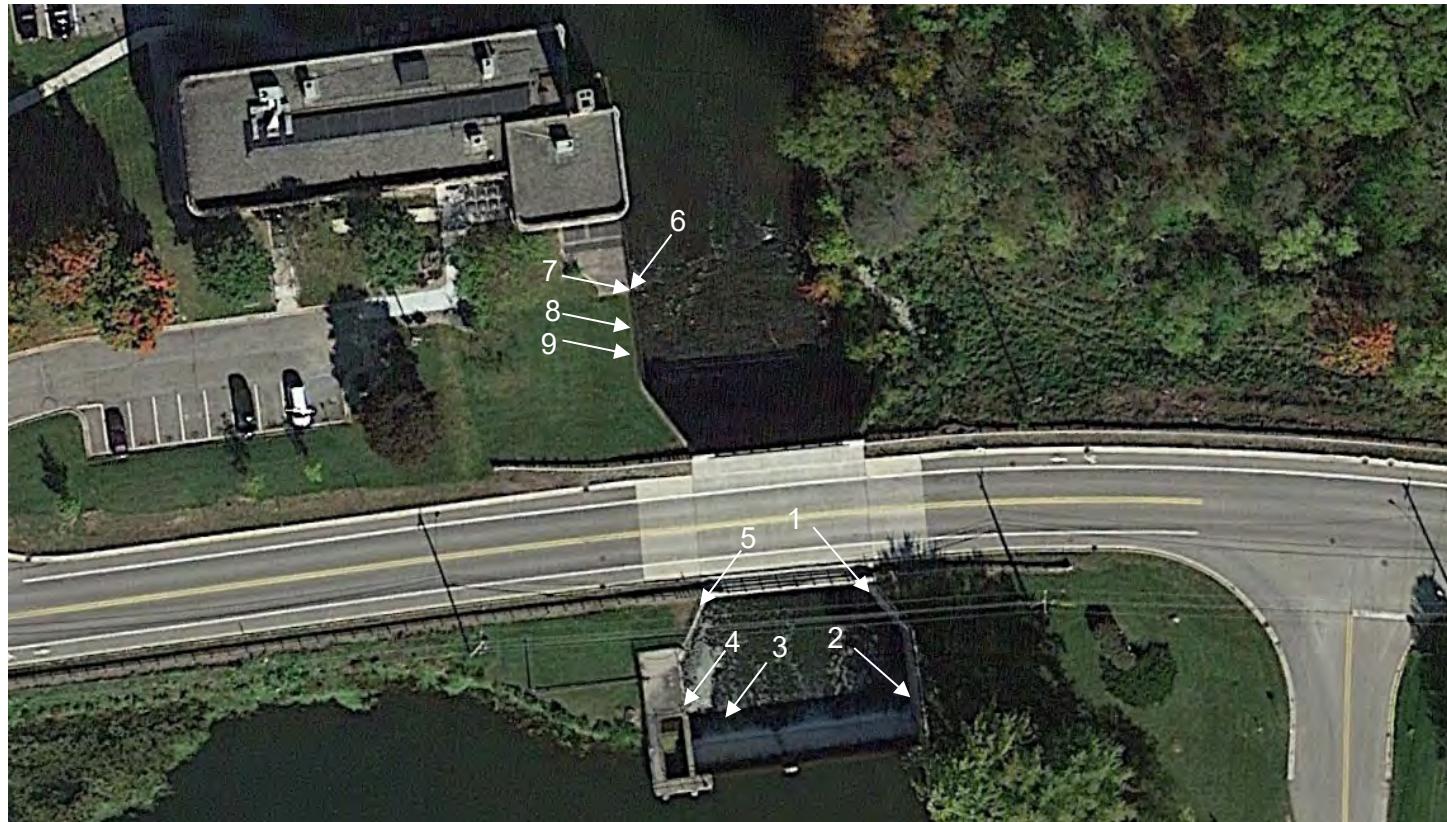
Stationing 1 – Cedar Falls Dam: Downstream

Station	Deficiency Type	Width	Height	Loss	Comments
1	Spalling	3.5"	11"	1"	3.5-inches above waterline, on east wall
2	Delamination	62"	57"	1.25"	30-inches above waterline, on east wall
3	Undermining	4"	8"	8"	Along the face of the Spillway
4	Spalling	14.5"	3"	3"	36-inches above waterline, on west wall
5	Spalling – Exposed Rebar	52"	83"	7.5"	West wall
6	Construction Joint Spalling – Exposed Rebar	28"	Entire Wall	6"	West wall, was leaking small amount of water
7	Construction Joint	N/A	N/A	N/A	Intake tunnel, source of leaking water at Station 6
8	Hairline Crack	N/A	N/A	N/A	Intake Tunnel, East Wall 27-feet upstream of the gates
9	Hairline Crack	N/A	N/A	N/A	Intake Tunnel, East Wall 40-feet upstream of the gates

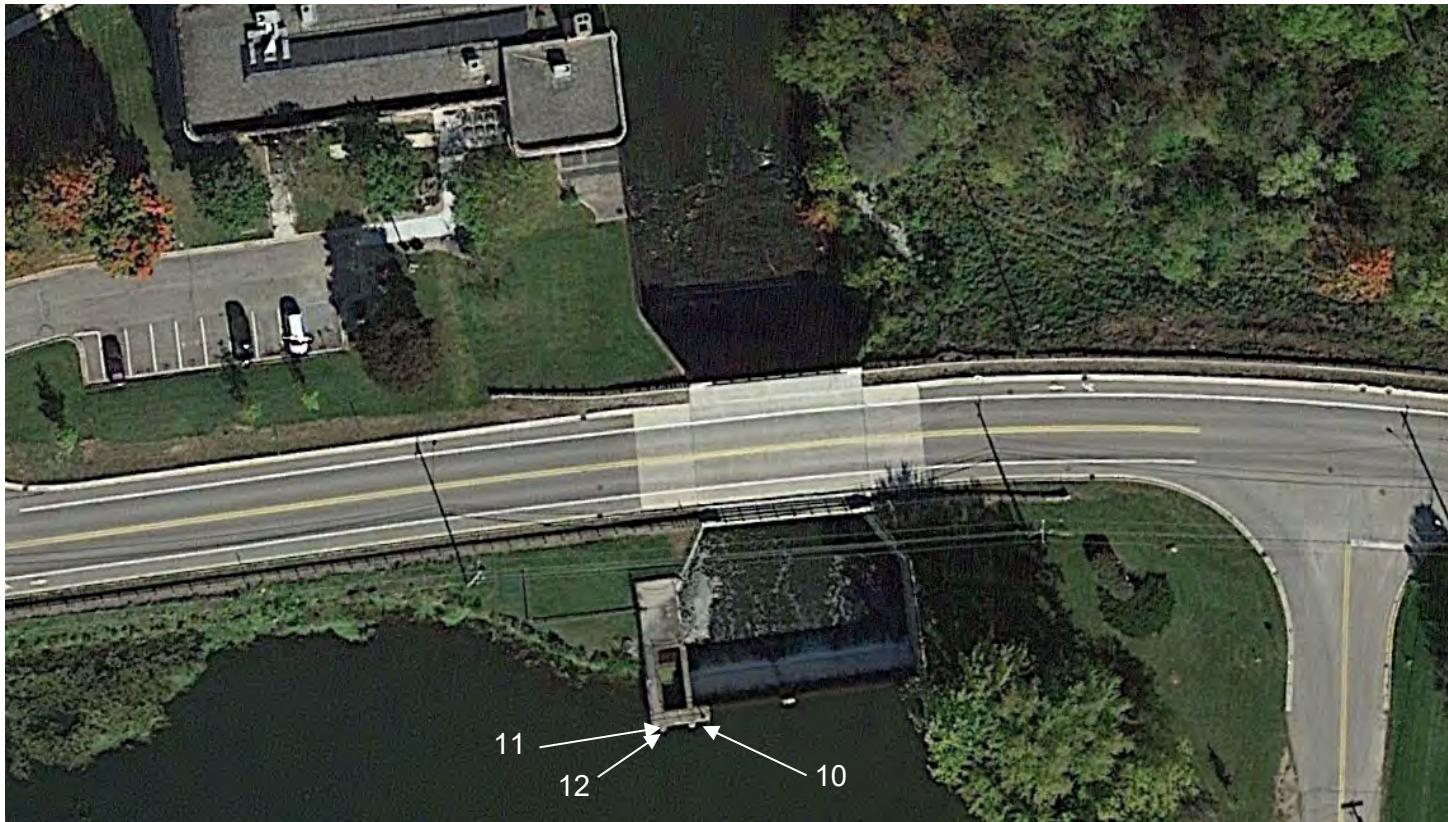
Stationing 1 – Cedar Falls Dam: Upstream

Station	Deficiency Type	Width	Height	Loss	Comments
10	Spalling	36"	27"	4"	At waterline, Bullnose 1
11	Spalling	36"	22"	6"	At waterline, Bullnose 2
12	Scaling	10"	16"	2"	7-inches below waterline, Bullnose 2
