Inspection, Analysis, and Recommendations Report Ford Manchester Dam

River Raisin
Manchester, Michigan
EGLE Dam ID No. 391

February 14, 2024
GEI Project No. 2204052

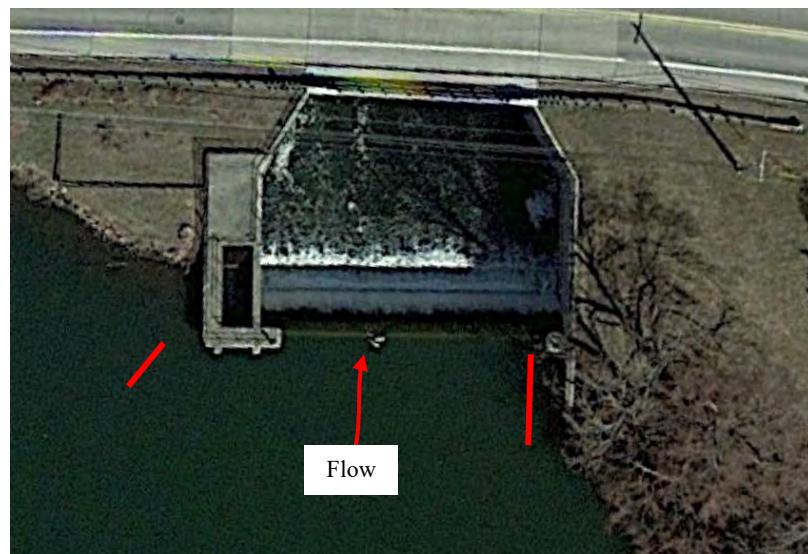
Figure 2-1: Upstream Wing Walls - Plan

GEI observed the condition of the top of the exposed upstream right wing wall outlined in red in **Figure 2-1** above. The top of wall concrete had spalling in localized areas with some areas extending down the face of the wall up to 18 inches. See Photos 14 through 16 in **Appendix B**.

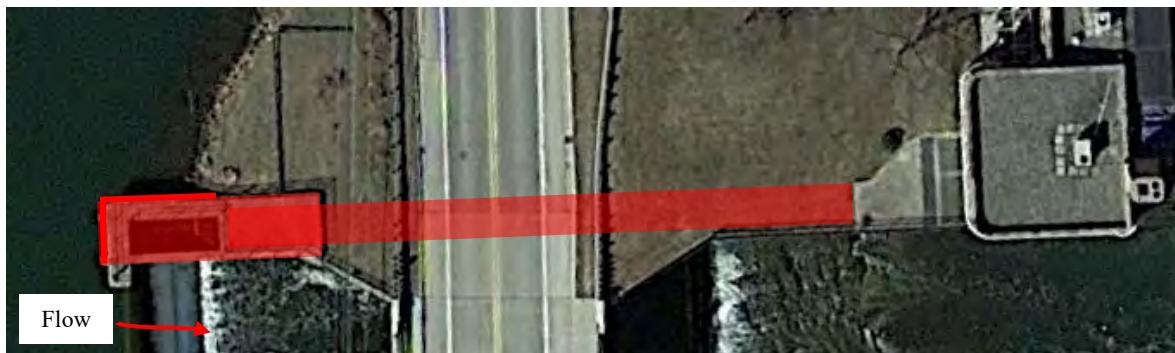
Figure 2-6: Penstock Intake and Penstock - Plan

GEI observed the condition of the deck above the penstock intake as highlighted in red in **Figure 2-6** above. The top face of the concrete deck appears to have hair line cracking. The edges and exposed sides on the concrete deck show signs of distress in the form of spalling for the majority of the deck perimeter. See Photos 24 through 36 in **Appendix B**.

JFB observed the condition of the face and foundation of the exterior walls of the penstock intake as outlined in red in **Figure 2-6** and the condition of the bullnoses highlighted in red in **Figure 2-7** above. The face of the exterior walls (left, upstream and right) of the penstock intake do not appear to have any signs of distress observed. Both bullnoses on the upstream face of the penstock intake have significant spalling at the freeze thaw line. In addition, the upstream left bullnose has an area of scaling below the headwater elevation. See Photos 24 through 36 in **Appendix B** and Figures 34, 36, and 37 in **Appendix C**.

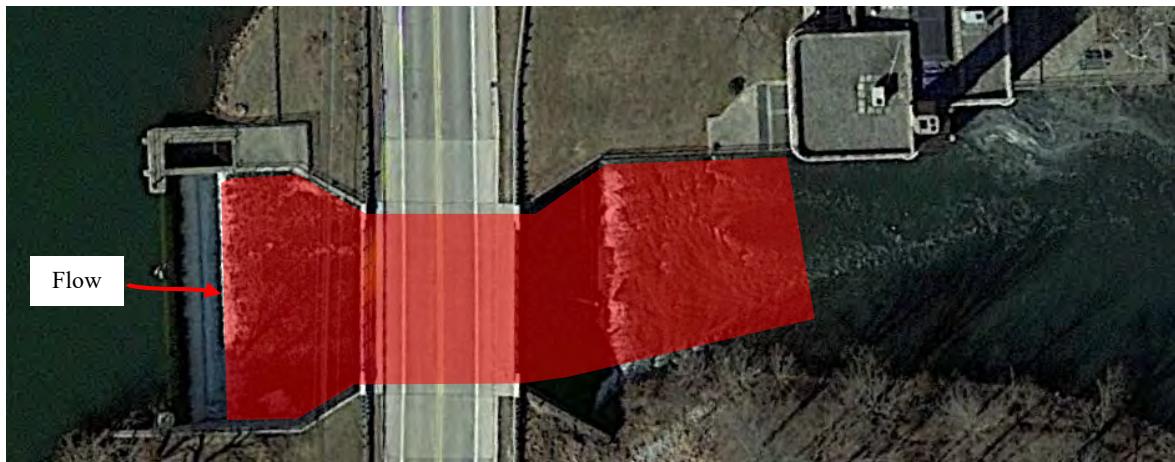
Figure 2-10: Downstream Spillway Slab - Plan

JFB observed the condition of the downstream left spillway slab as shown in **Figure 2-10** above. An area of undermining was noted at the downstream face of the concrete gravity spillway structure. However, the concrete gravity structure is founded on the spillway slab. Therefore, it appears that there may be separation of the concrete gravity structure and the spillway slab or an area of deteriorated concrete. This location was only observed by feel and would need to be dewatered for further inspection. The weir structure was located during the observations as depicted in **Figure 2-12** above. The drains shown in **Figure 2-11** above were not found during the inspection; however, the slab was not able to be visually inspected due to the amount of water present during the dive observations.

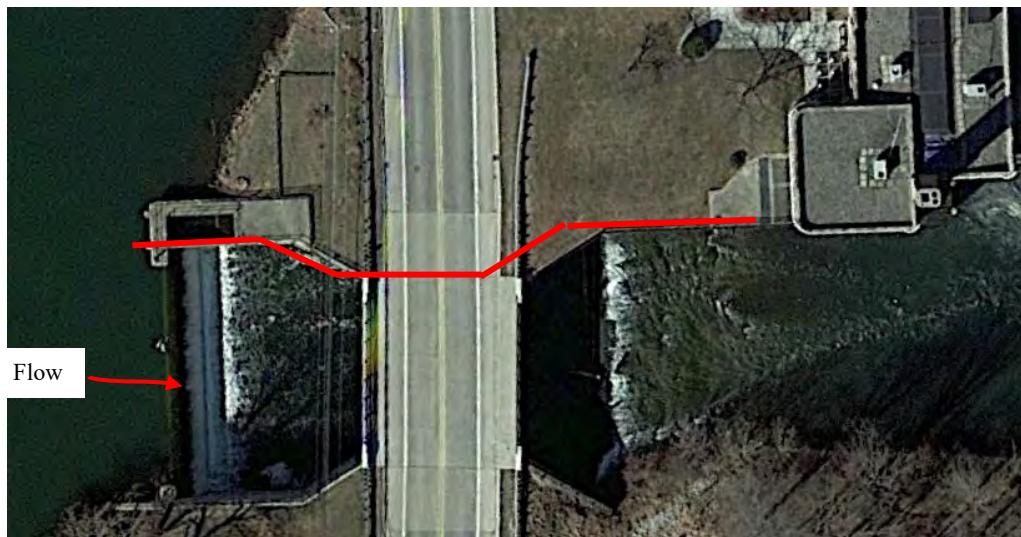
Figure 2-13: Downtown Left Wall - Plan

JFB observed the condition of the face and foundation of the downstream left wall located upstream of the M-52 bridge as outlined in red in **Figure 2-13** and highlighted in red in **Figure 2-14** above. The wall did not appear to have any undermining. However, spalling was noted on the face of the wall above the tailrace water elevation at two (2) locations, with one (1) location having exposed rebar and vegetation growth. See Photo 47 in **Appendix B** and Figures 9 through 11 in **Appendix C**.

JFB observed the condition of the face and foundation of the downstream left wall located downstream of the M-52 bridge as outlined in red in **Figure 2-13** and highlighted in red in **Figure 2-14** above. The wall did not appear to have any undermining. However, spalling with exposed reinforcing steel was noted on the face of the wall at the construction joint above the tailrace water elevation. In addition, to spalling water was present seeping through the construction joint from the inside of the penstock. See Photos 49 and 50 in **Appendix B** and Figures 12 through 14 in **Appendix C**.

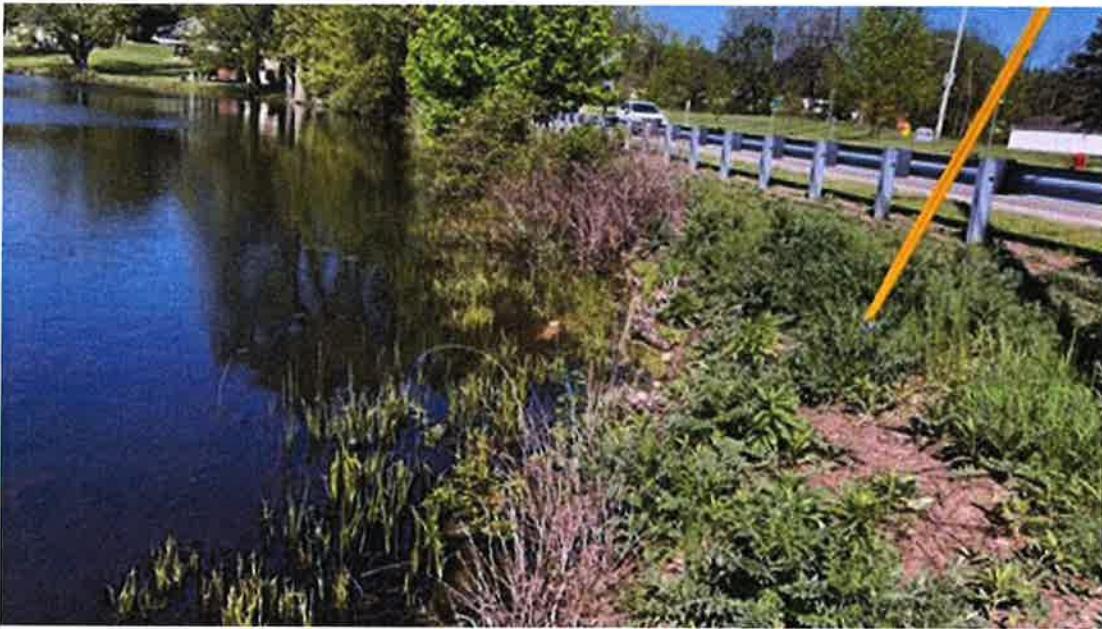
Photo #3 - Upstream slope of left embankment. Brush and trees present

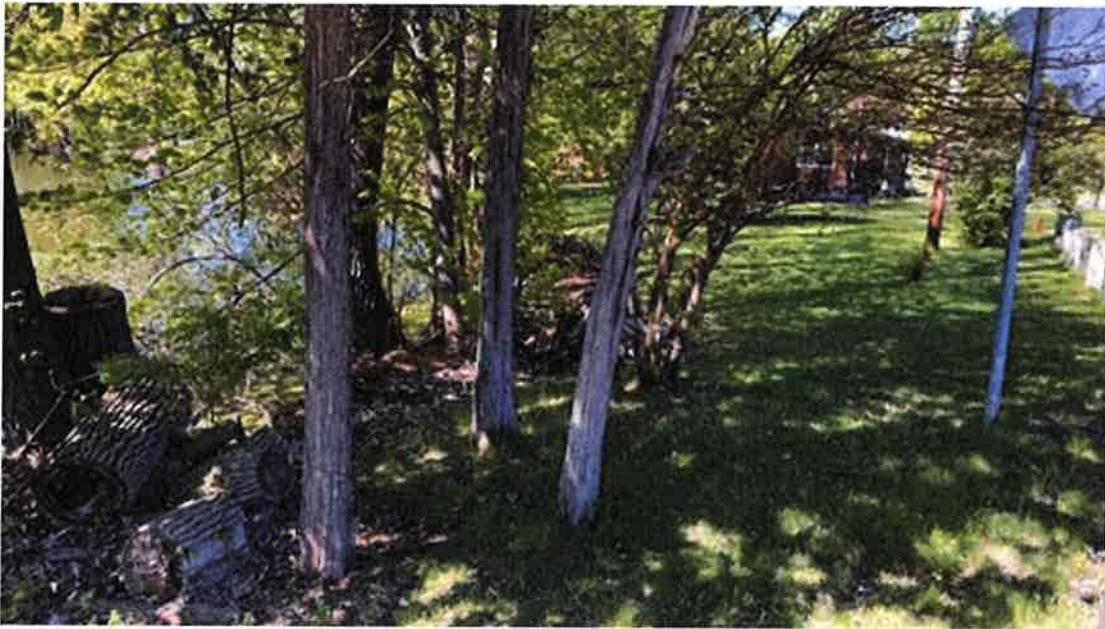
Photo #7 - Upstream slope of left embankment at embankment end

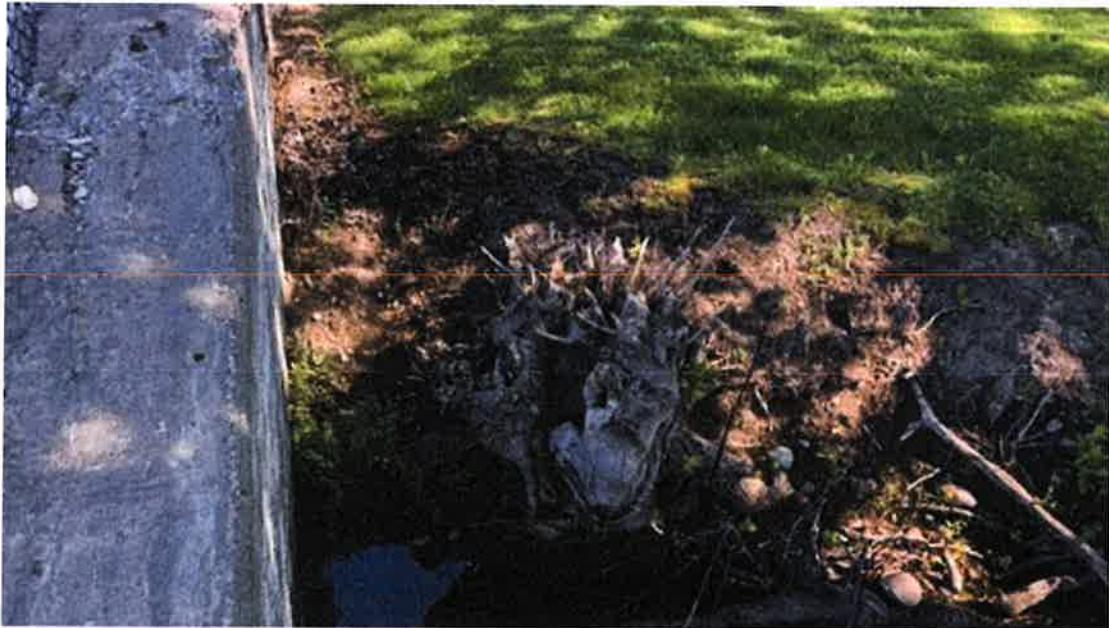
Photo #8 - Upstream slope of right embankment at abutment with spillway

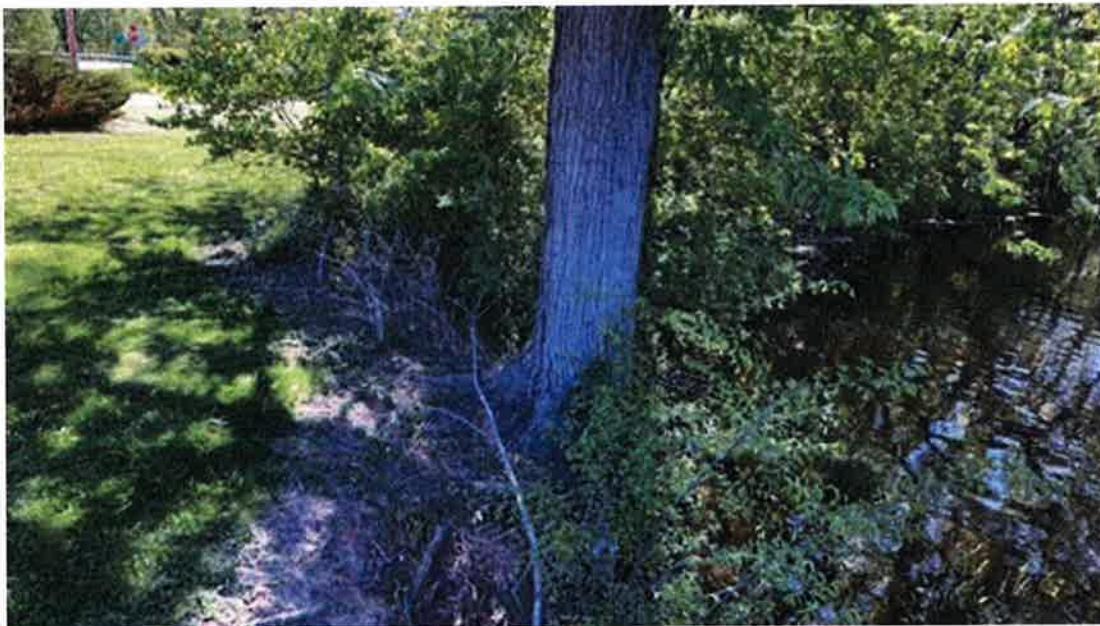
Photo #9 - Upstream slope of right embankment. Tree and brush present towards end of embankment

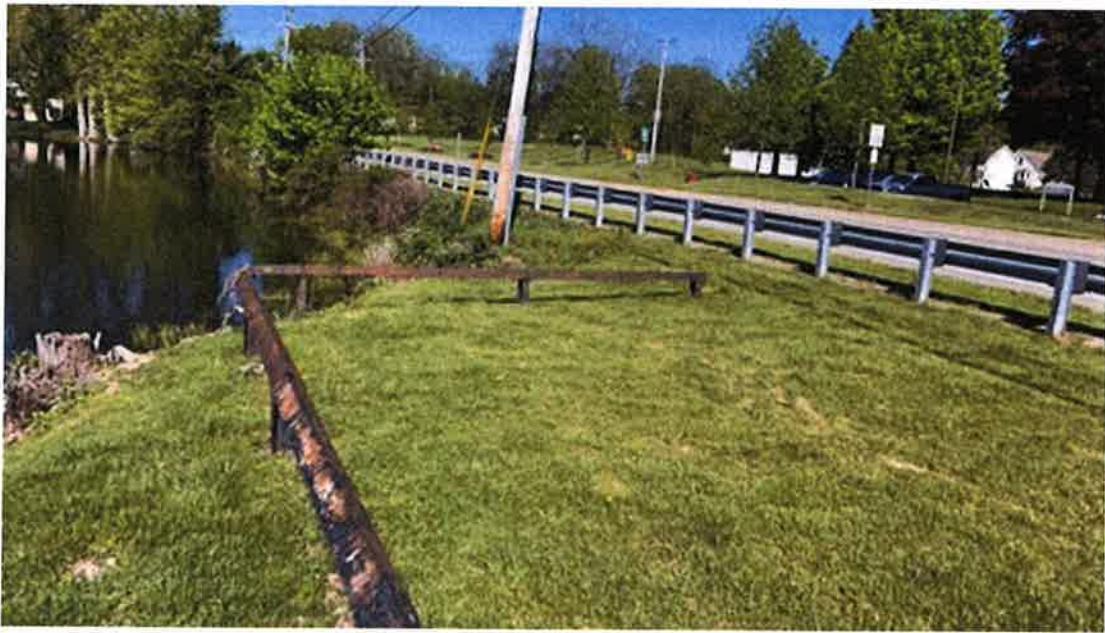
Photo #11 - Crest of left embankment viewed from spillway

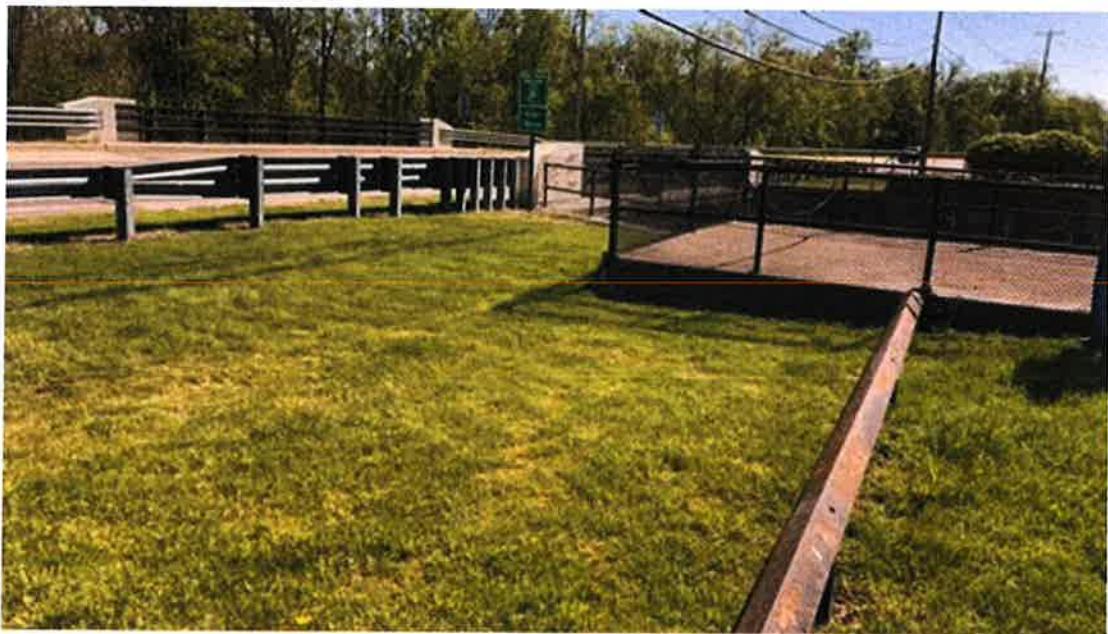
Photo #12 - Crest of left embankment viewed from left towards spillway

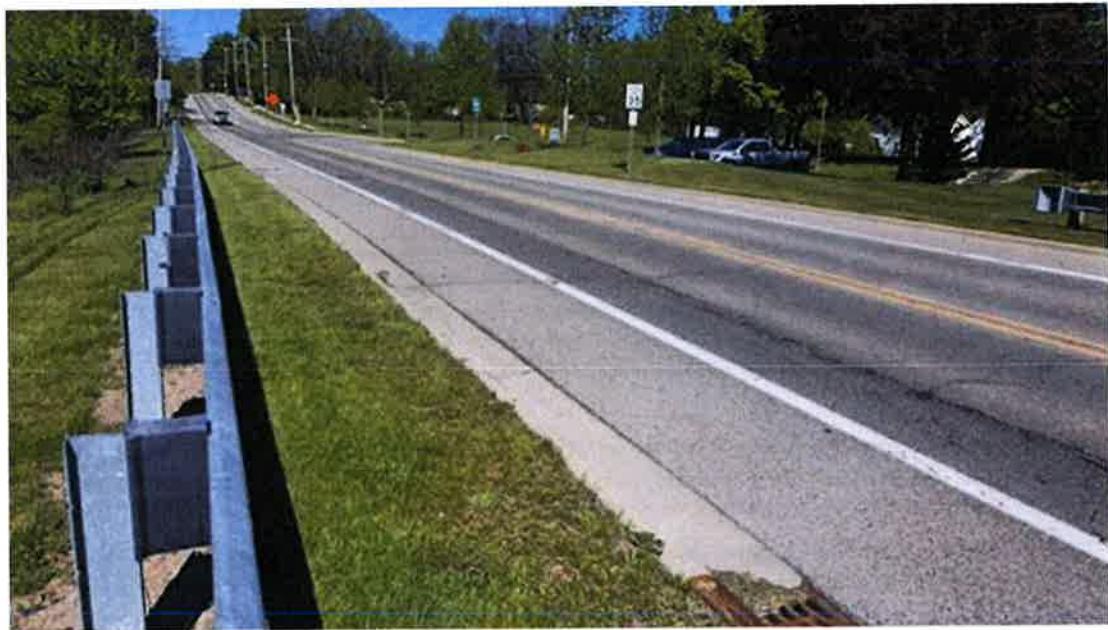
Photo #14 - Crest of left embankment; Roadway near village offices

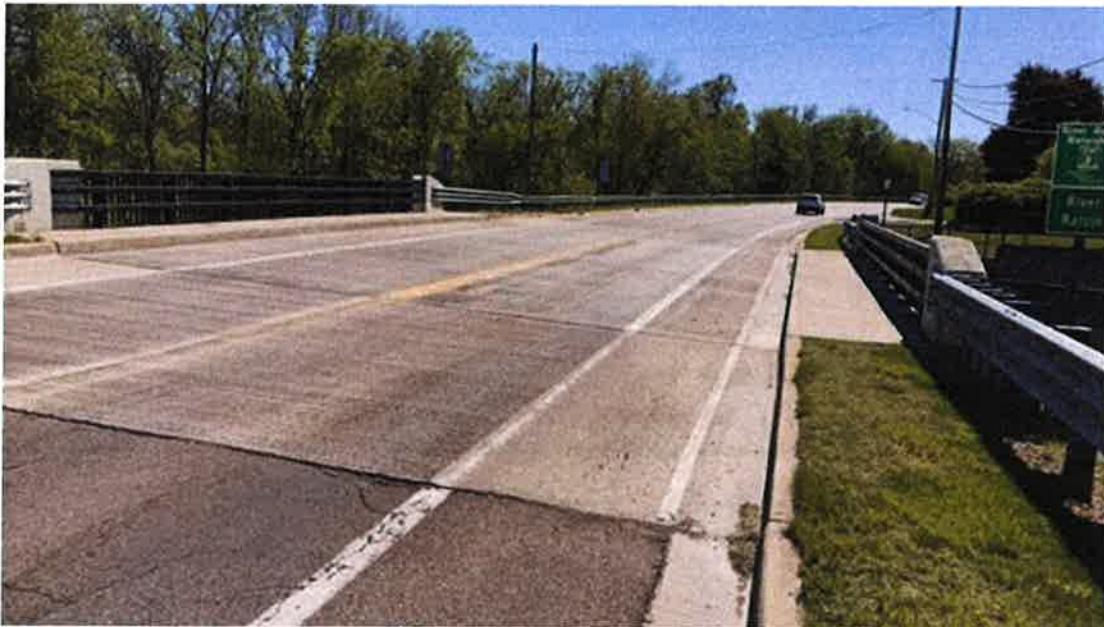
Photo #15 - Bridge over spillway outlet

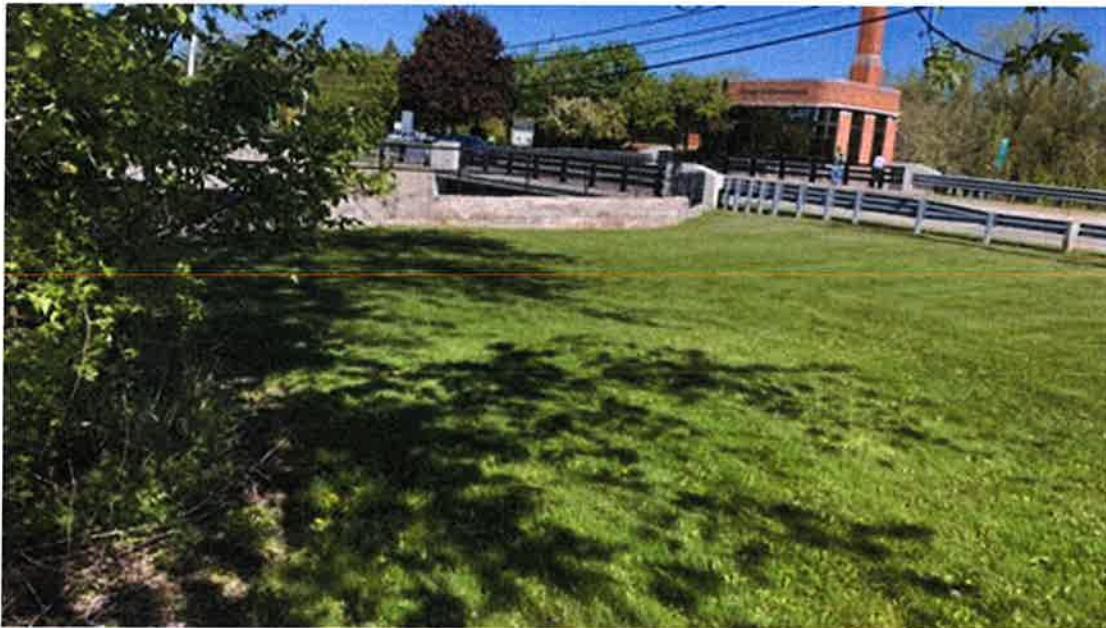
Photo #16 - Crest of right embankment

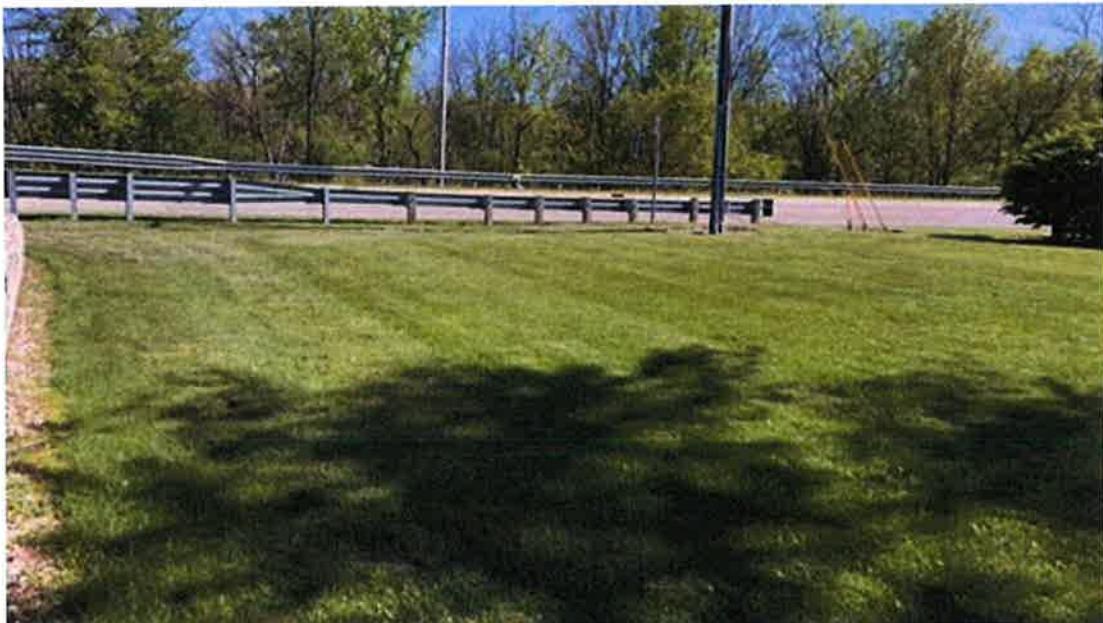
Photo #17 - Crest of right embankment

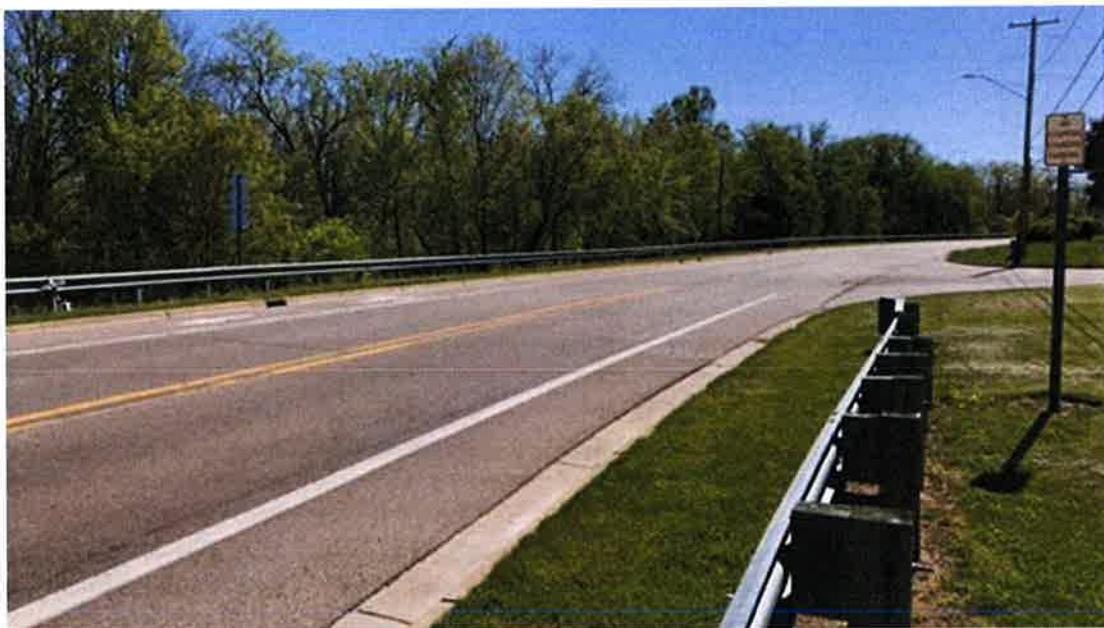
Photo #18 - Crest of right embankment

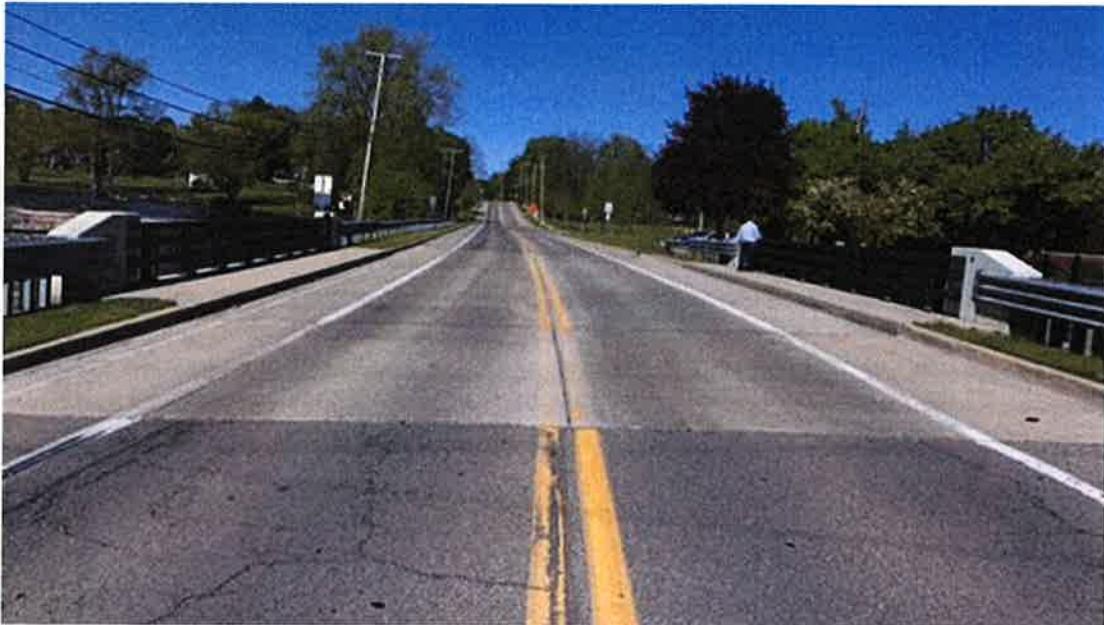
Photo #19 - Crest of embankment viewed from right

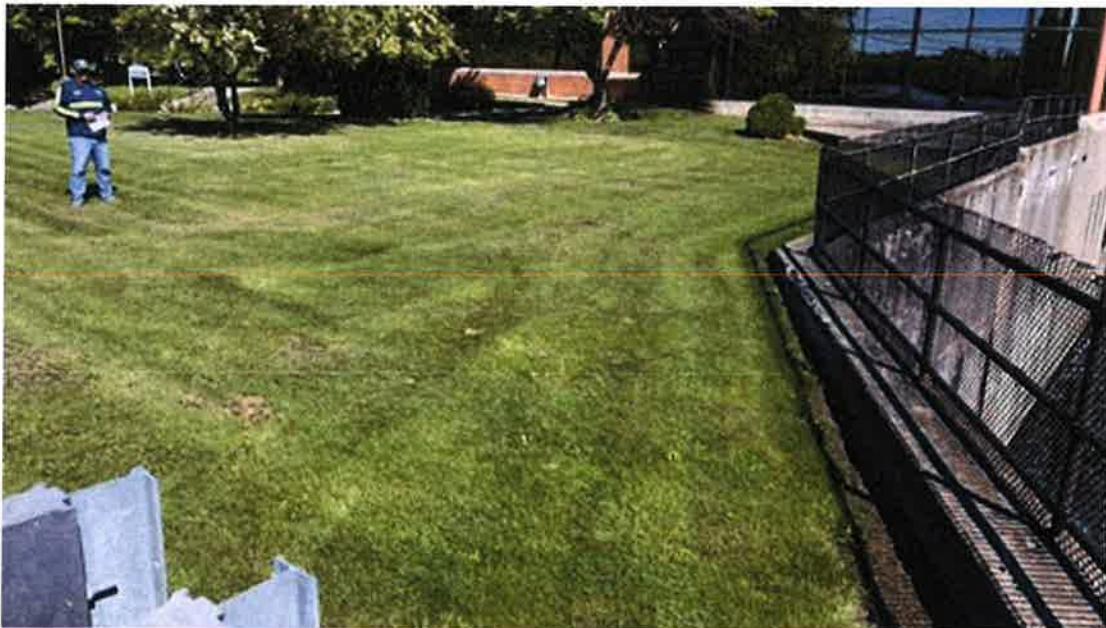
Photo #20 - Crest of left embankment in front of village offices

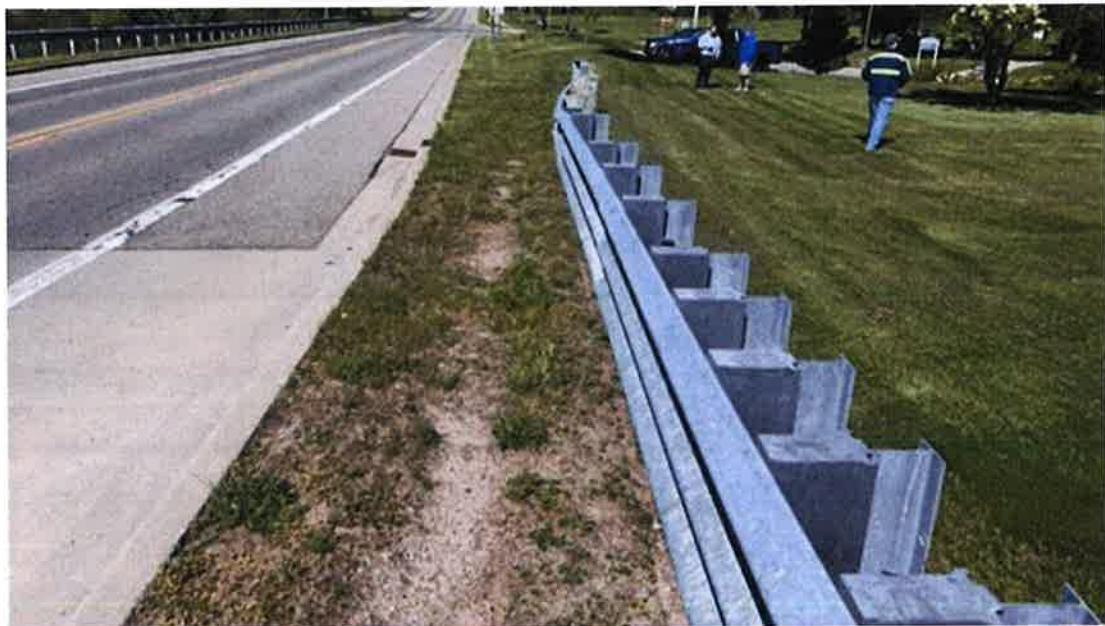
Photo #21 - Crest of left embankment in front of village offices

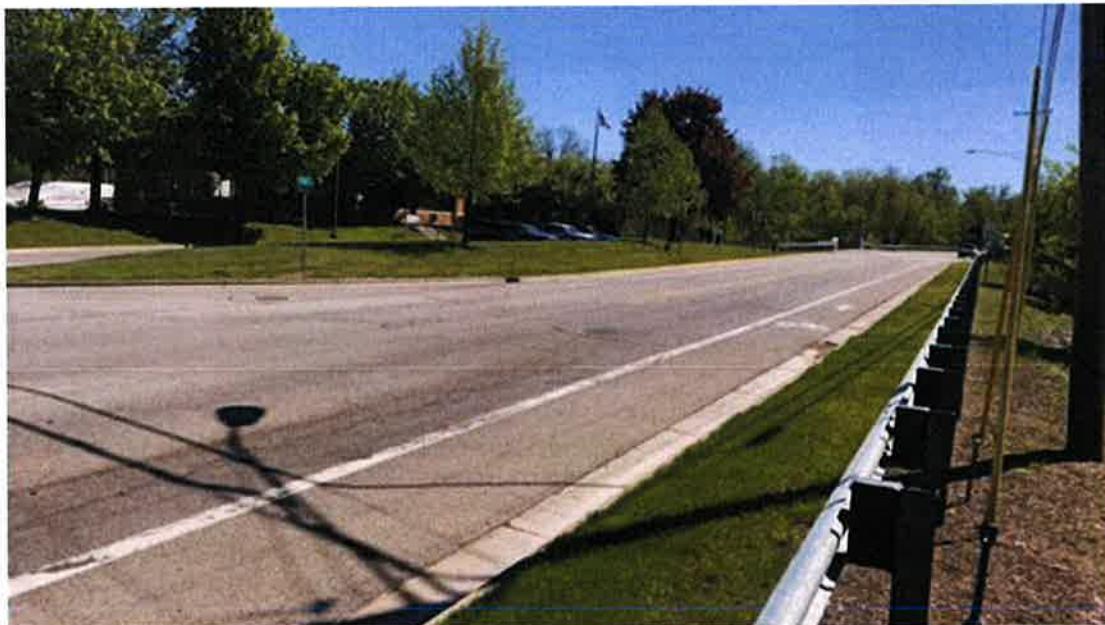
Photo #22 - Crest of left embankment viewed from left at left end

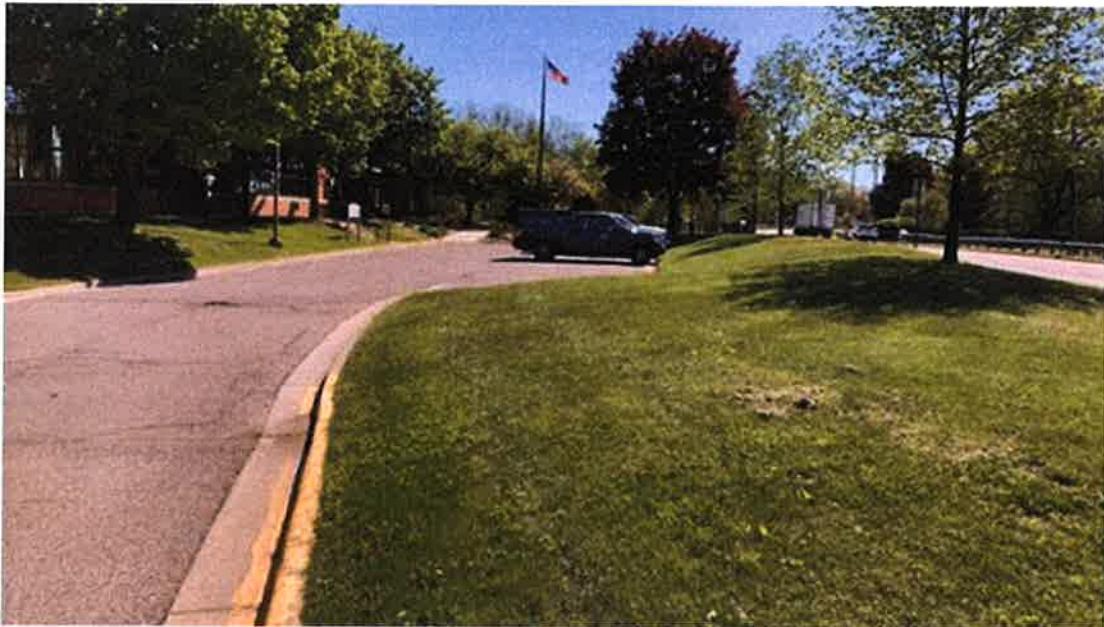
Photo #23 - Crest/Downstream slope of left embankment in front of village offices

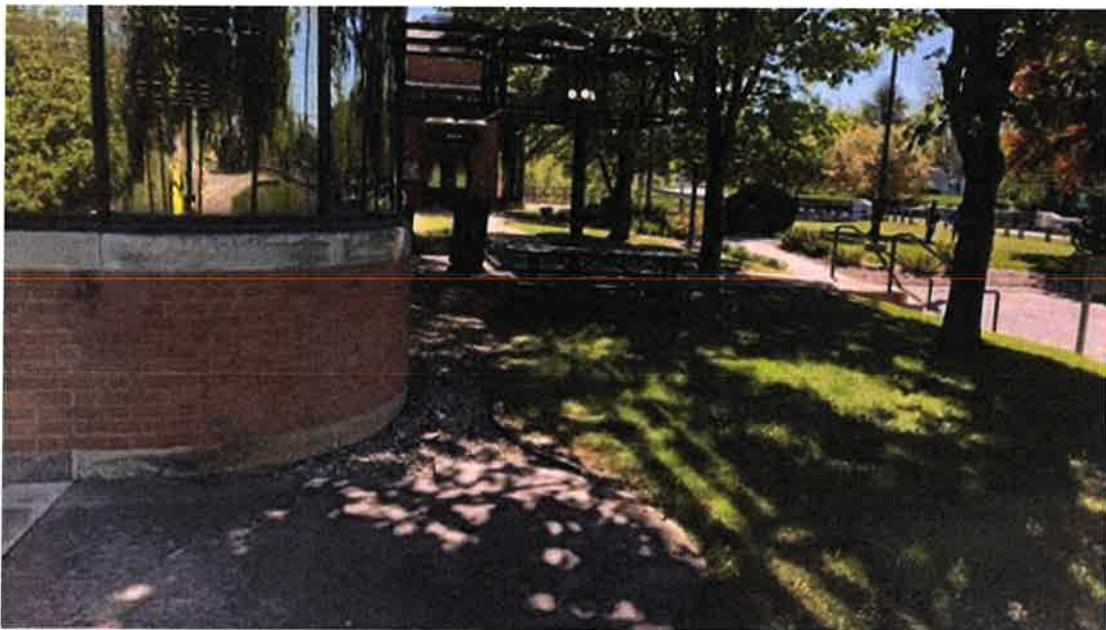
Photo #24 - Crest/Downstream slope of left embankment in front of village offices

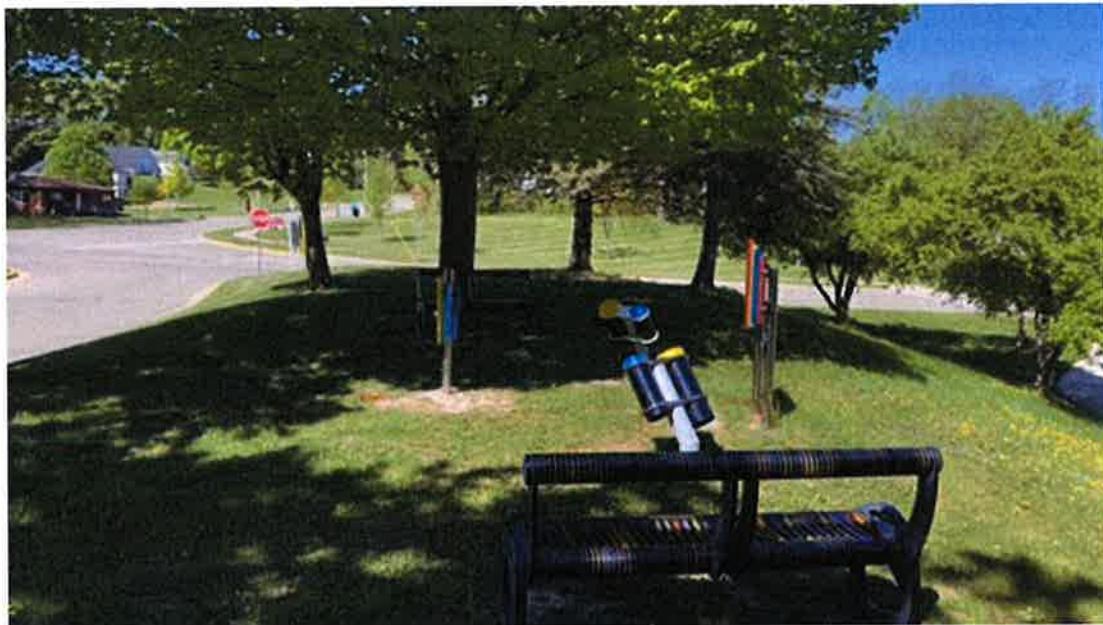
Photo #25 - Crest/Downstream slope of left embankment beside village offices

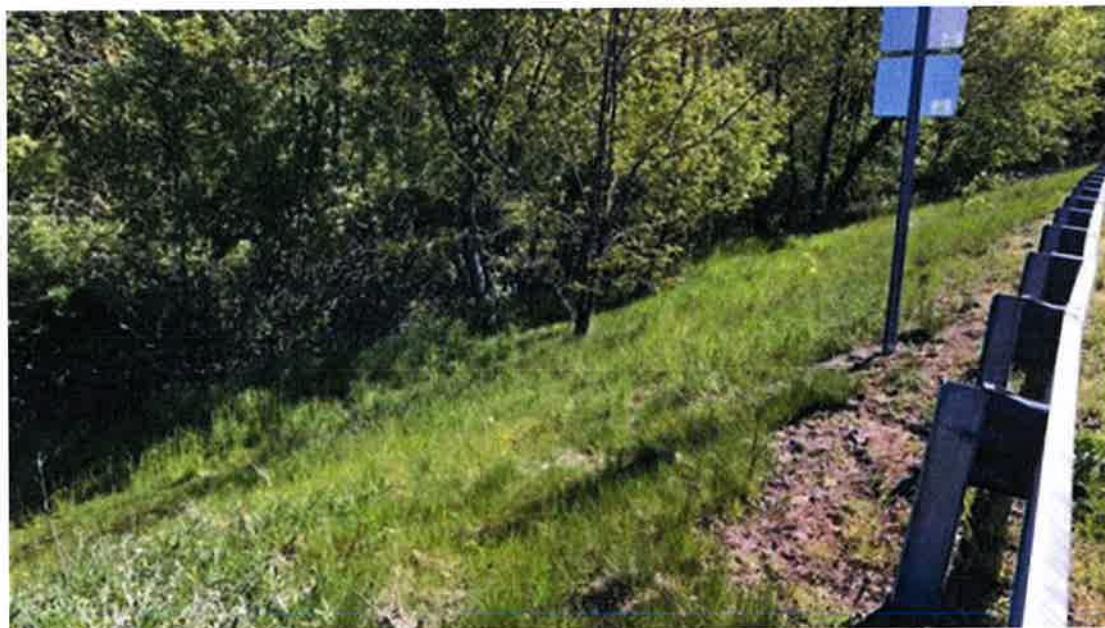
Photo #26 - Downstream slope of right embankment viewed from crest. Trees and brush encroaching past groin and past toe

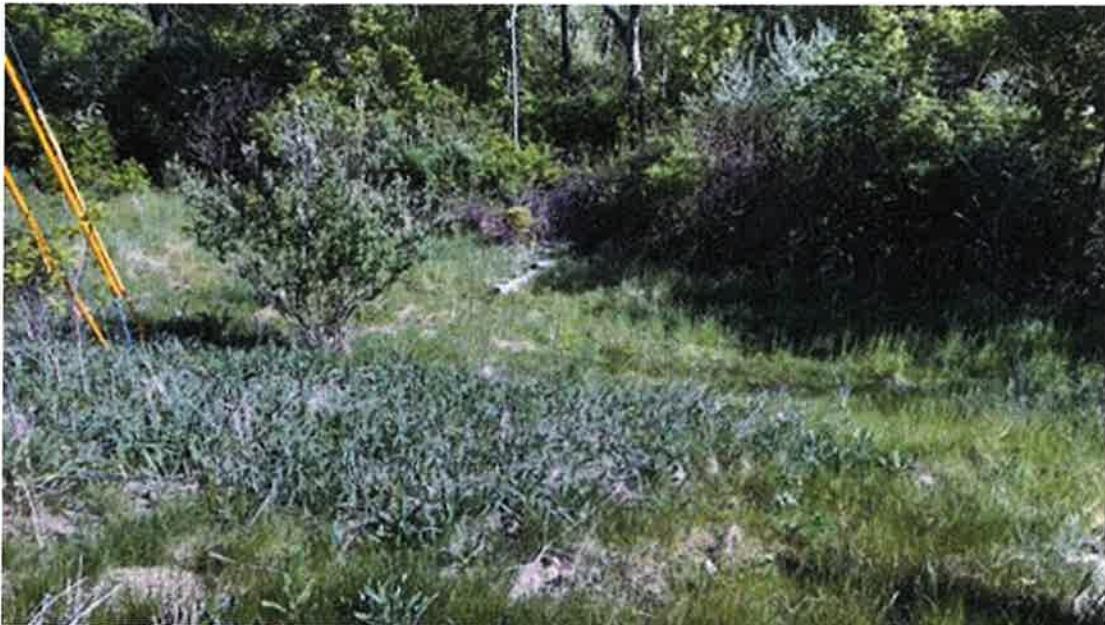
Photo #27 - Downstream slope of right embankment viewed from crest. Some brush is present and encroaching upward beyond toe

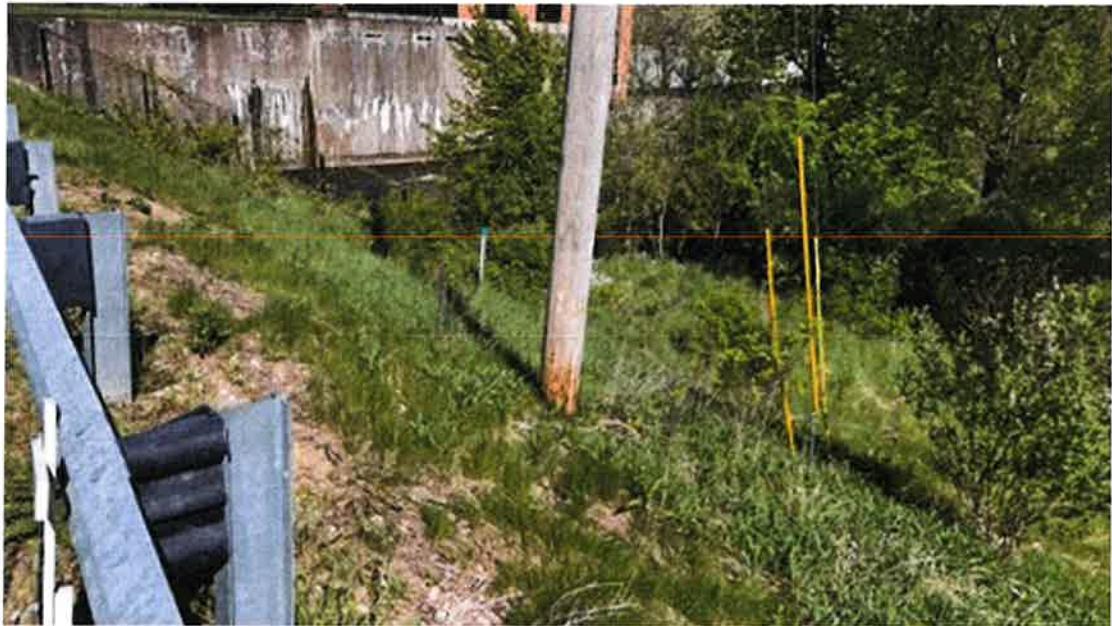
Photo #28 - Downstream slope of right embankment viewed from crest

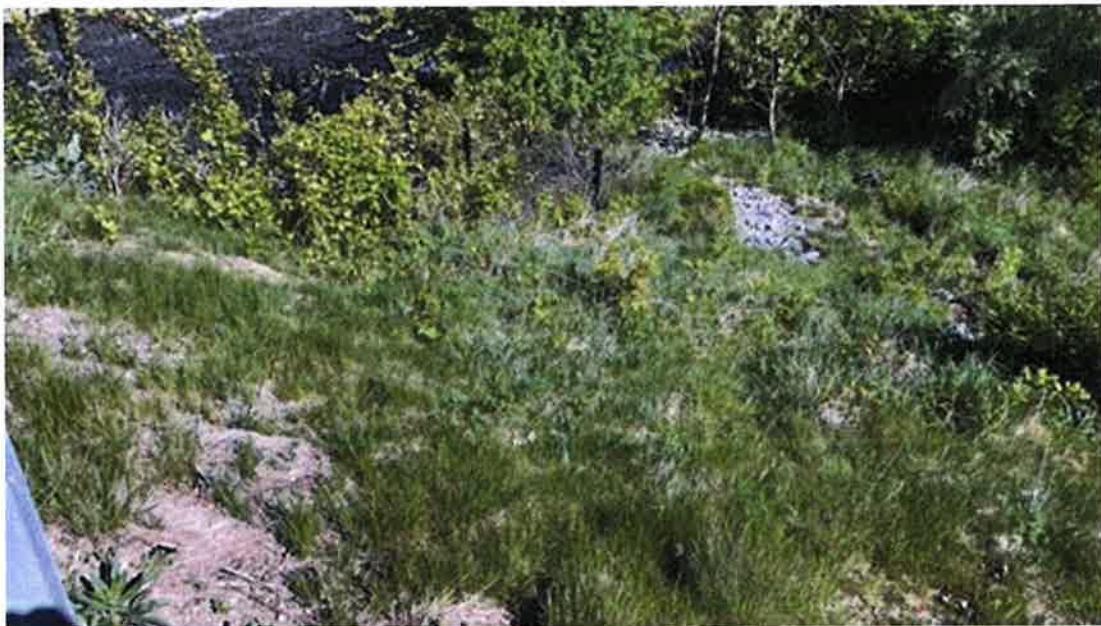
Photo #29 - Downstream slope of right embankment viewed from crest

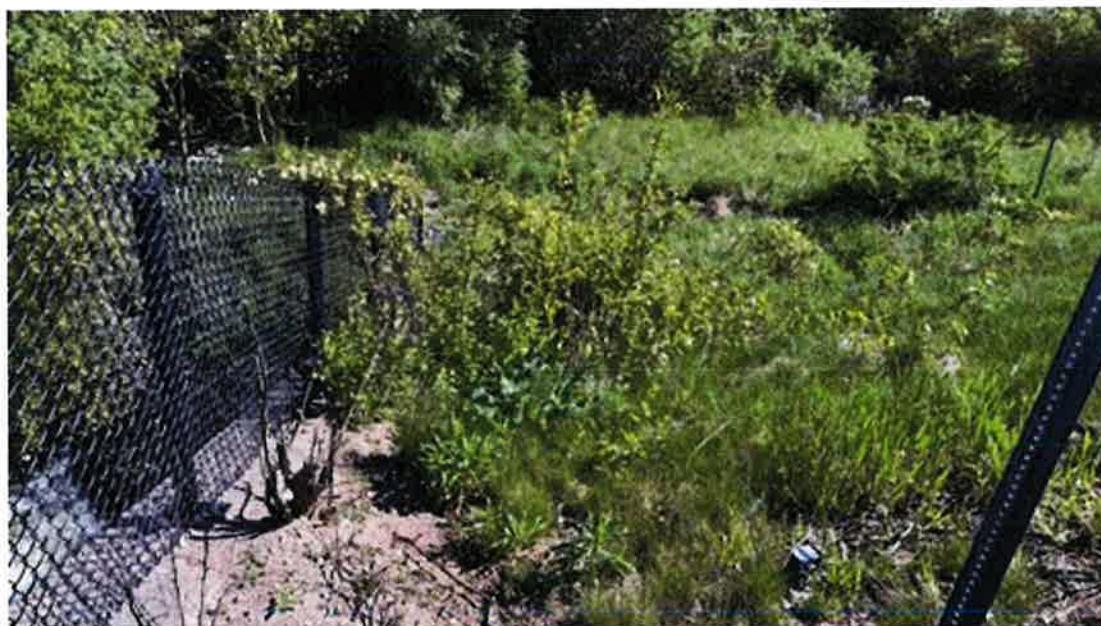
Photo #30 - Downstream slope of right embankment viewed from crest adjacent to spillway

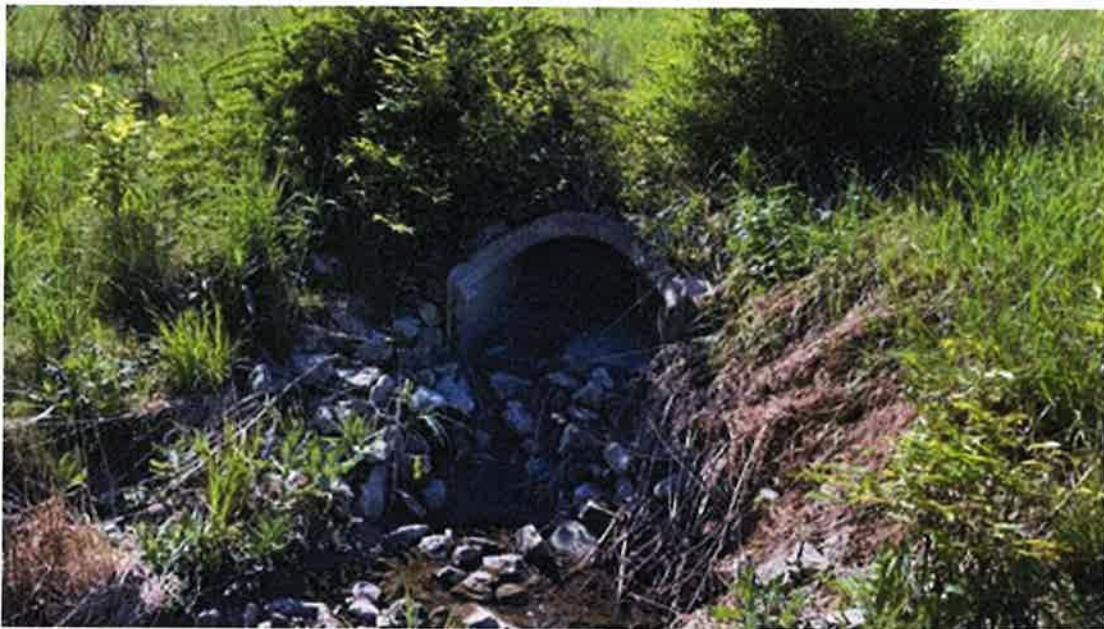
Photo #31 - Storm sewer outfall on right embankment downstream slope

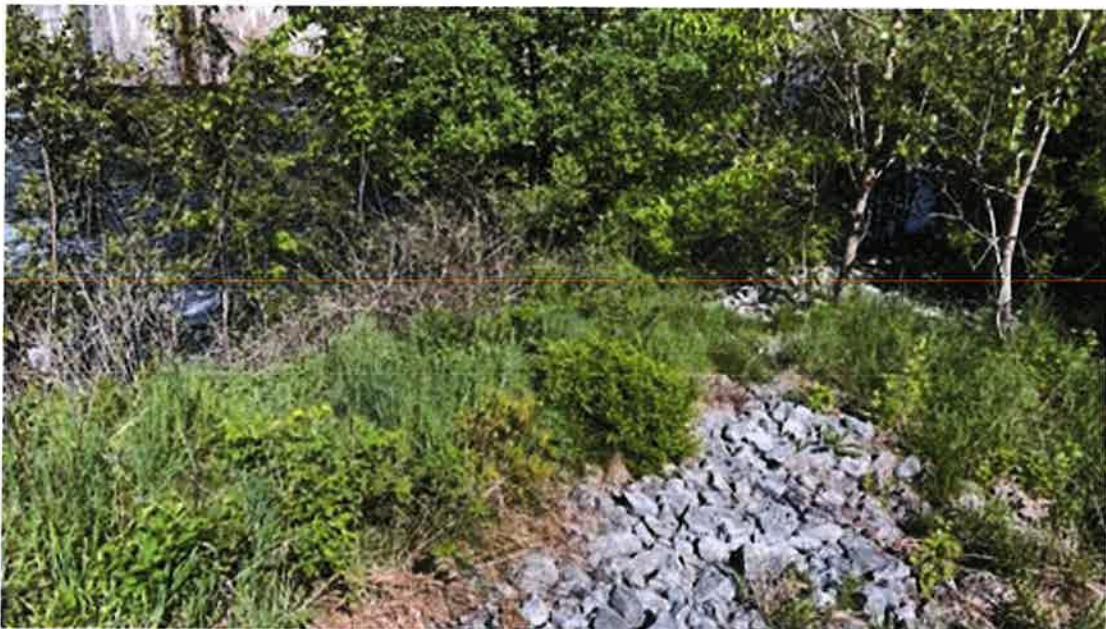
Photo #32 - Storm sewer outfall downstream flow path. Some of the flow path has been armored. Downstream of the armoring in the photo, runoff gullies are present

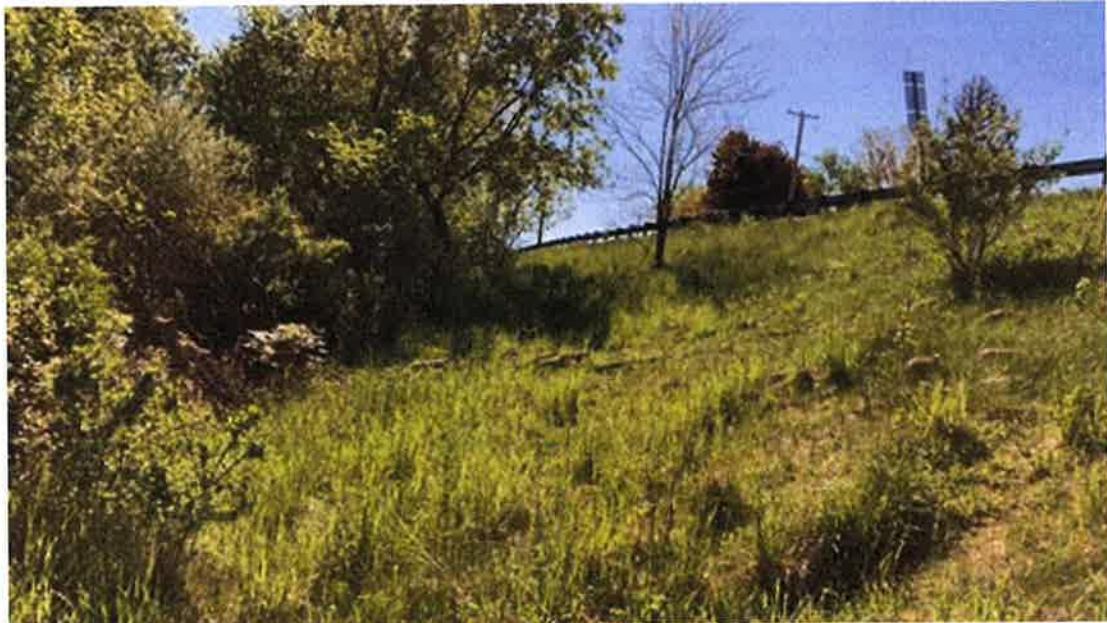
Photo #33 - Downstream slope of right embankment viewed from near downstream toe

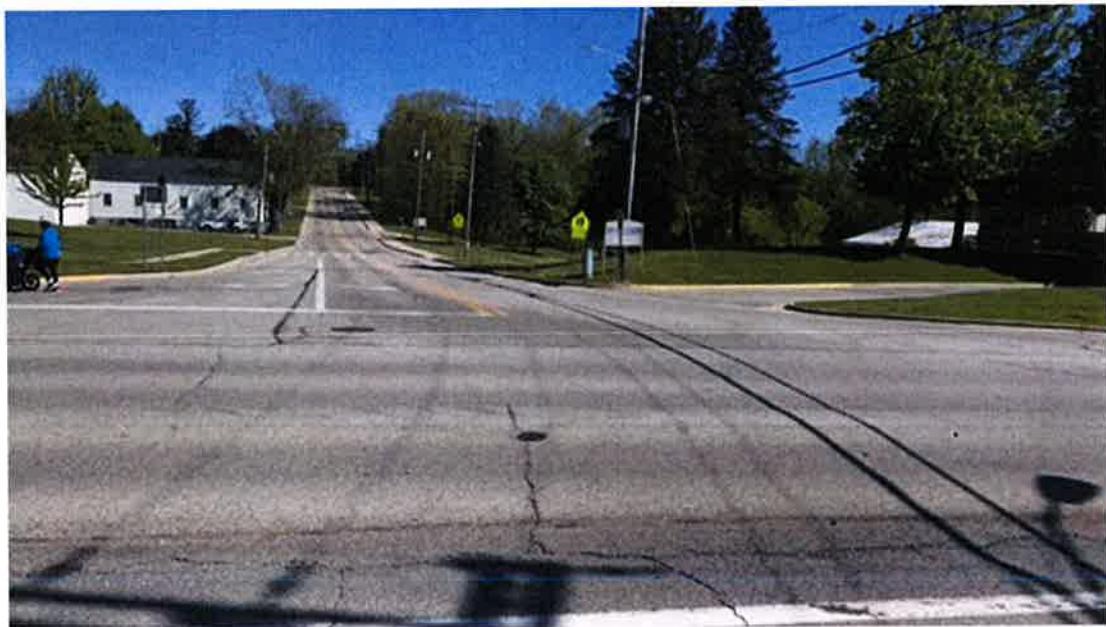
Photo #34 - Downstream slope of the left end of the left embankment

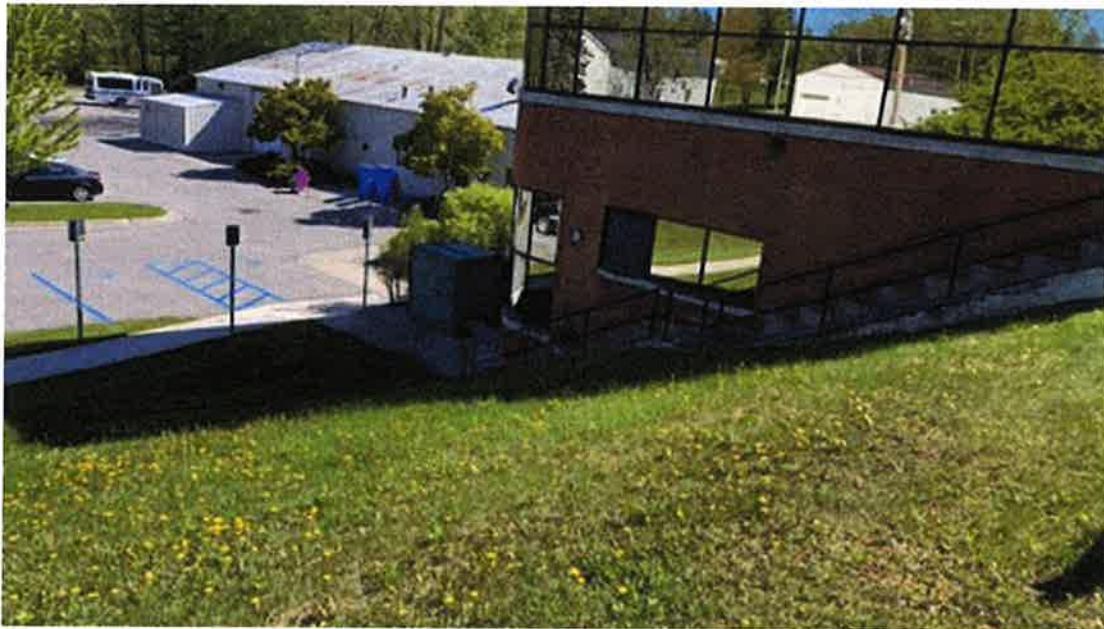
Photo #35 - Downstream slope of left embankment at village offices
