Inspection, Analysis, and Recommendations Report Ford Manchester Dam

River Raisin
Manchester, Michigan
EGLE Dam ID No. 391

February 14, 2024
GEI Project No. 2204052

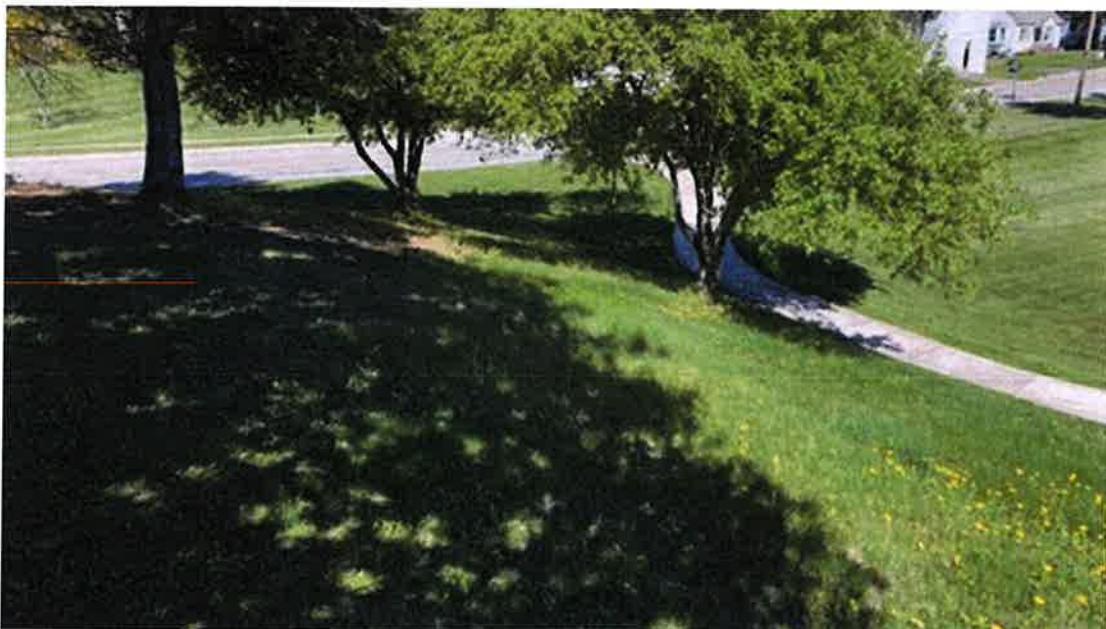
Photo #36 - Downstream slope of left embankment on village office grounds

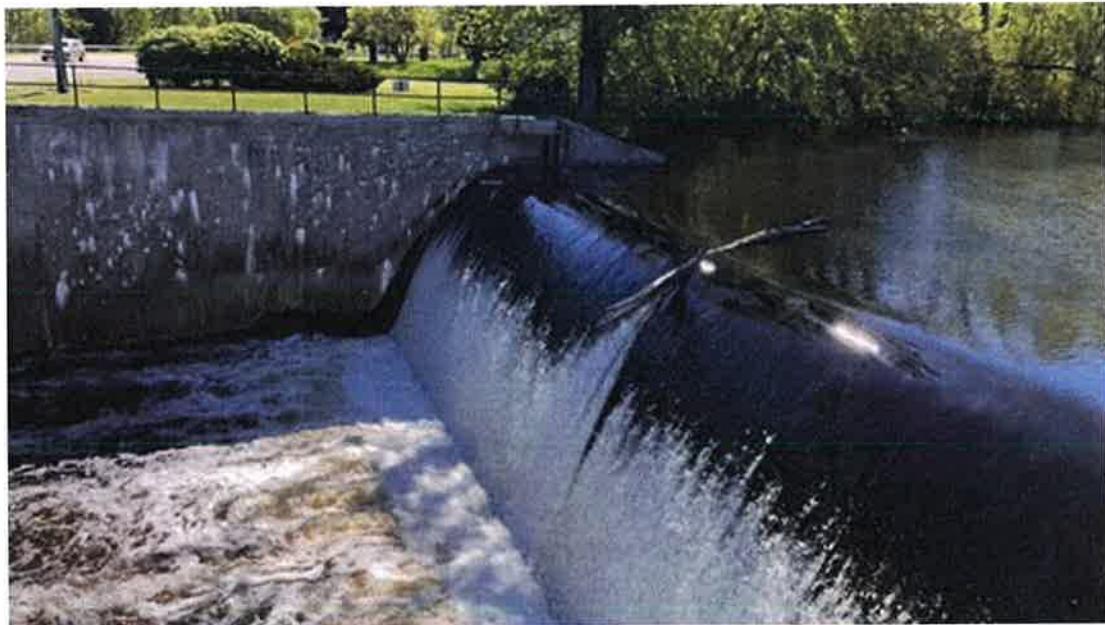
Photo #37 - Spillway crest. Note branch stuck on crest that should be removed

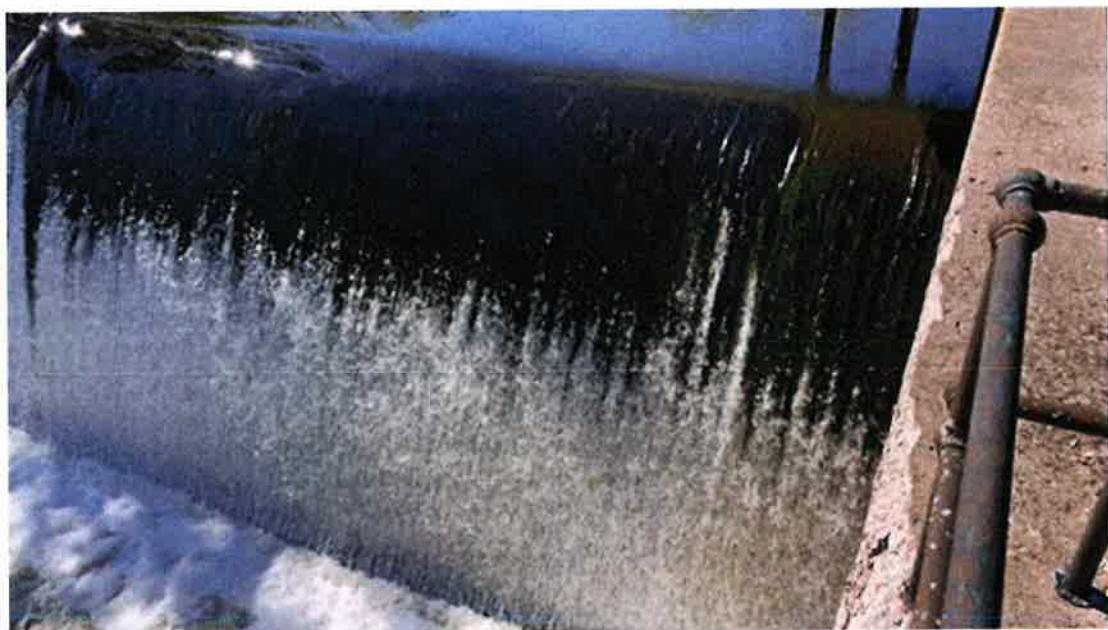
Photo #38 - Left end of spillway crest

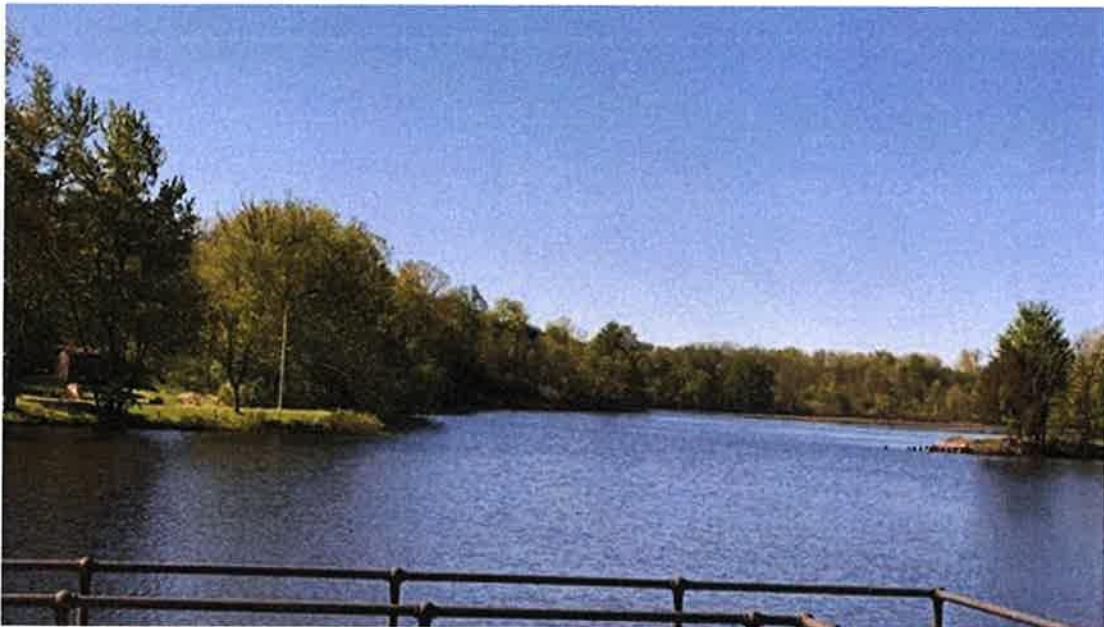
Photo #39 - Upstream impoundment viewed from spillway

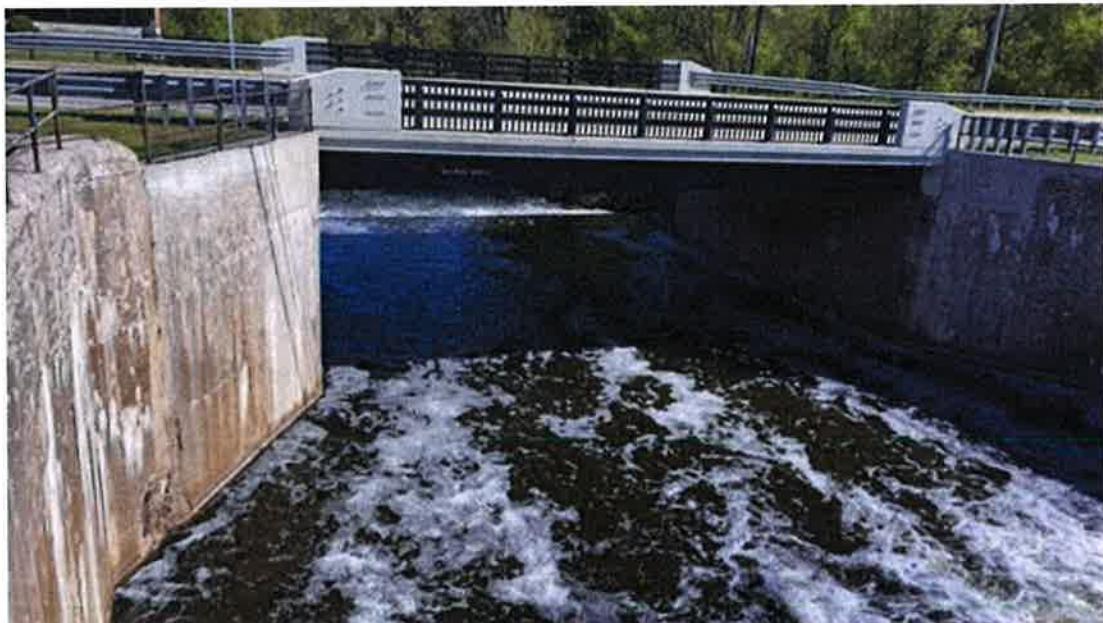
Photo #41 - Downstream spillway receiving channel under bridge

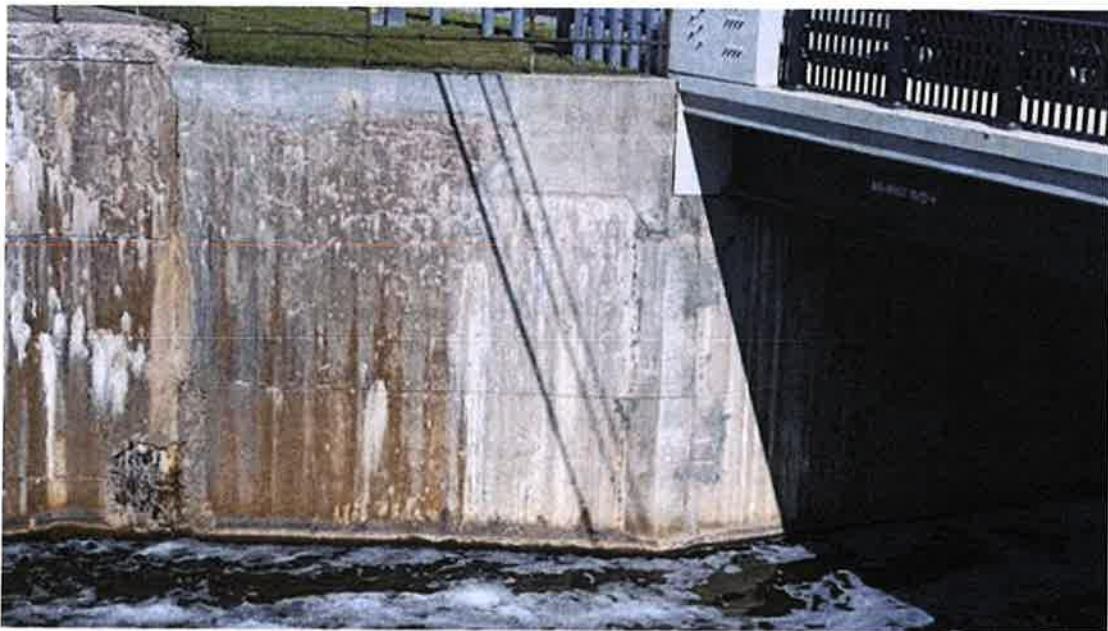
Photo #44 - Left downstream spillway abutment wall at joint with bridge

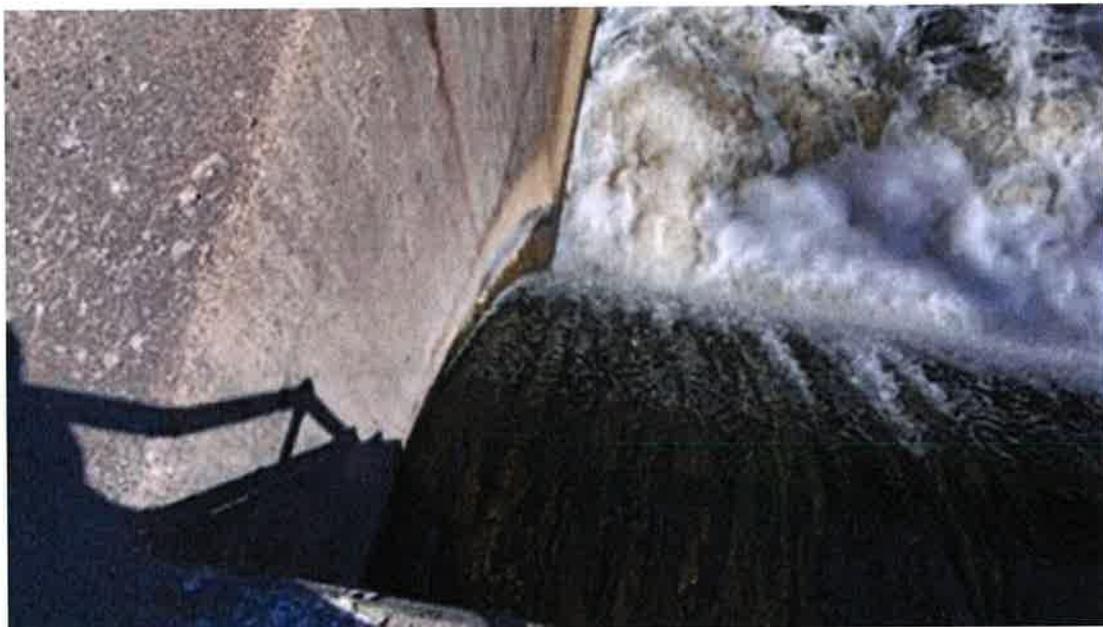
Photo #45 - Left end of spillway

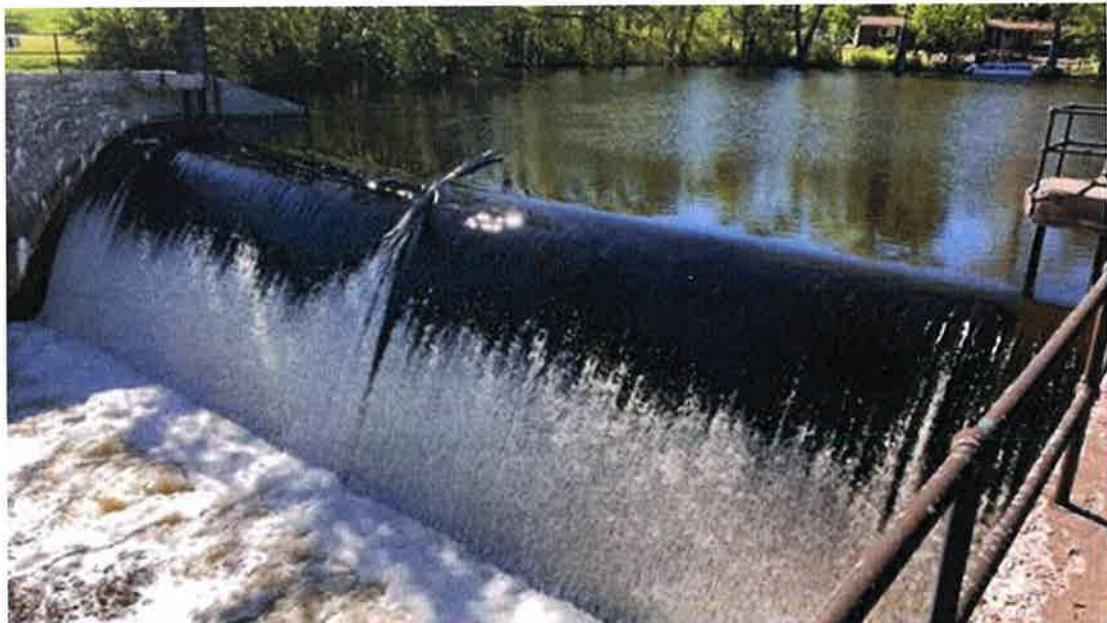
Photo #49 - Spillway crest

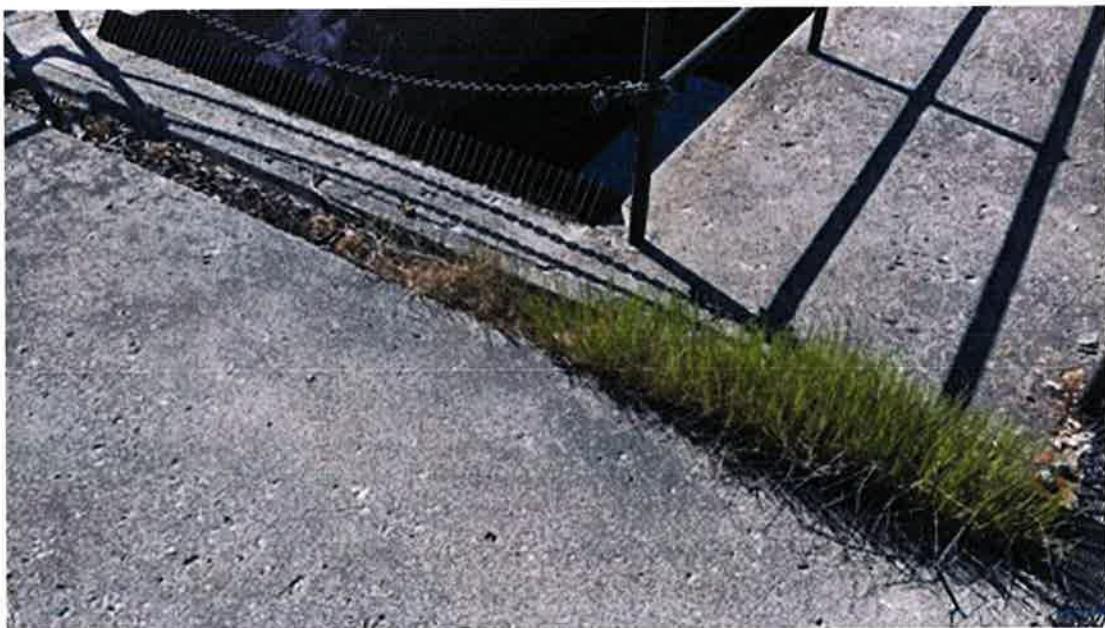
Photo #50 - Some vegetation growing within concrete spillway structure that should be removed

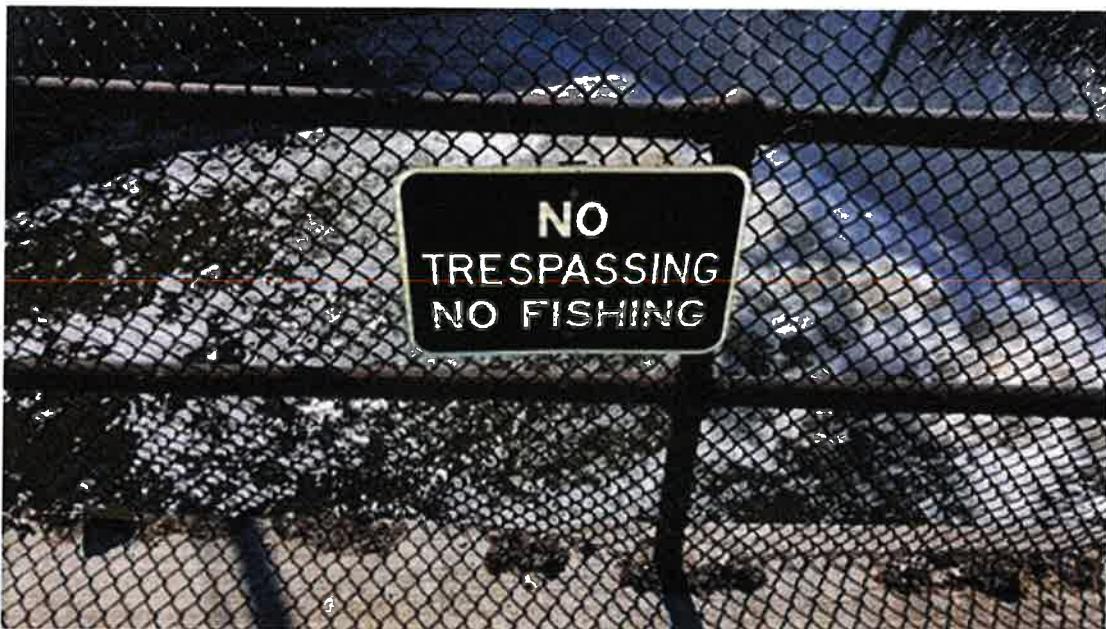
Photo #52 - Posted security sign

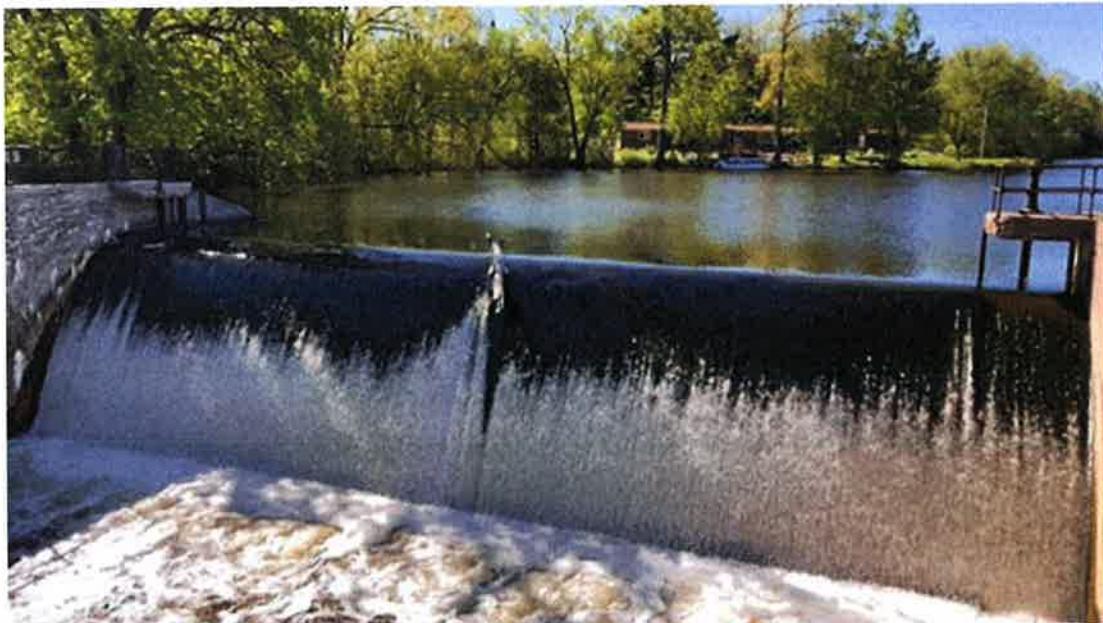
Photo #53 - Spillway crest

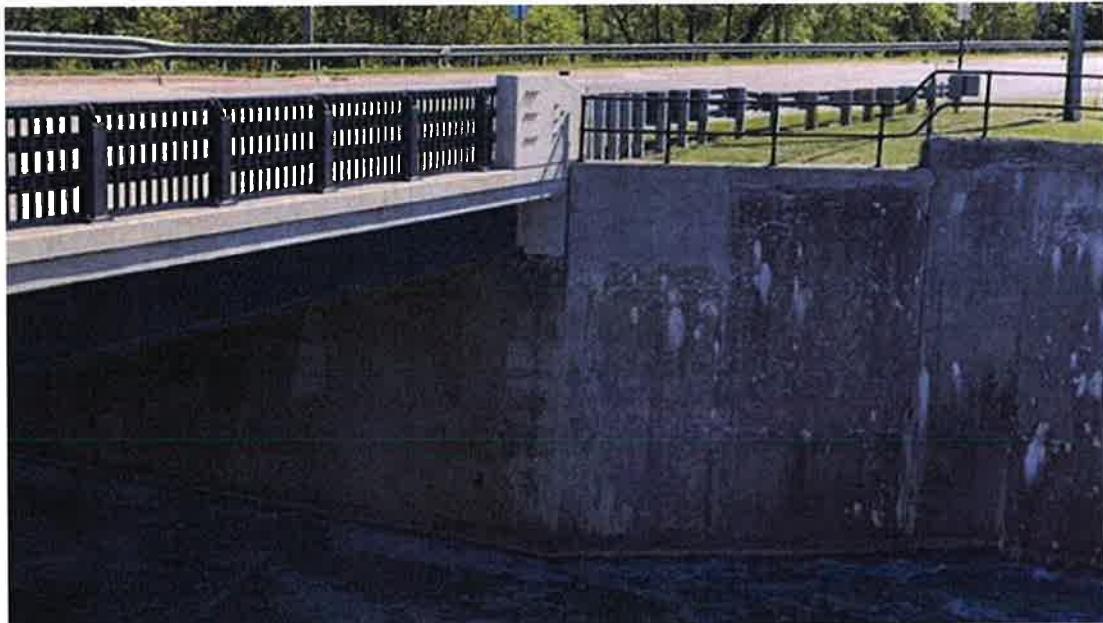
**Photo #57 - Right downstream spillway abutment wall at joint with bridge.
Efflorescence present throughout, spalling present at the top of the wall**

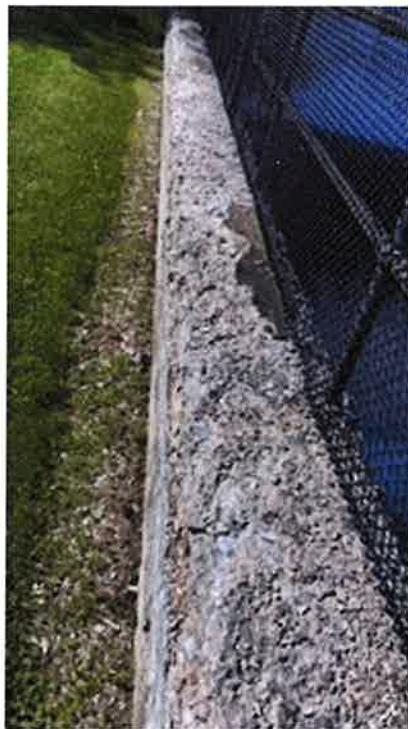
Photo #59 - Spalling on top of the spillway's right downstream abutment wall

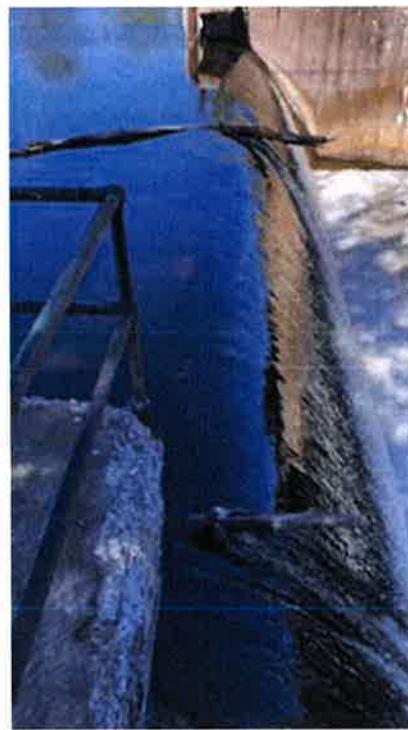
Photo #62 - Spillway crest viewed from right

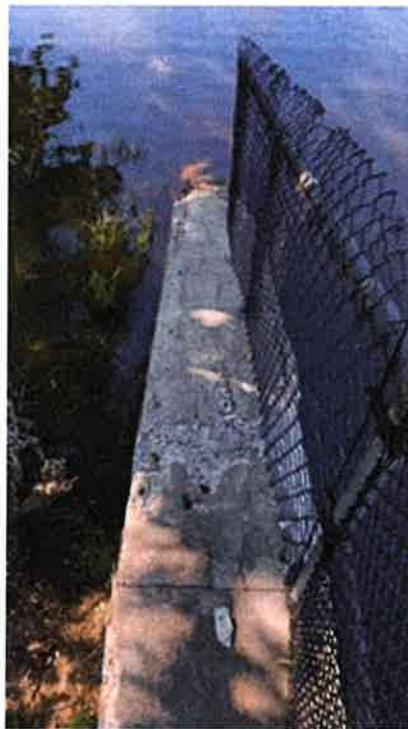
Photo #63 - Top of spillway's right upstream abutment wall. Minor spalling observed

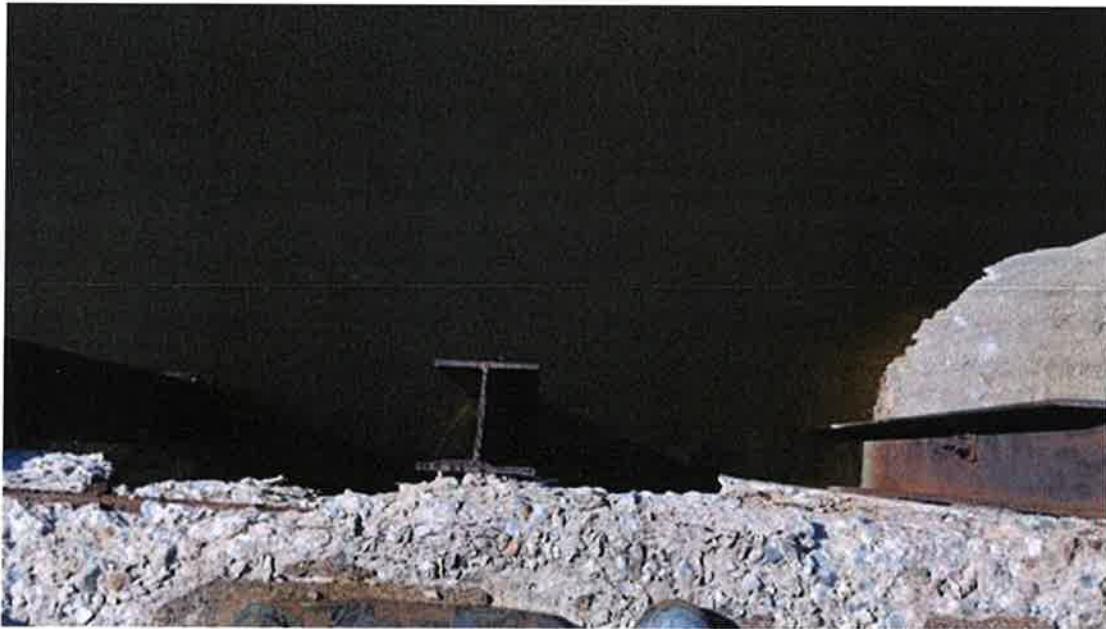
Photo #68 - Stoplog grooves at left drawdown gate operator deck

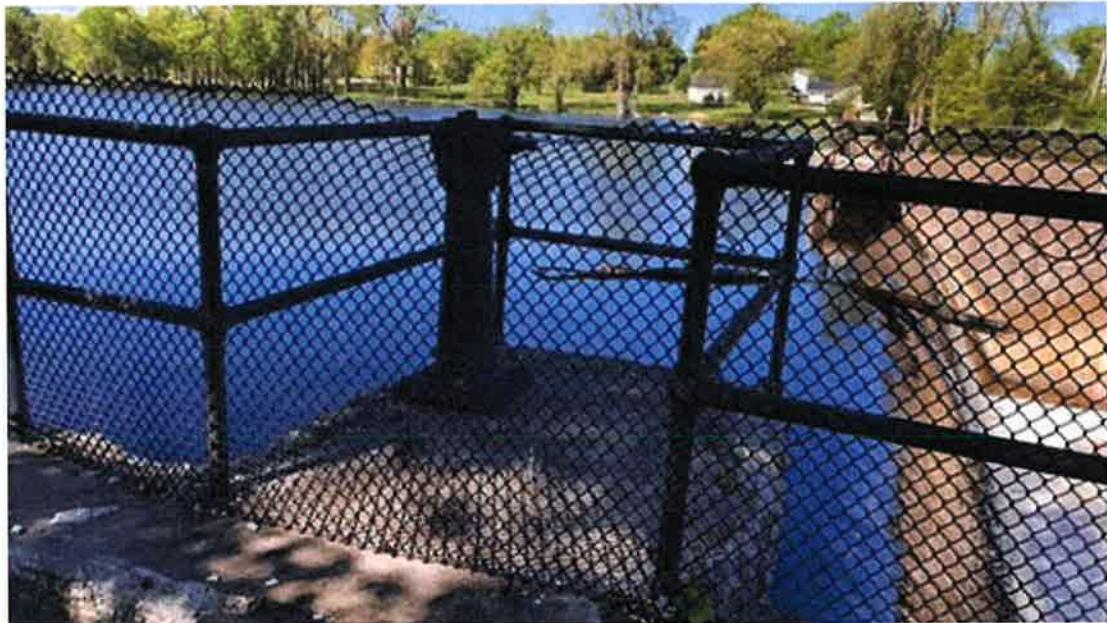
Photo #69 - Right drawdown gate operator

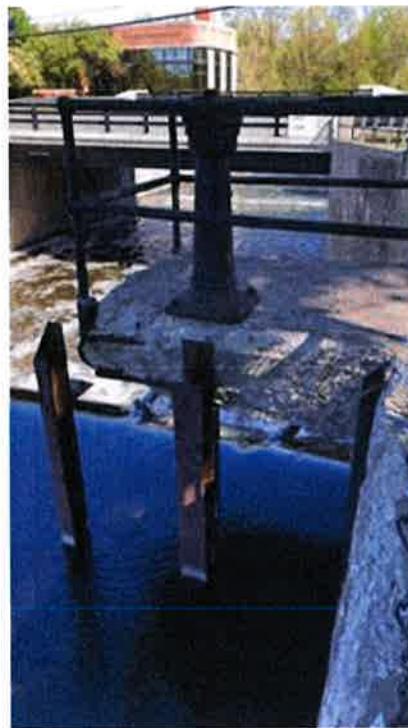
Photo #70 - Right drawdown gate operator. Note severe deterioration of concrete on operator deck

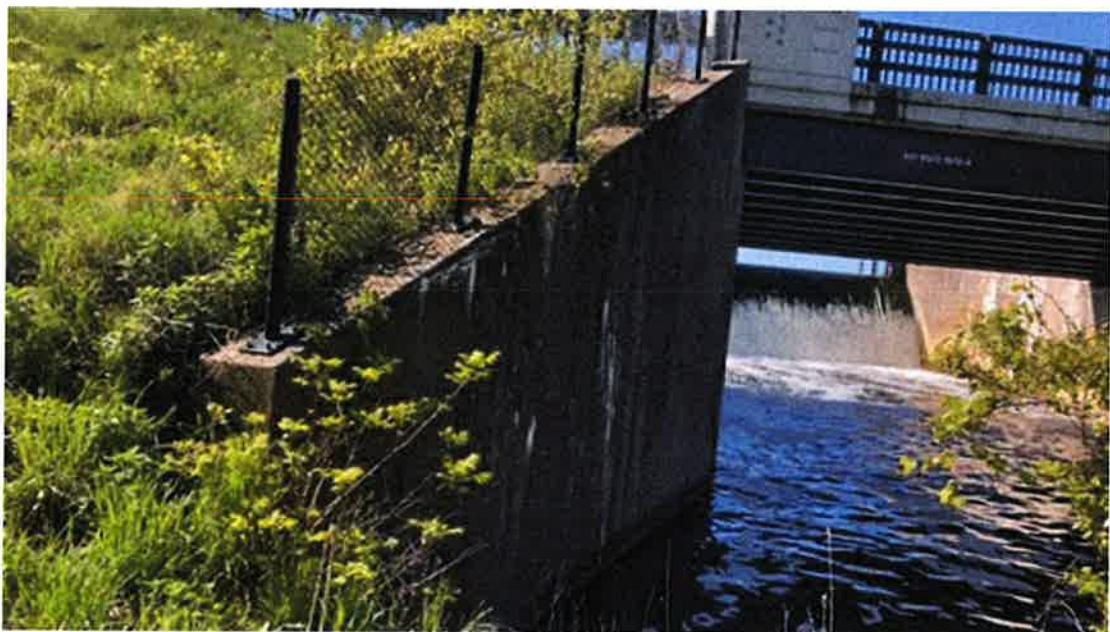
Photo #72 - Spillway right downstream abutment wall downstream of bridge

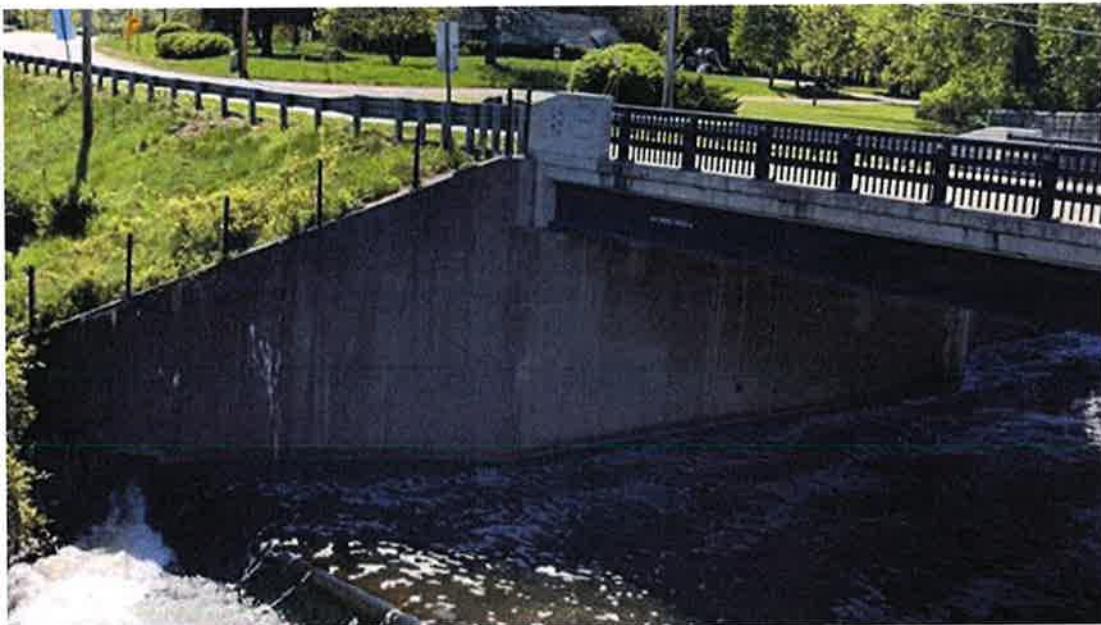
Photo #73 - Spillway right downstream abutment wall downstream of bridge

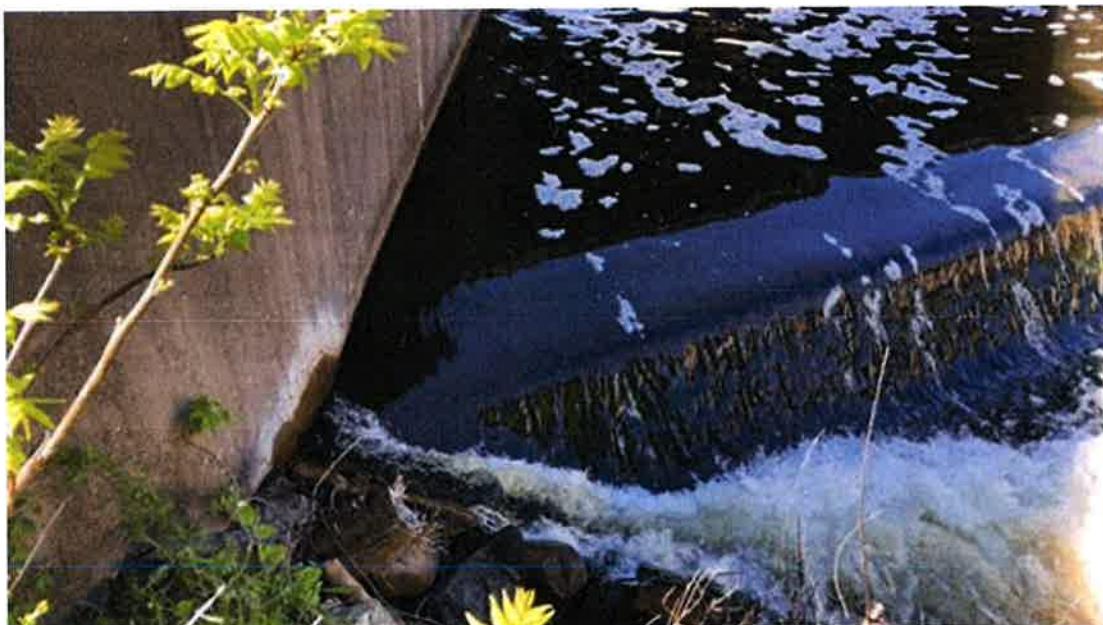
Photo #74 - Right end of spillway sill downstream of bridge

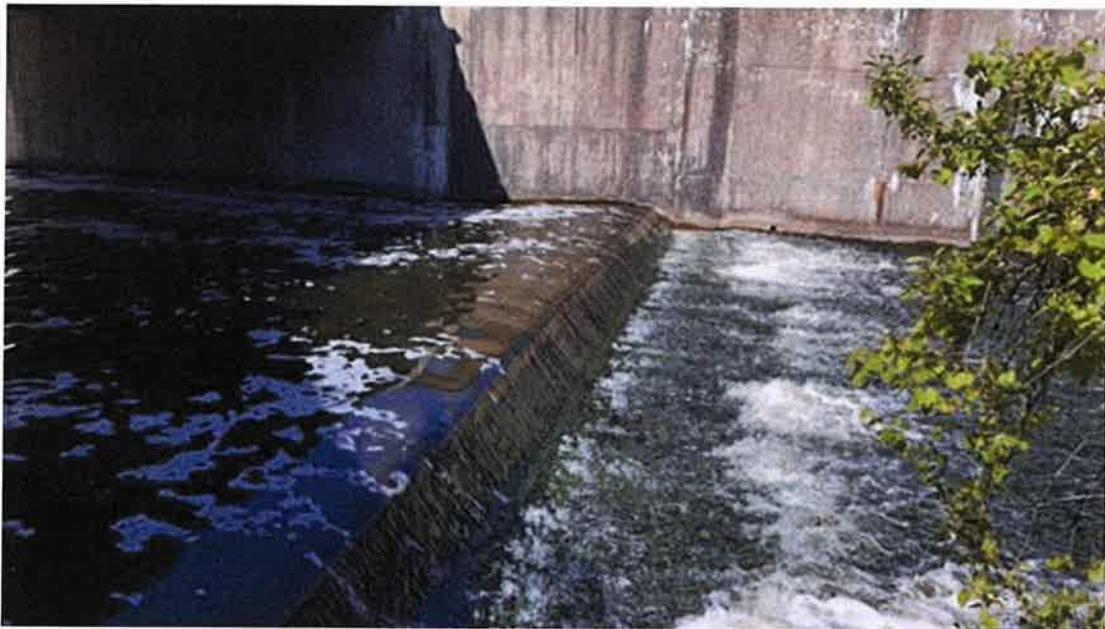
Photo #75 - Spillway sill downstream of bridge

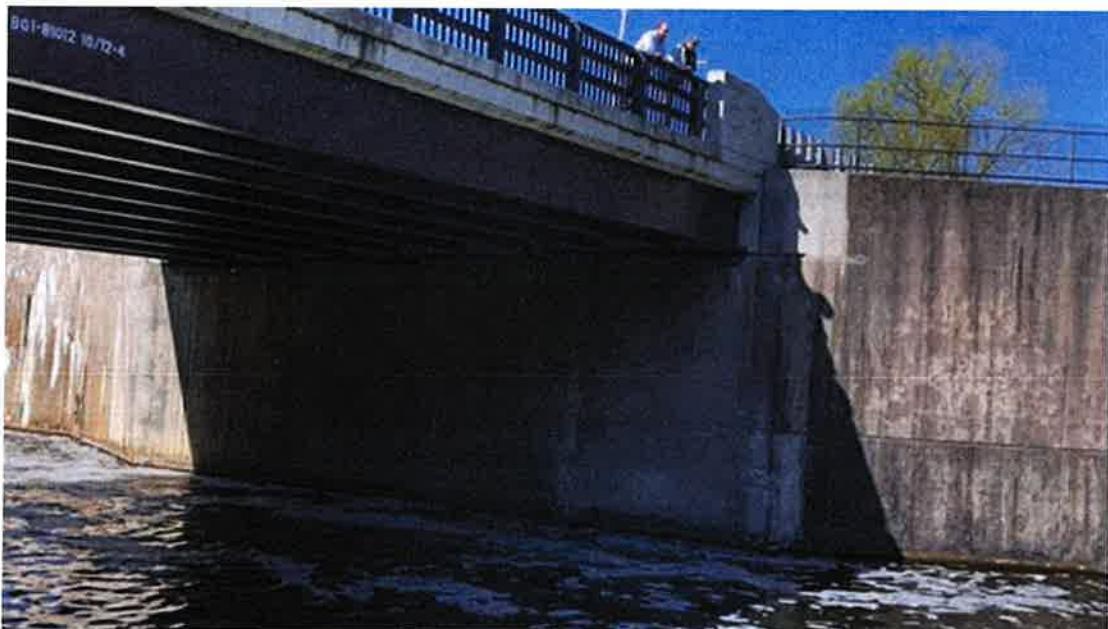
Photo #76 - Spillway left downstream abutment wall under bridge

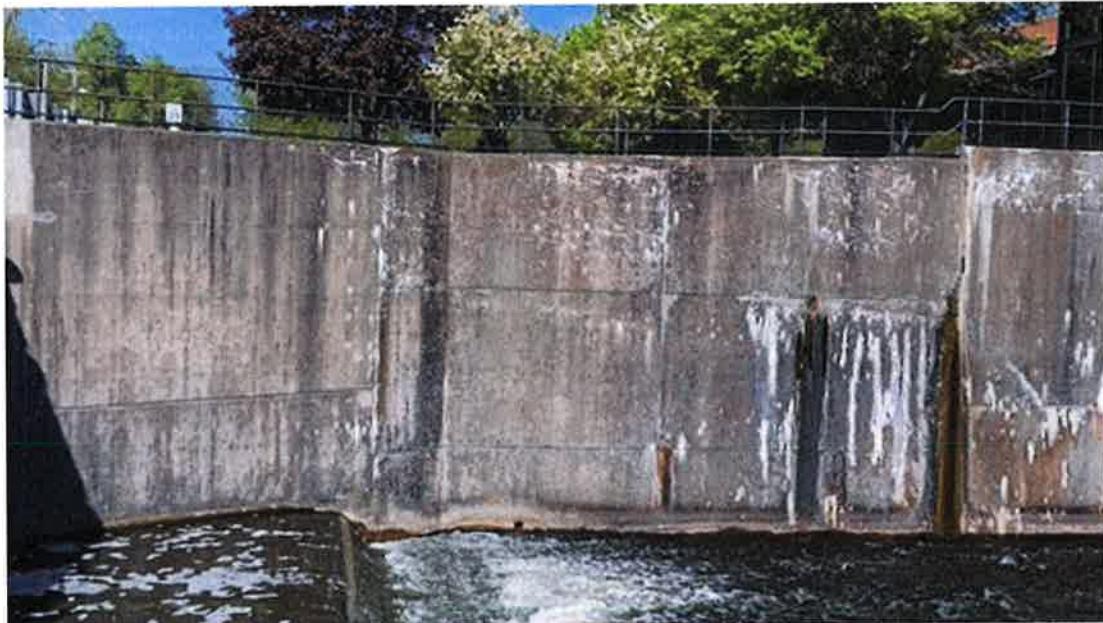
Photo #77 - Spillway left downstream abutment wall downstream of bridge. Some efflorescence present. Seepage observed

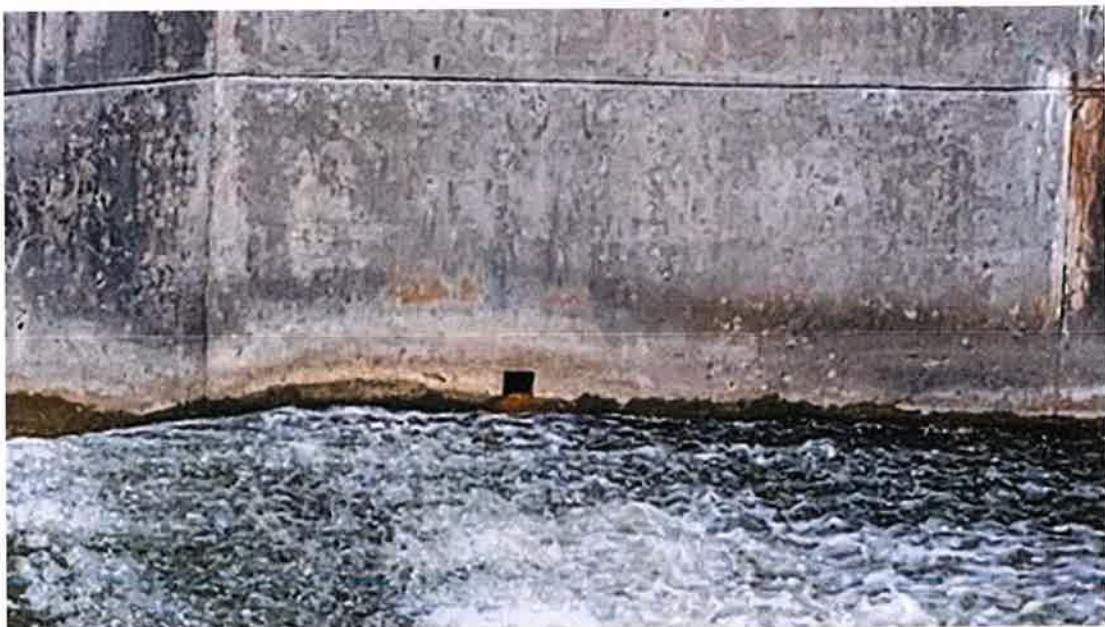
Photo #78 - Wall drain on left downstream abutment wall

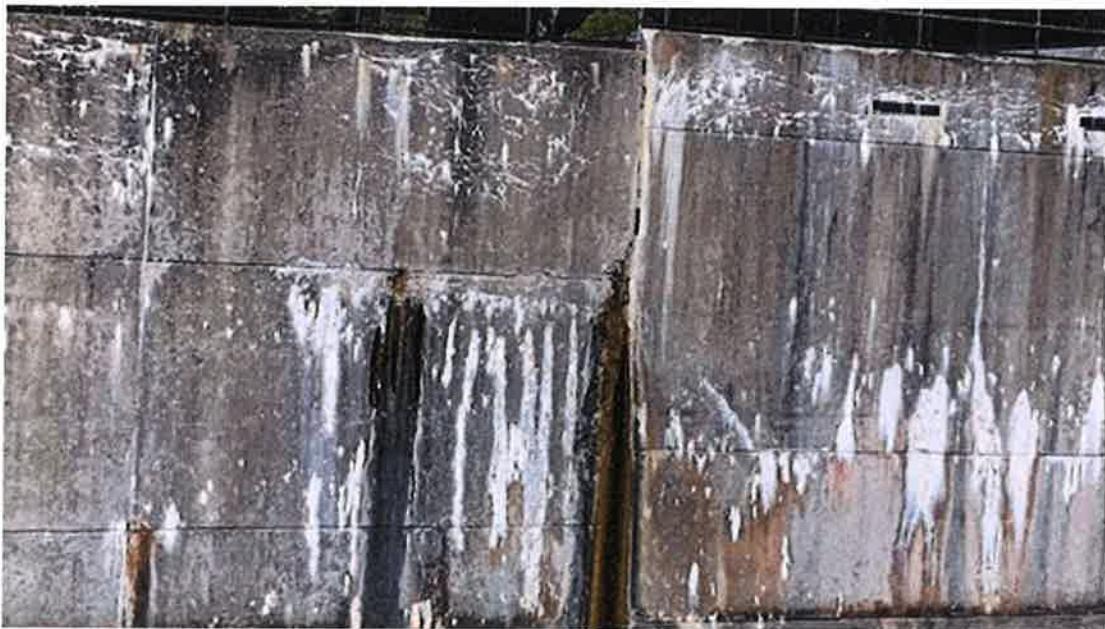
Photo #79 - Seepage in left downstream abutment wall

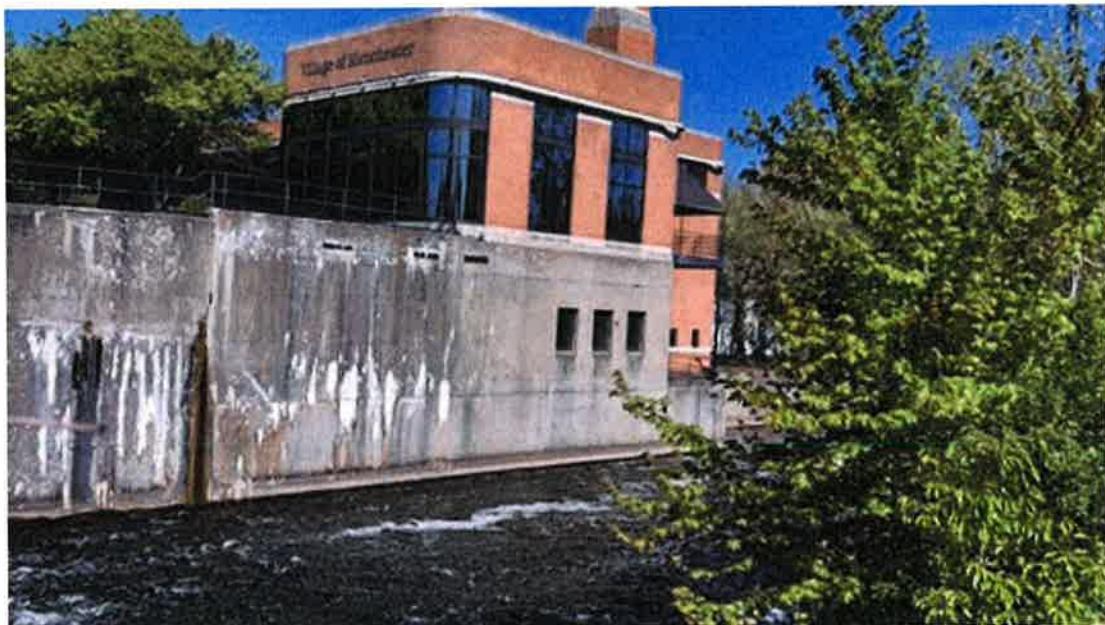
GEI observed the condition of the bullnoses above the tailwater elevation. The left bullnose has scaling present and has spalling at the freeze thaw line. See Photo 81 in **Appendix B**.

Photo #81 - Left downstream abutment wall and village offices/historic powerhouse

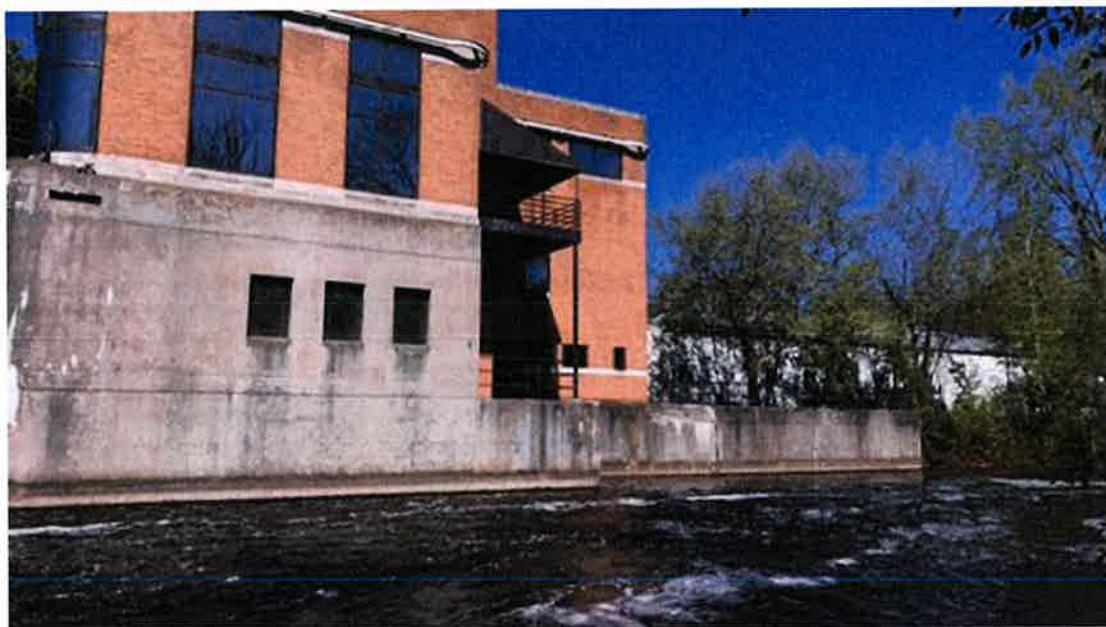
JFB observed the condition of the bullnoses and stop log slots for the left and right draft bay outlets. The bullnoses appeared to be in satisfactory condition with light scaling present. The left and right stoplog grooves in both bays appeared to be in satisfactory condition with broken timbers present at the bottom of both bays. See Photo 82 in **Appendix B**.

Photo #82 - Receiving channel left wall at base of previous powerhouse

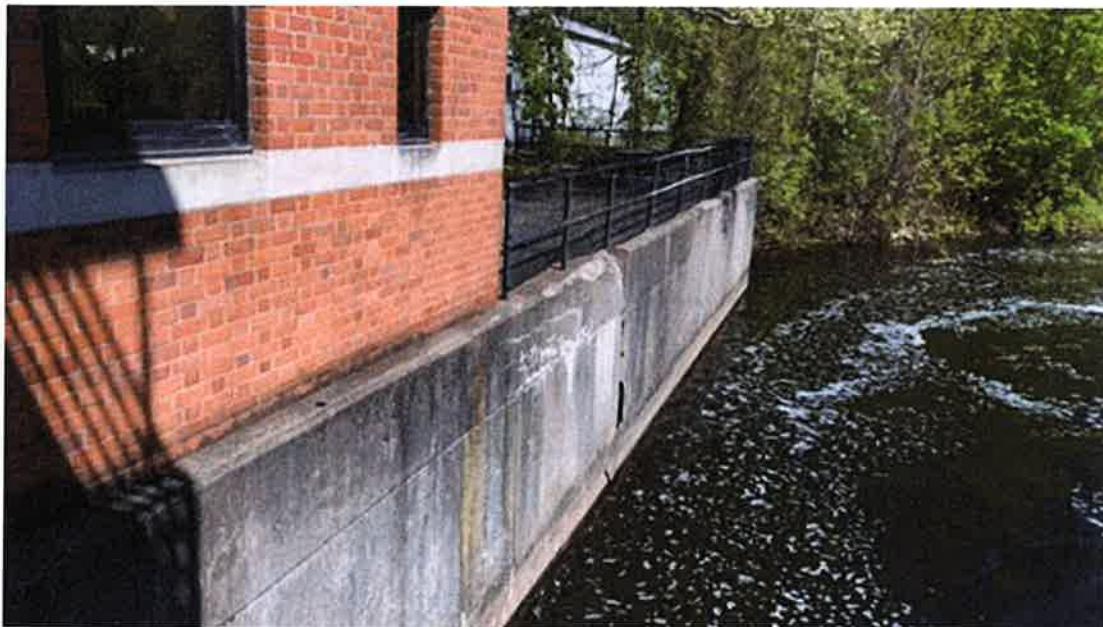
Photo #83 - Receiving channel left wall at powerhouse outlet

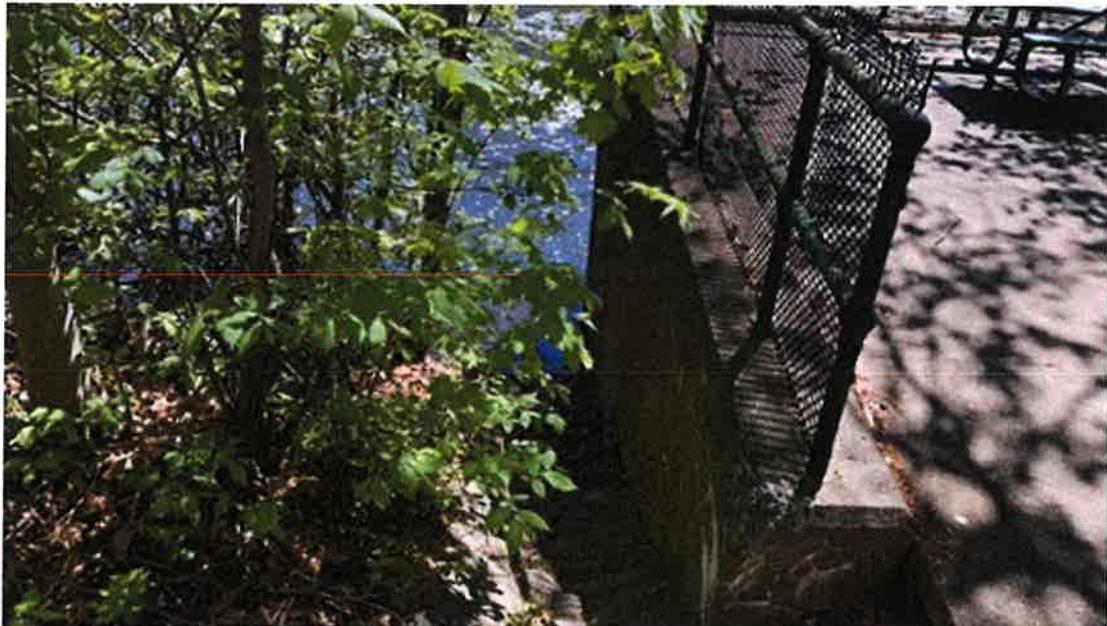
Photo #84 - Receiving channel left wall downstream face

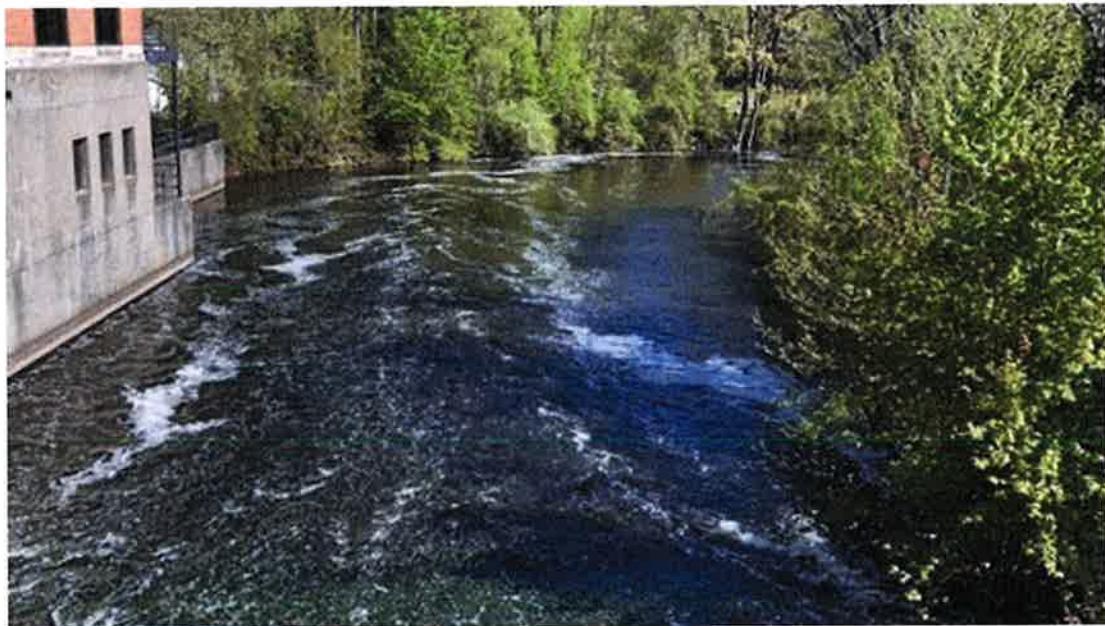
Photo #85 - Receiving channel viewed from bridge

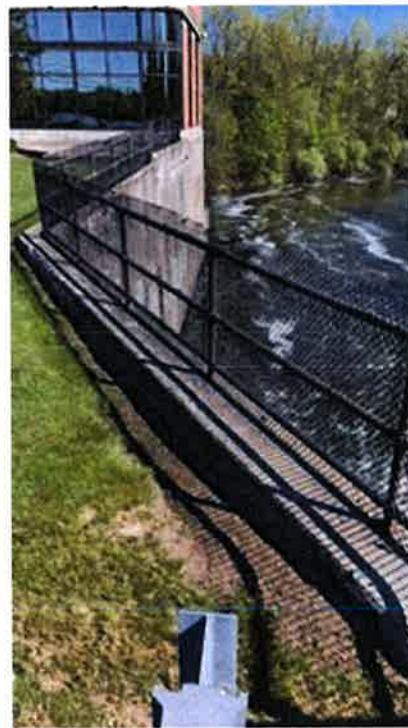
Photo #86 - Spillway left downstream abutment wall viewed from crest in front of village offices

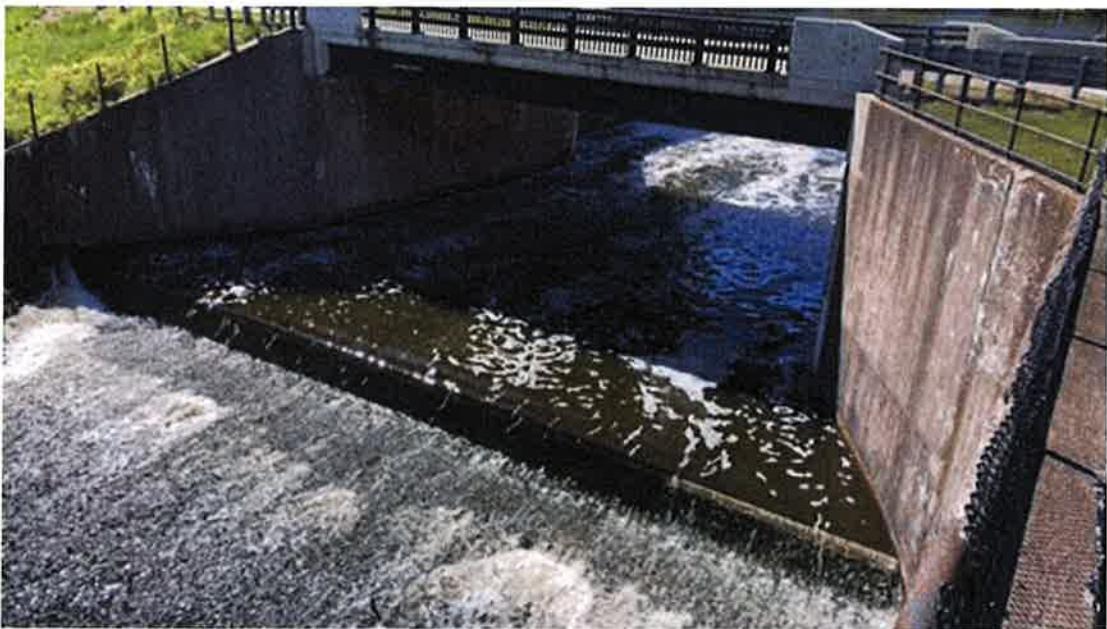
Photo #87 - Spillway outlet and sill

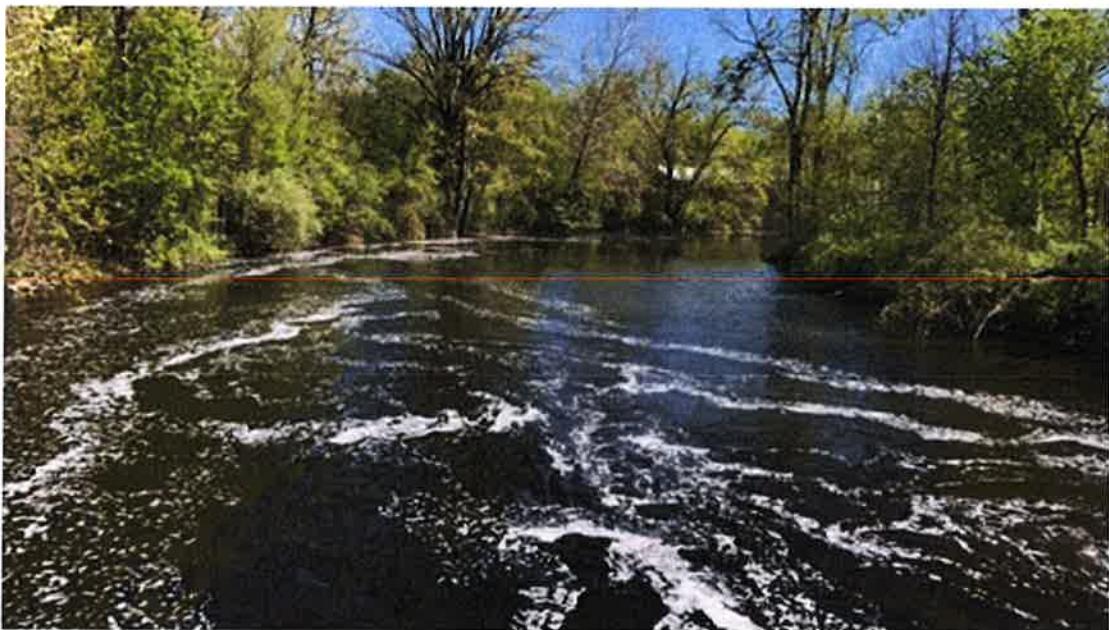
Photo #88 - Receiving channel

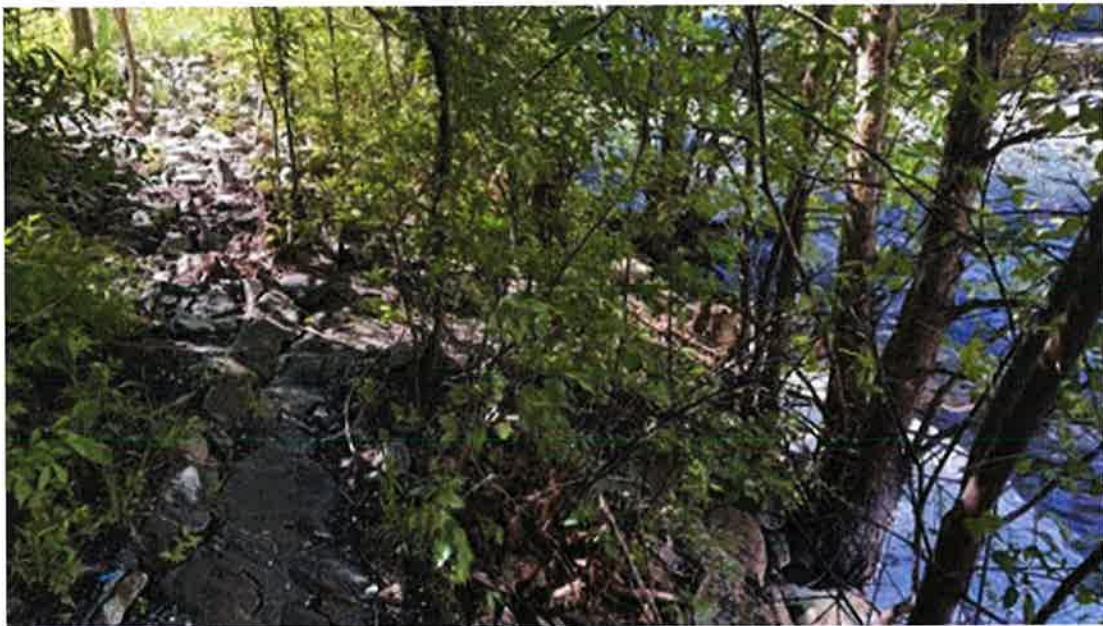
Photo #89 - Right bank of channel downstream of dam across from the powerhouse. Grouted riprap has become overgrown with trees and brush
