Inspection, Analysis, and Recommendations Report Ford Manchester Dam

River Raisin
Manchester, Michigan
EGLE Dam ID No. 391

February 14, 2024
GEI Project No. 2204052

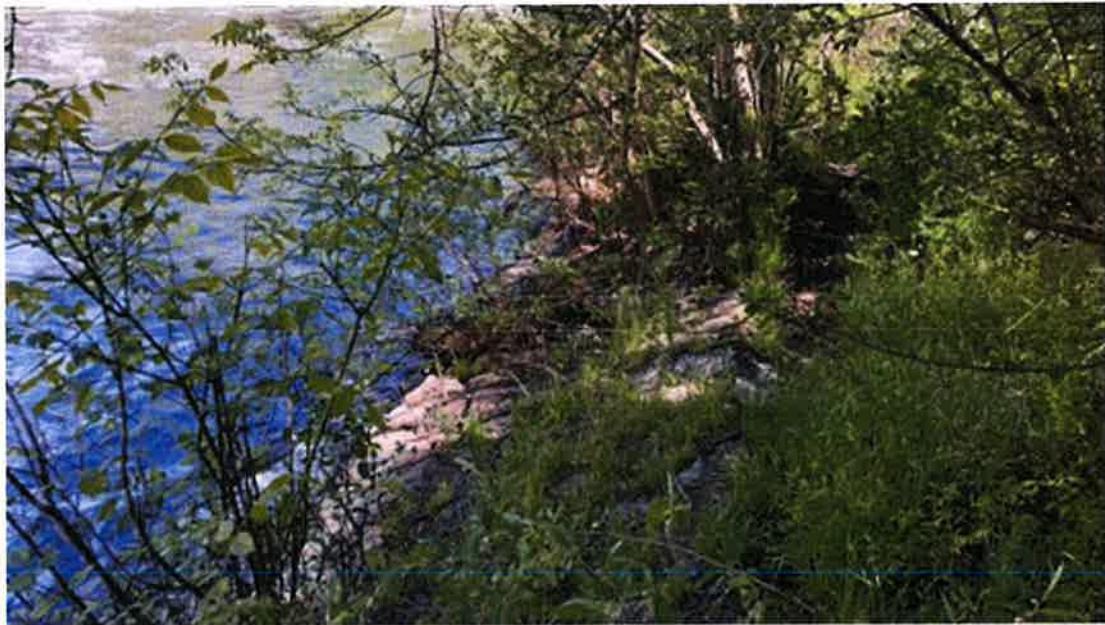
Photo #90 - Right bank of channel downstream of dam across from the powerhouse. Grouted riprap has become overgrown with trees and brush

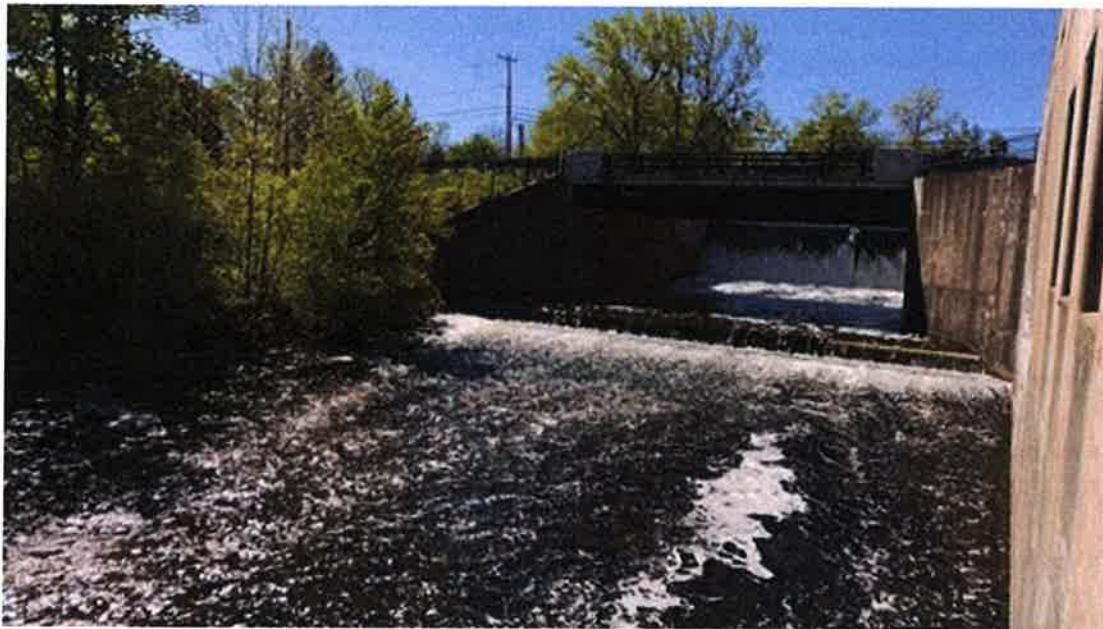
Photo #91 - Spillway outlet viewed from powerhouse outlet deck

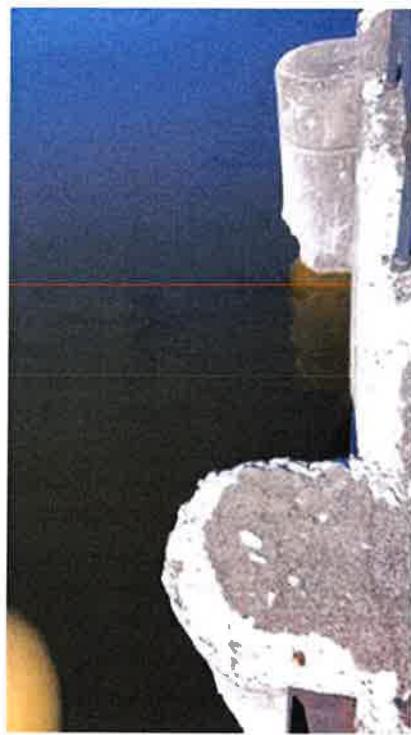
Photo #92 - Powerhouse sluiceway inlet. Concrete shows severe spalling at piers

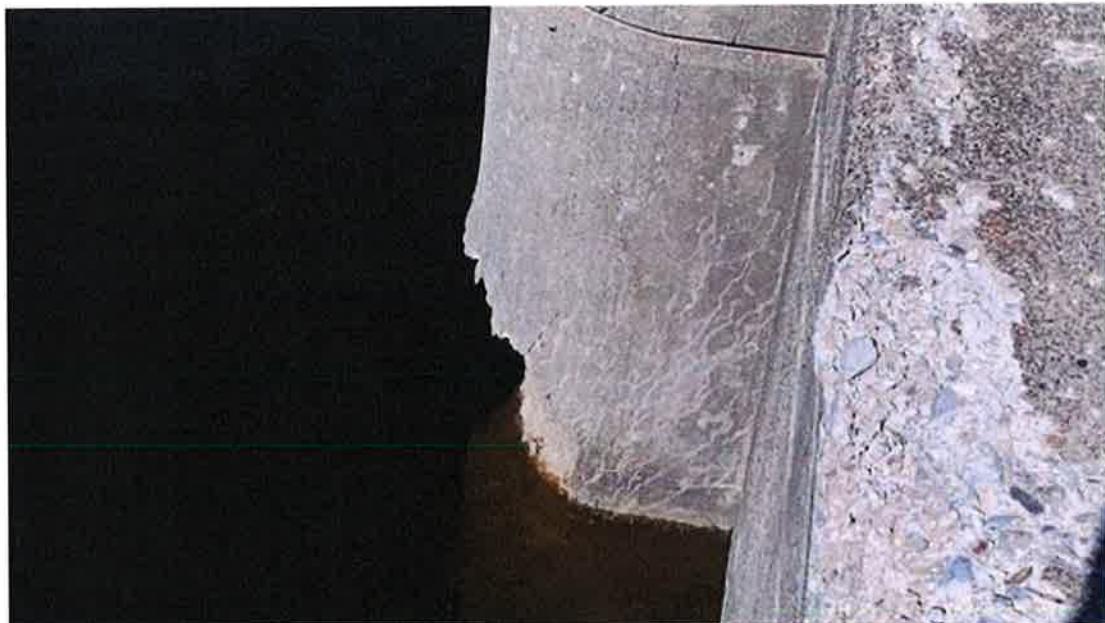
Photo #93 - Loss of concrete at waterline of powerhouse sluiceway inlet, left side

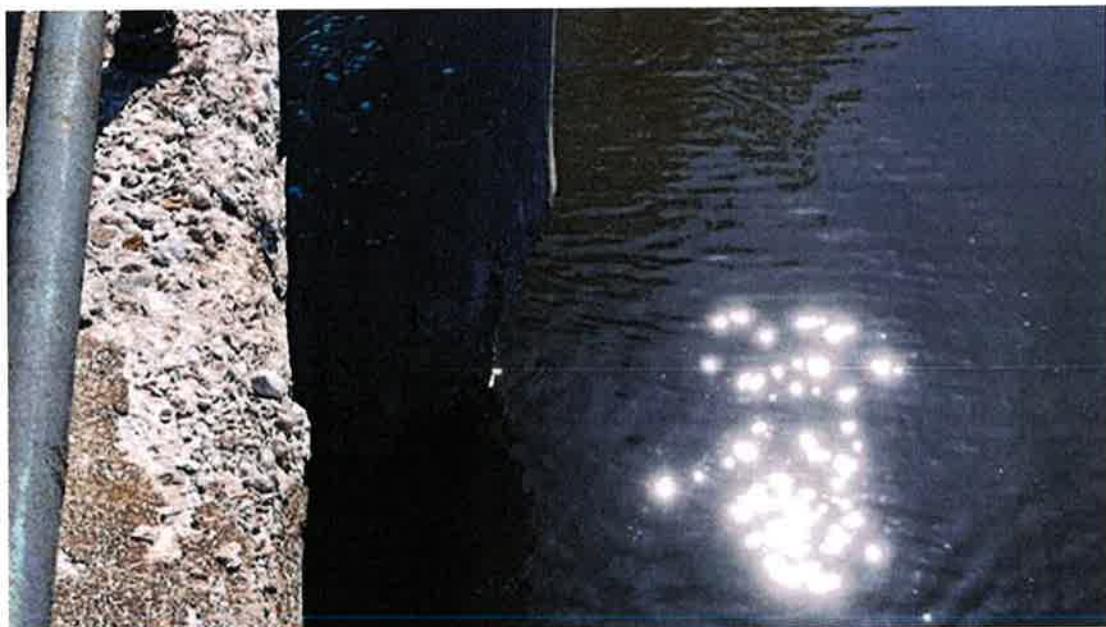
Photo #94 - Loss of concrete at waterline of powerhouse sluiceway inlet, right side

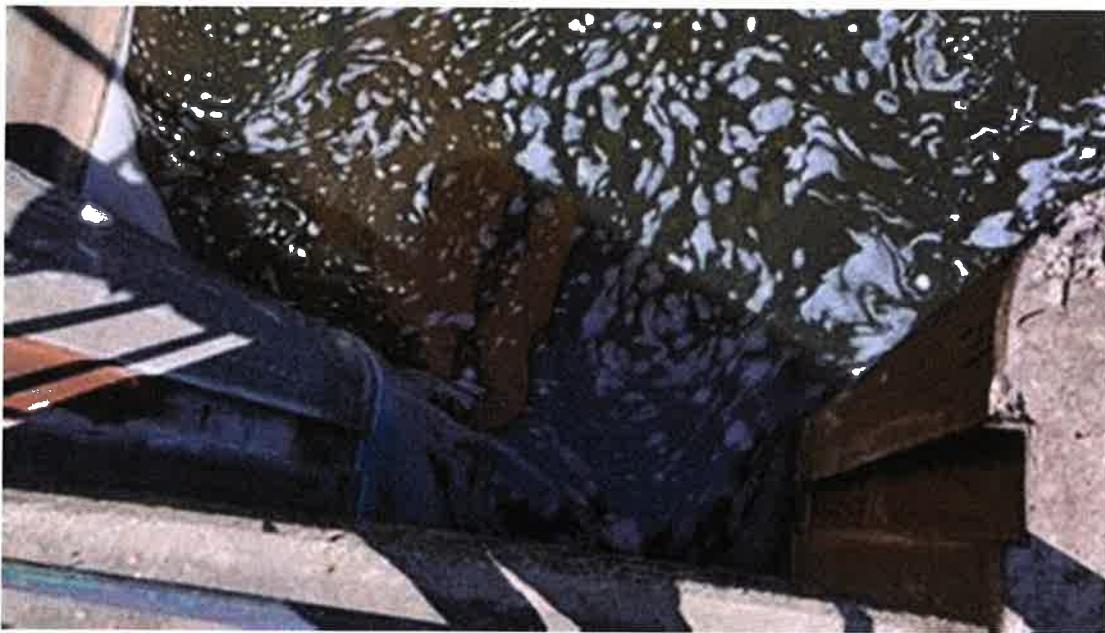
Photo #95 - Previous powerhouse outlet into river. No water currently flows through sluiceway

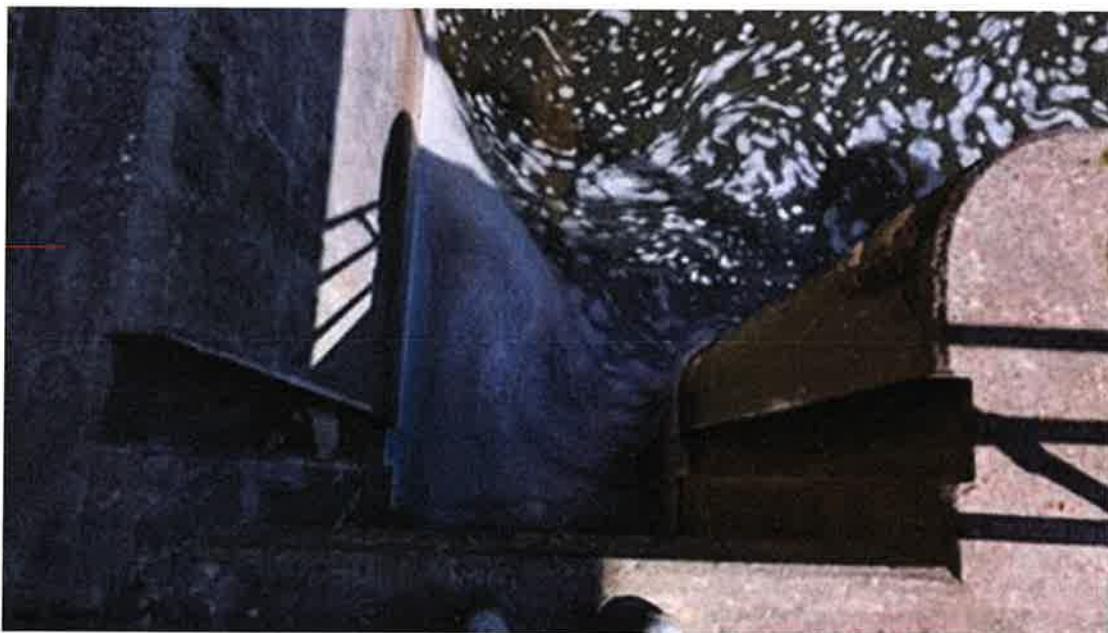
Photo #96 - Previous powerhouse outlet into river. No water currently flows through sluiceway

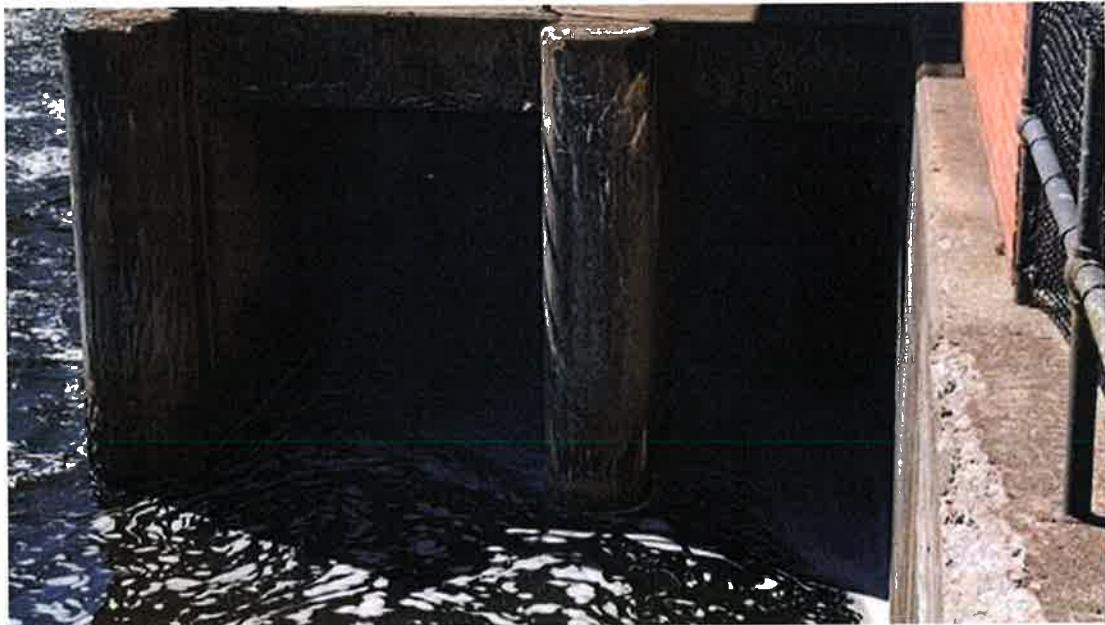
Photo #97 - Powerhouse outlet. Efflorescence present on concrete piers

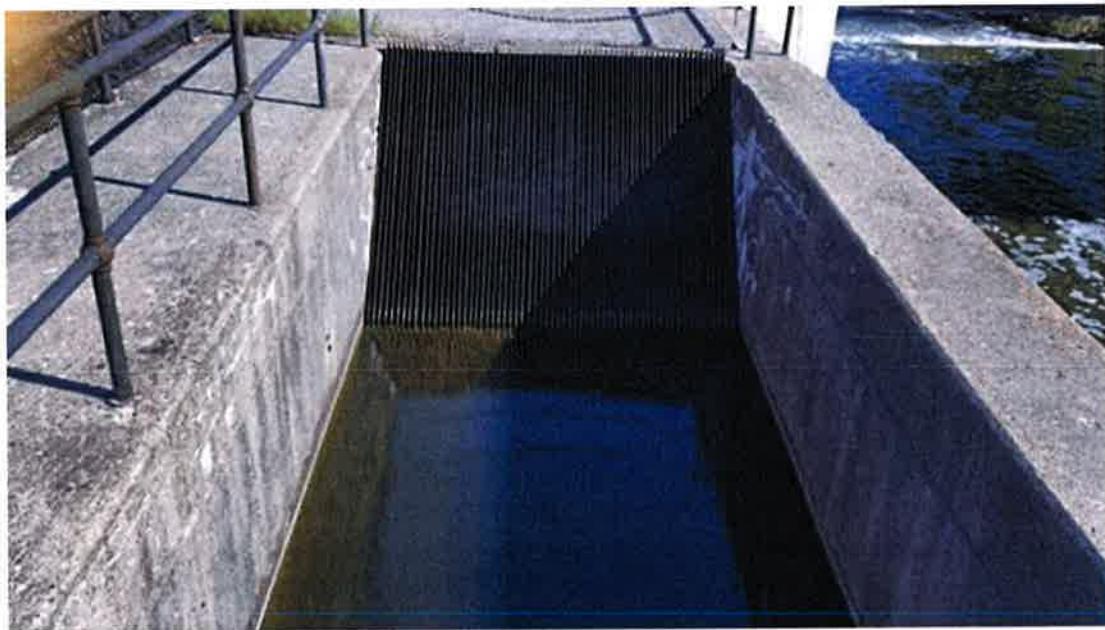
Photo #98 - Sluiceway inlet adjacent to principal spillway, looking downstream towards powerhouse

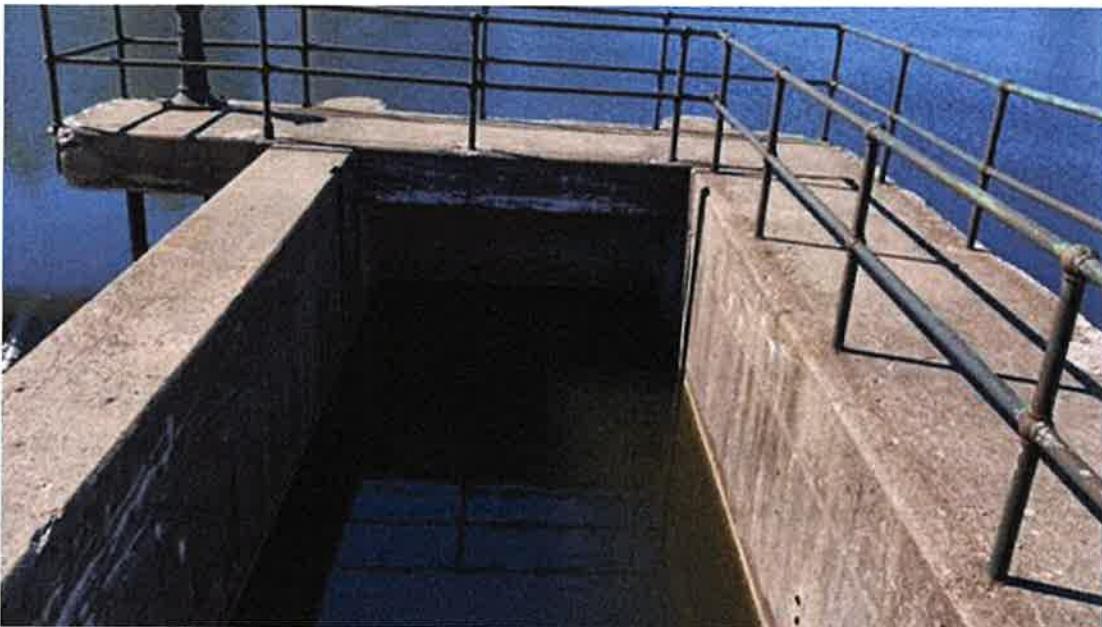
Photo #99 - Sluiceway inlet adjacent to principal spillway, looking upstream

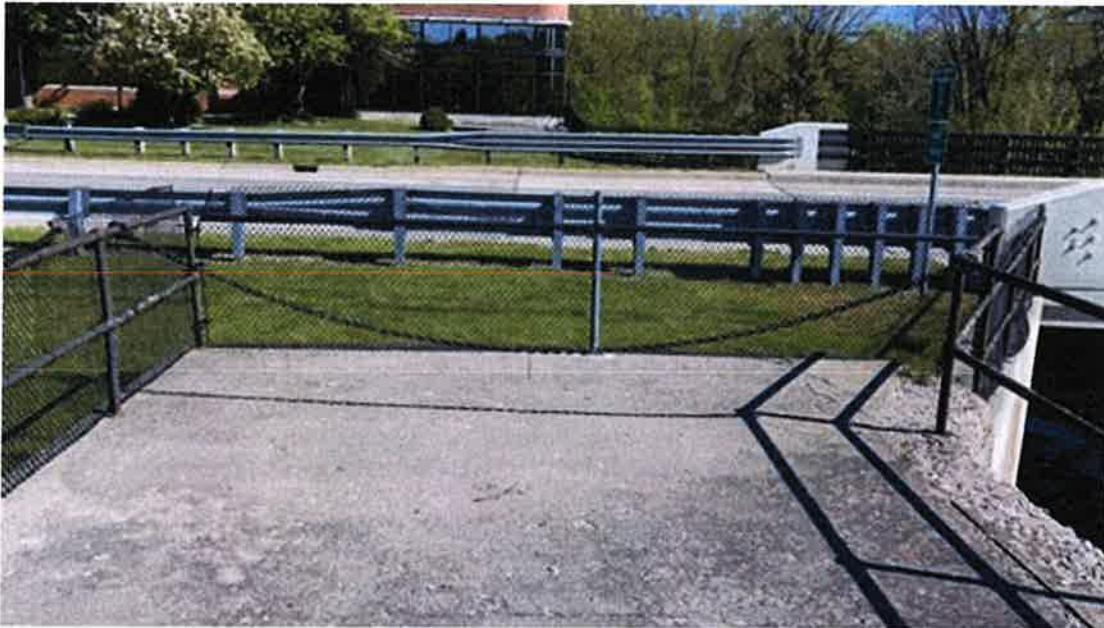
Photo #100 - Sluiceway alignment from inlet to powerhouse

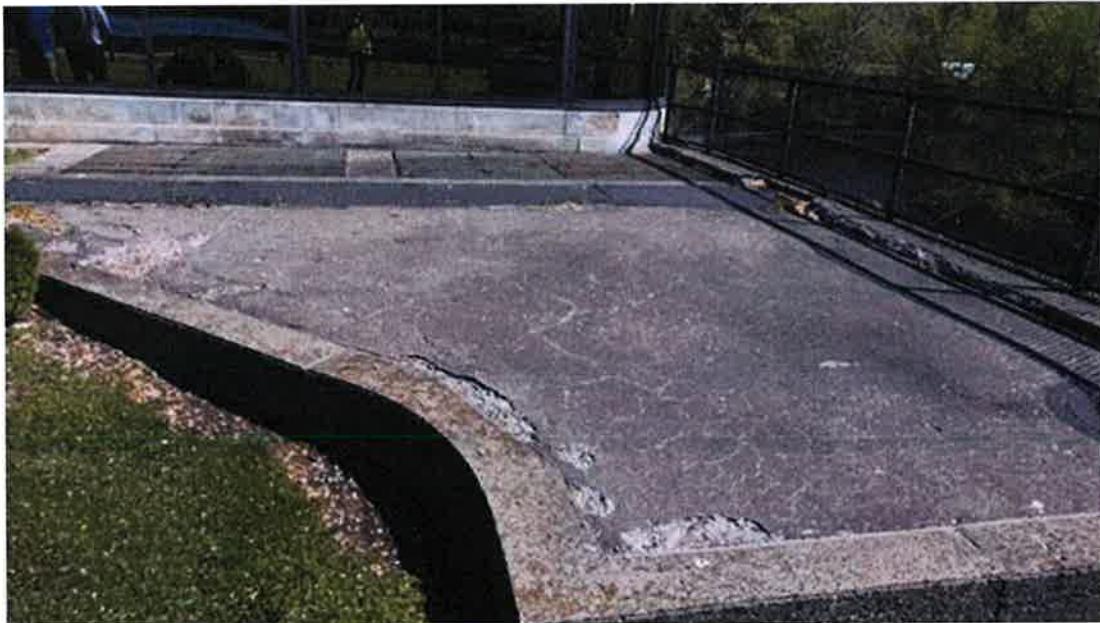
Photo #101 - Concrete deck over sluiceway at powerhouse. Sluiceway at this location was not observed during the inspection

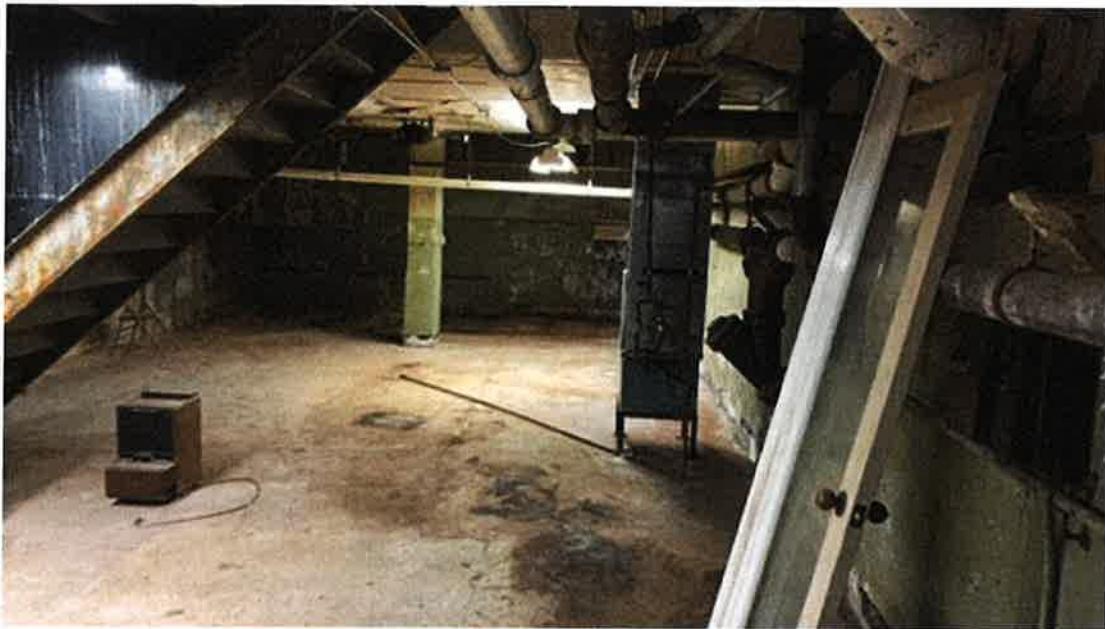
Photo #103 - Previous location of turbines in powerhouse

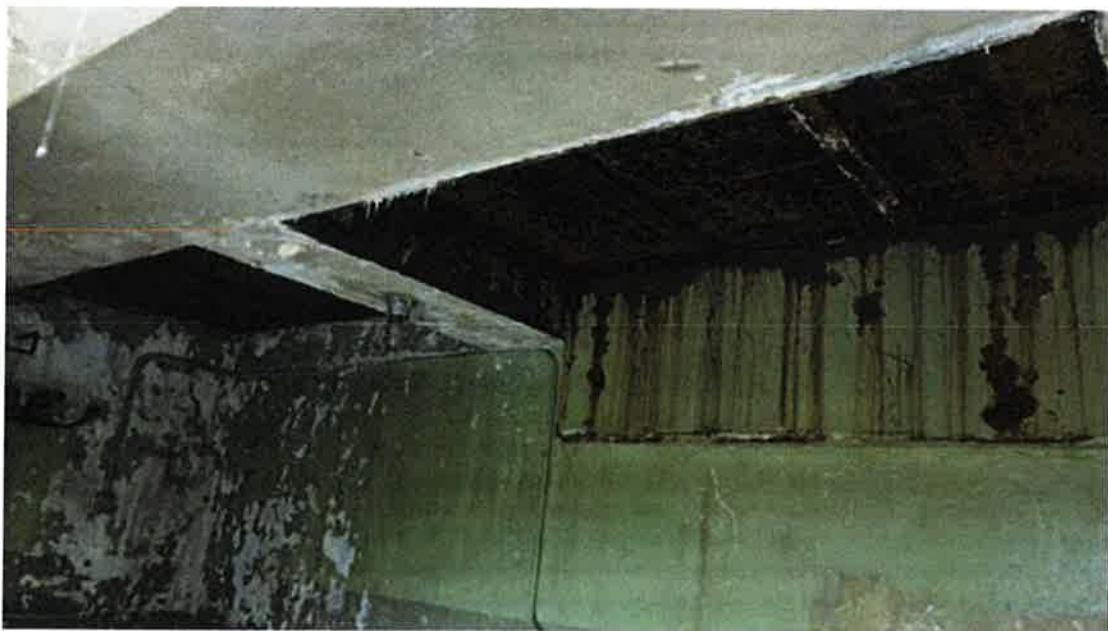
Photo #104 - Previous location of turbines in powerhouse

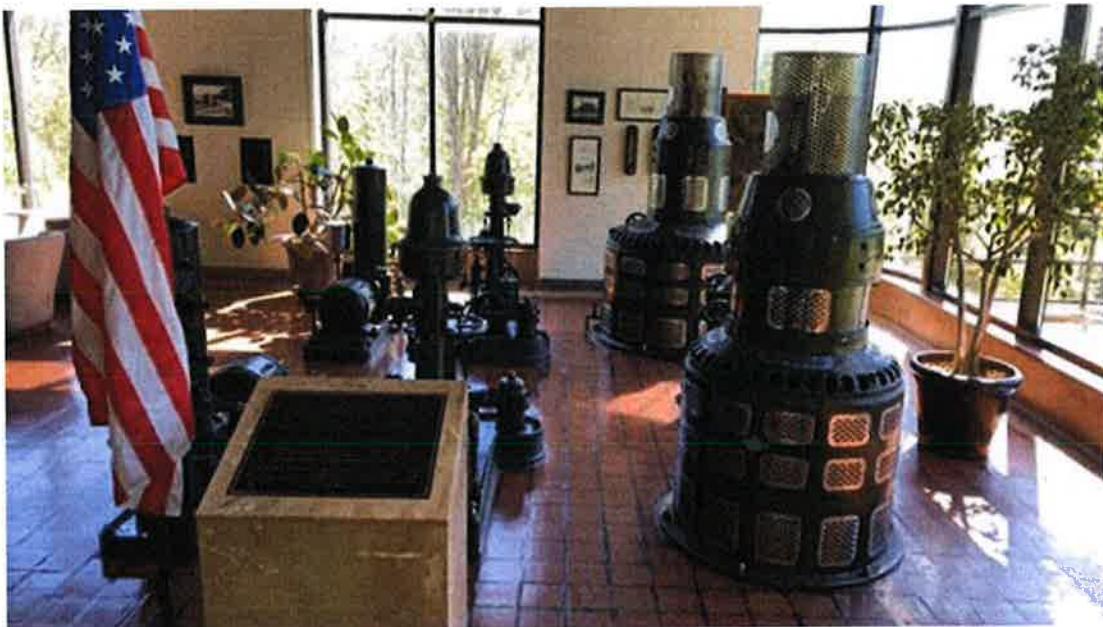
Photo #105 - Village office lobby with historic powerhouse equipment

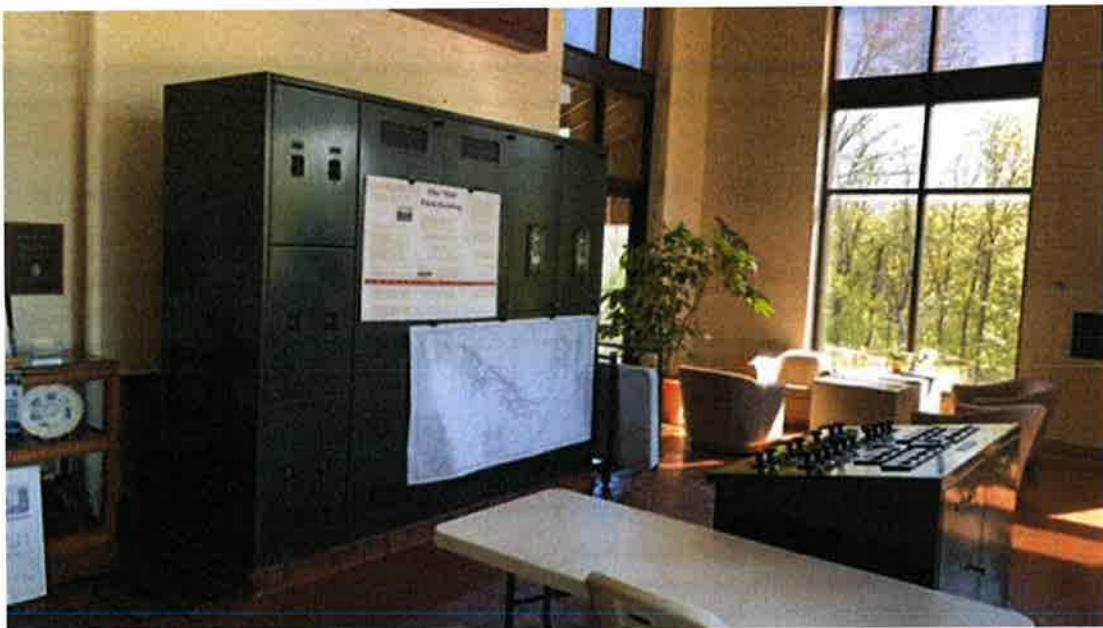
Photo #106 - Village office lobby with historic powerhouse equipment

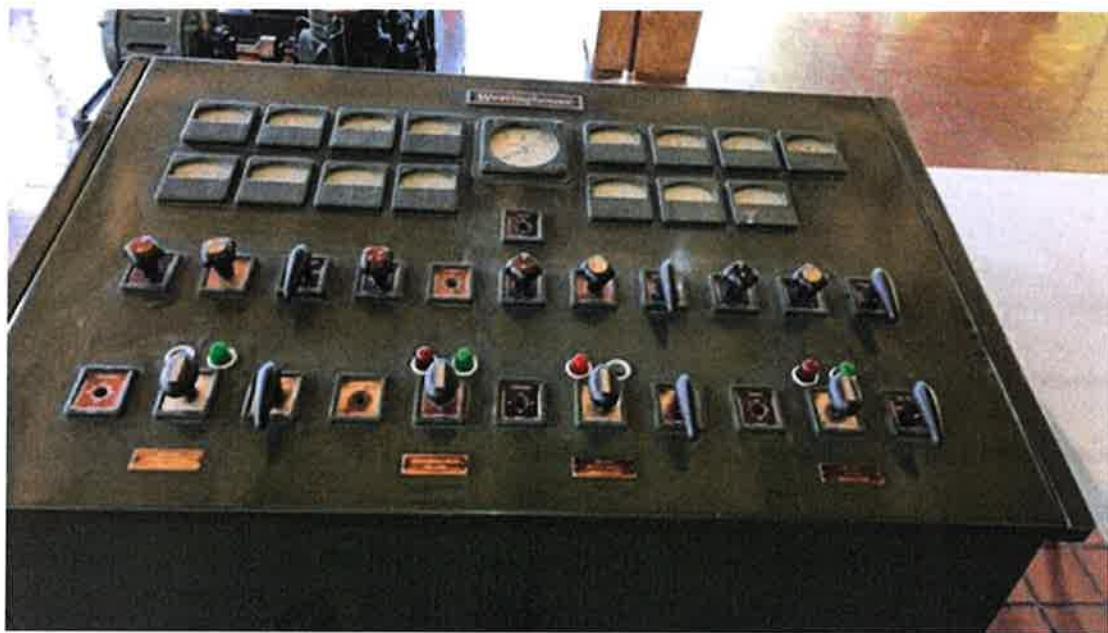
Photo #107 - Village office lobby with historic powerhouse equipment

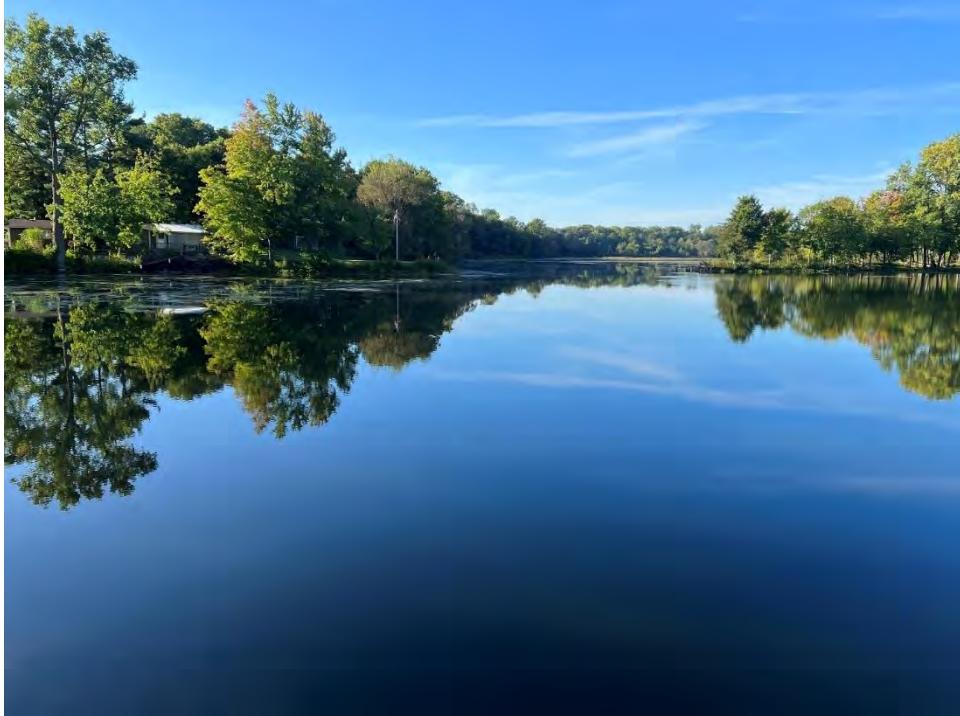
Photo No. 1 – Impoundment Looking Upstream

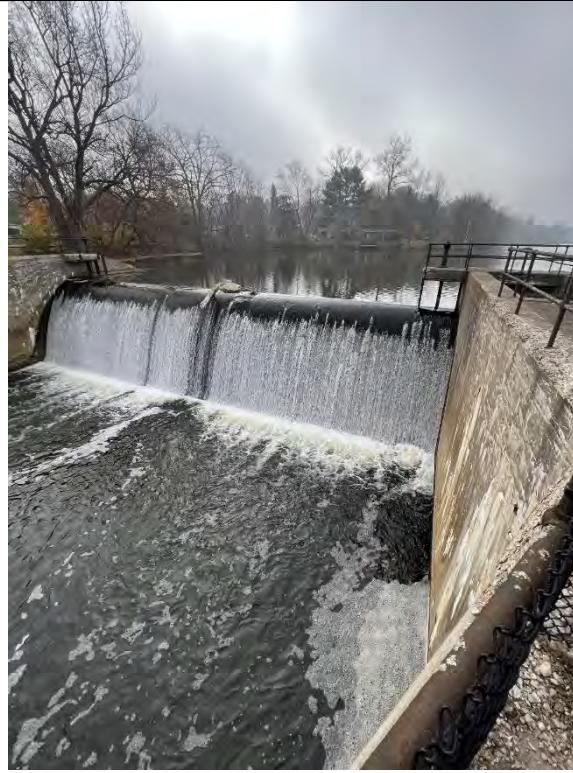
Photo No. 2 – Gravity Spilway Looking Upstream

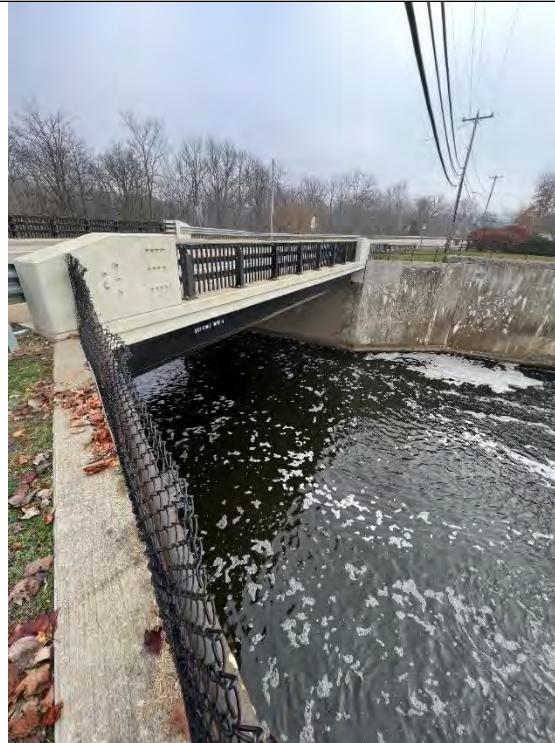
Photo No. 3 – Upstream of M-52 Bridge Looking Downstream

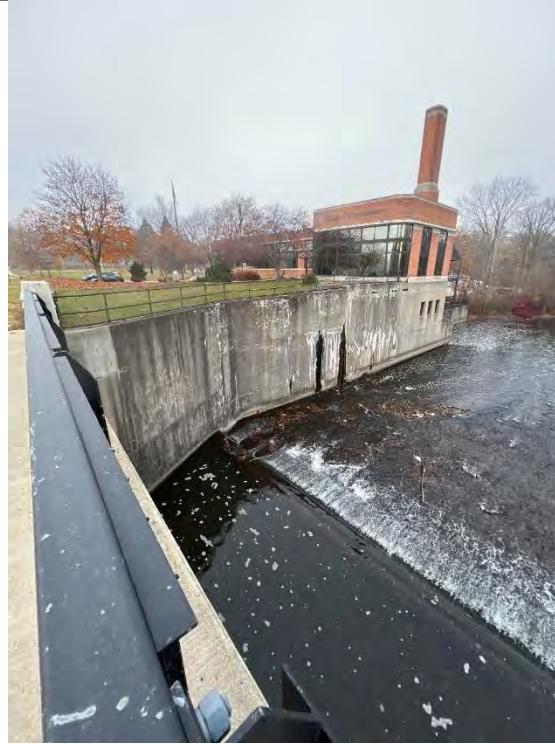
Photo No. 4 – M-52 Bridge Looking Downstream Toward Powerhouse

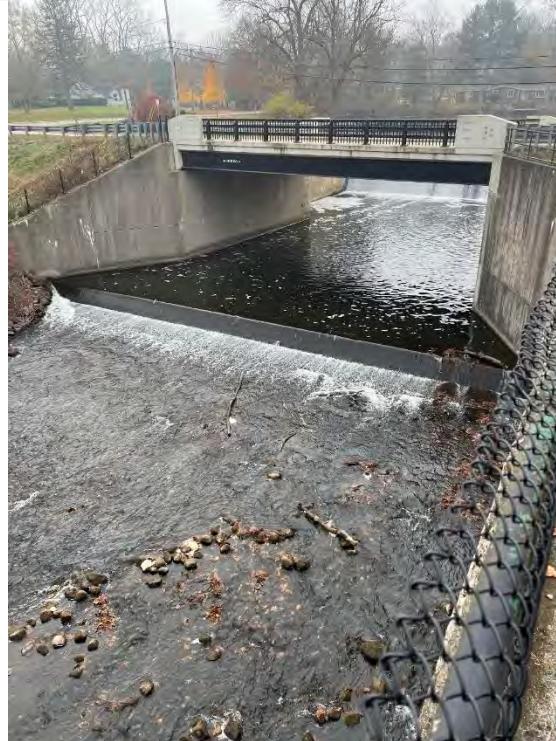
Photo No. 5 – Downstream of M-52 Bridge Looking Upstream

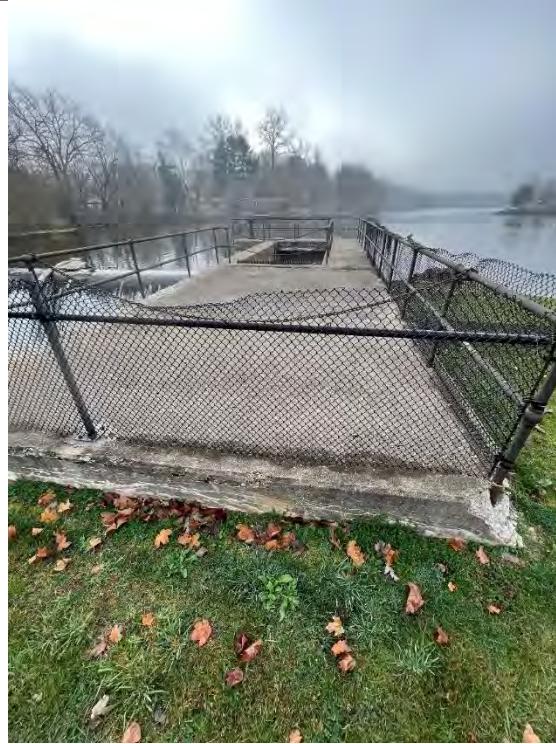
Photo No. 6 – Penstock Intake Looking Upstream

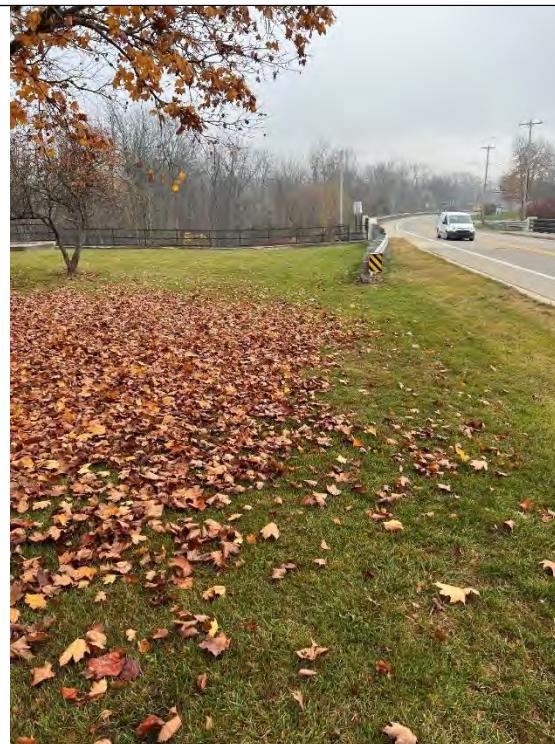
Photo No. 8 – Downstream Left Embankment Looking Right

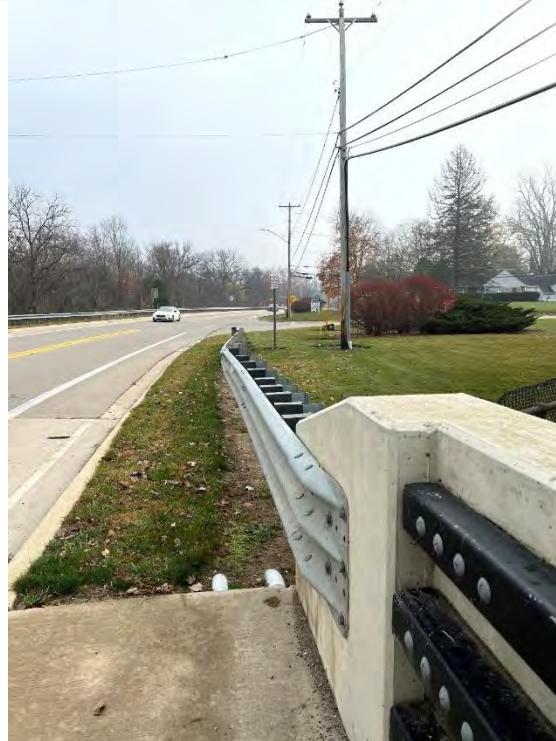
Photo No. 9 – Upstream Right Embankment Looking Right

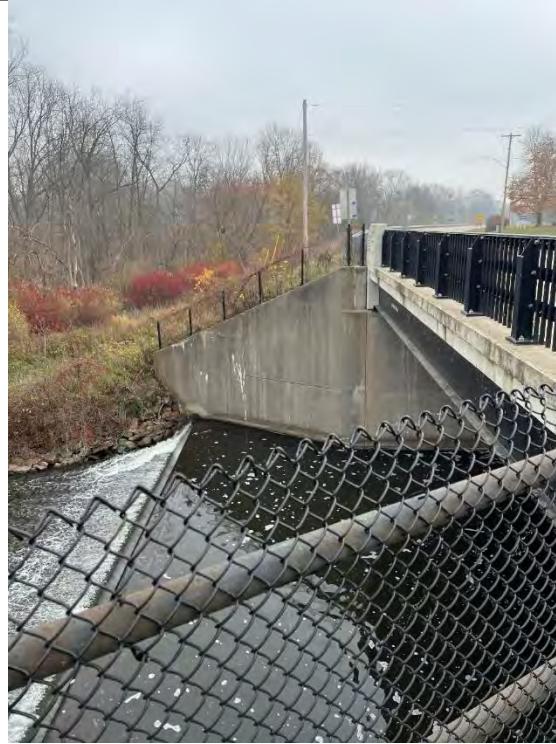
Photo No. 10 – Downstream Right Embankment Looking Right

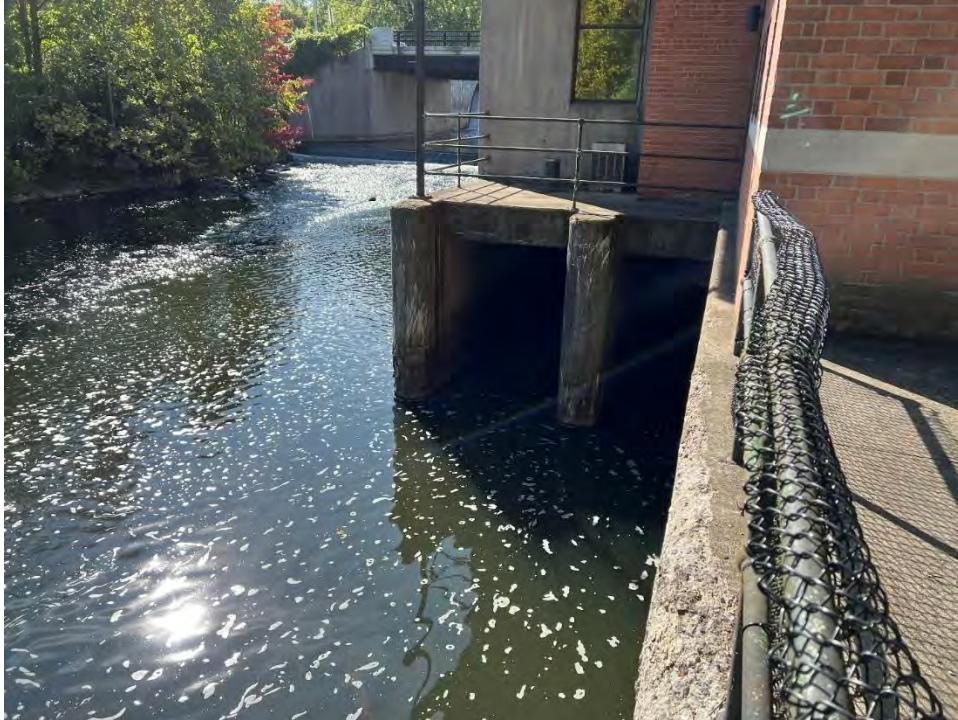
Photo No. 11 – Draft Bay Outlet Looking Upstream

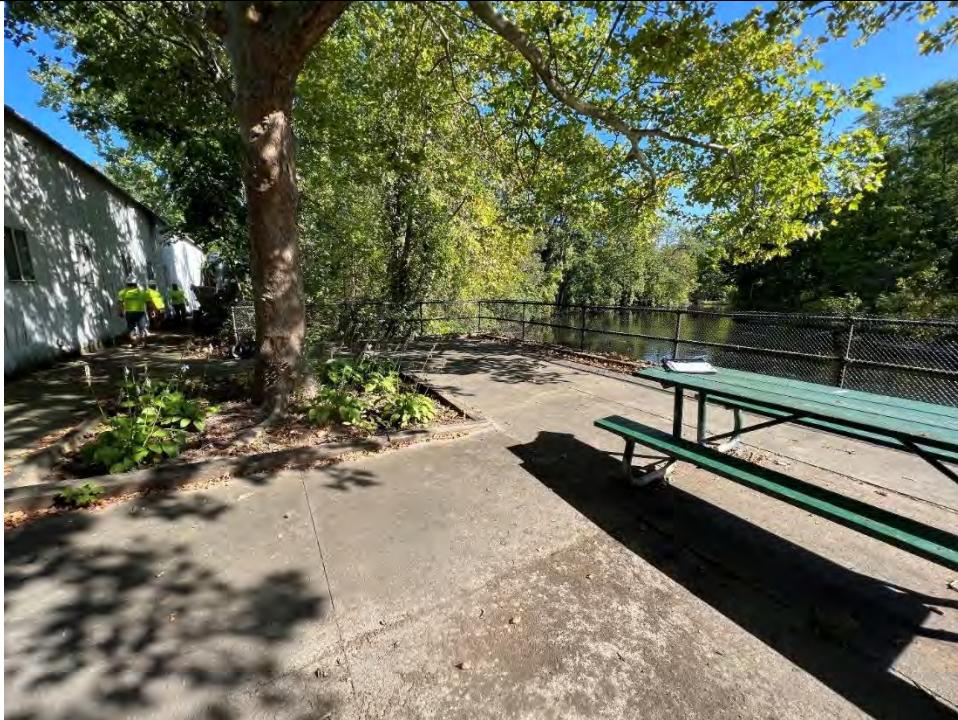
Photo No. 12 – Seating Area Downstream of Powerhouse Looking Downstream

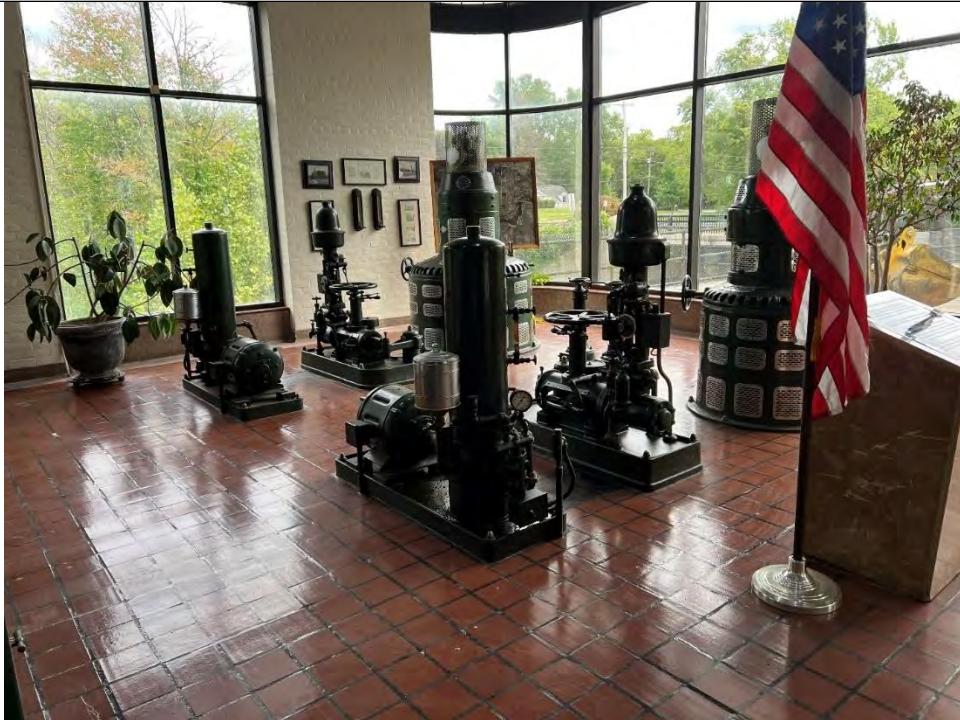
Photo No. 13 – Decommissioned Equipment in Powerhouse Looking Right

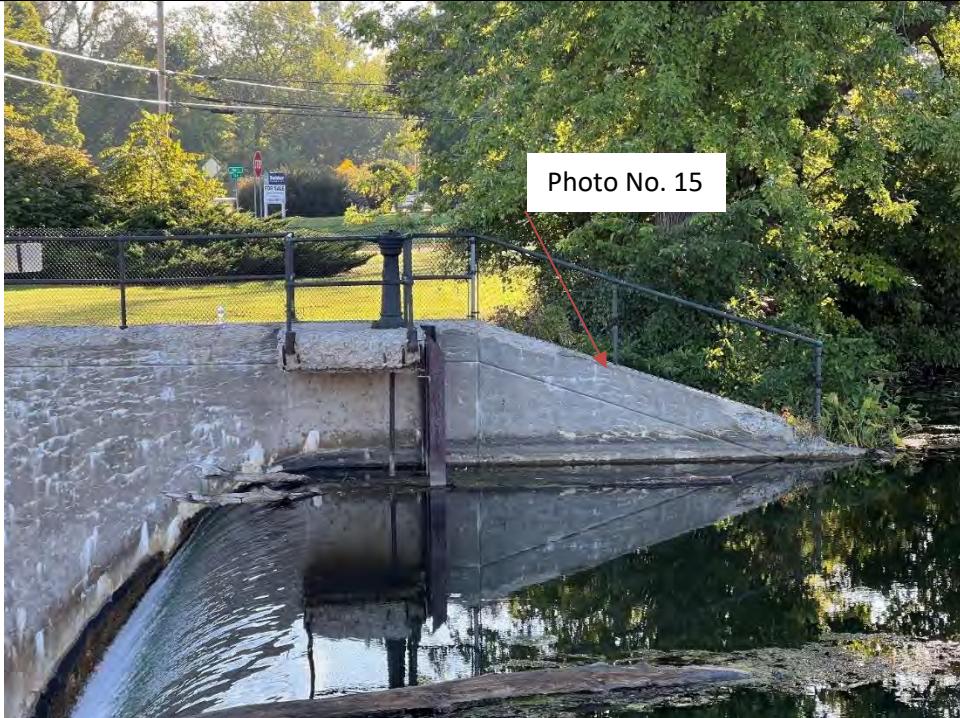
Photo No. 14 – Upstream Right Wing Wall and Right Operator Deck Looking Right

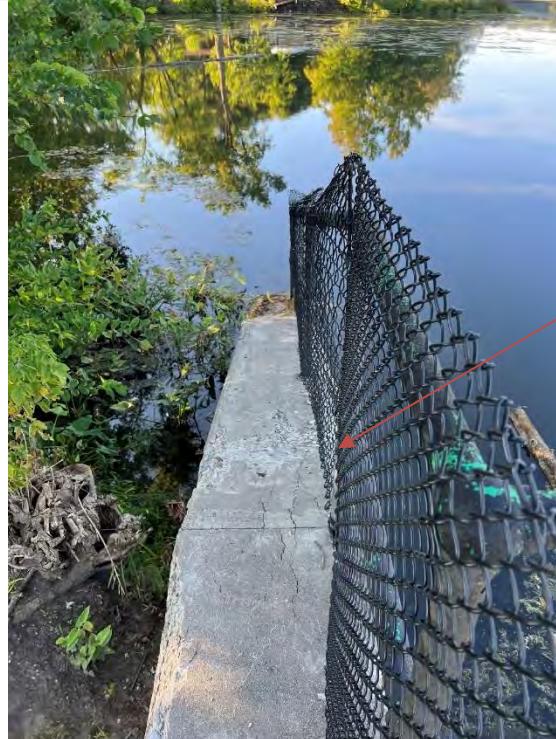
Photo No. 15 – Top of Upstream Right Wing Wall Looking Upstream

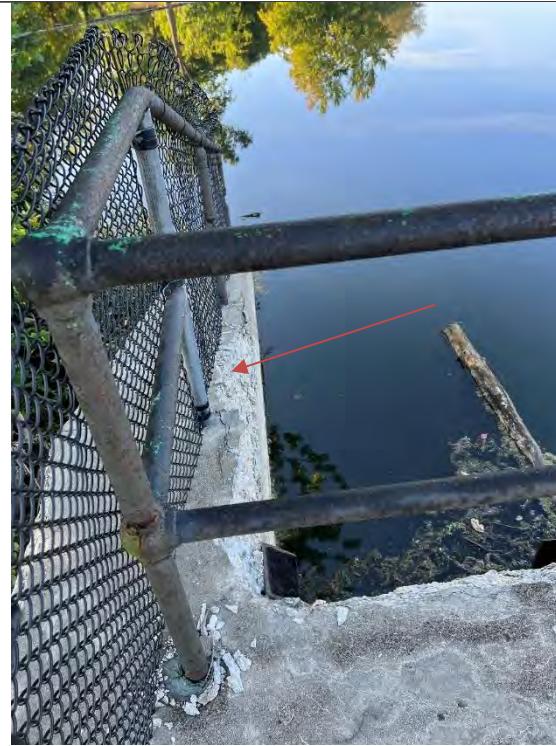
Photo No. 16 – Concrete Deterioration on Top of Upstream Right Wing Wall

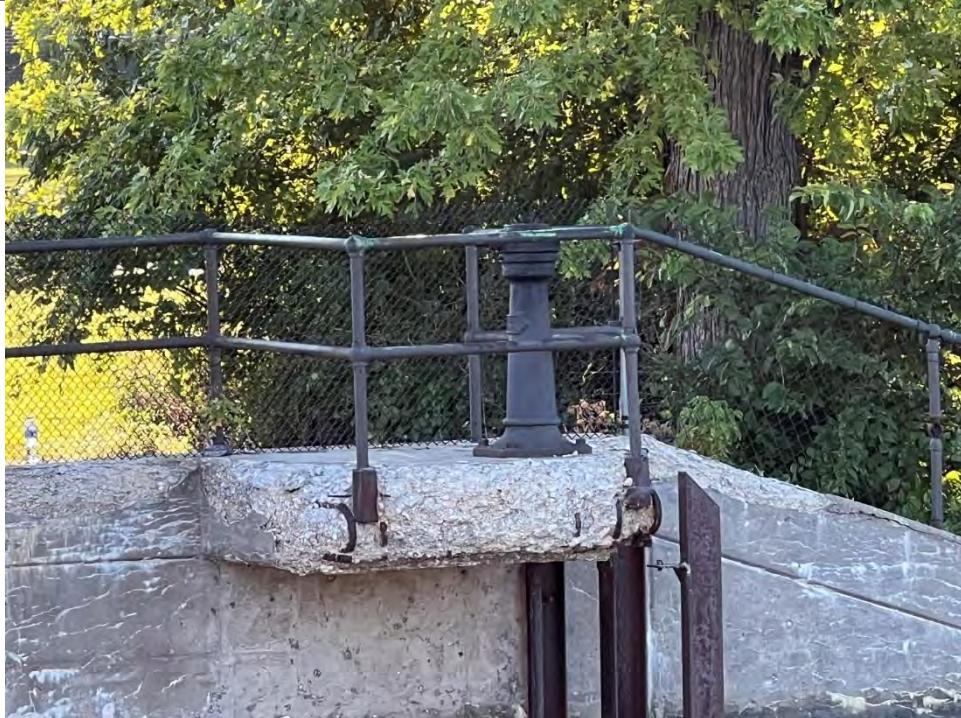
Photo No. 20 – Right Operator Deck Looking Right

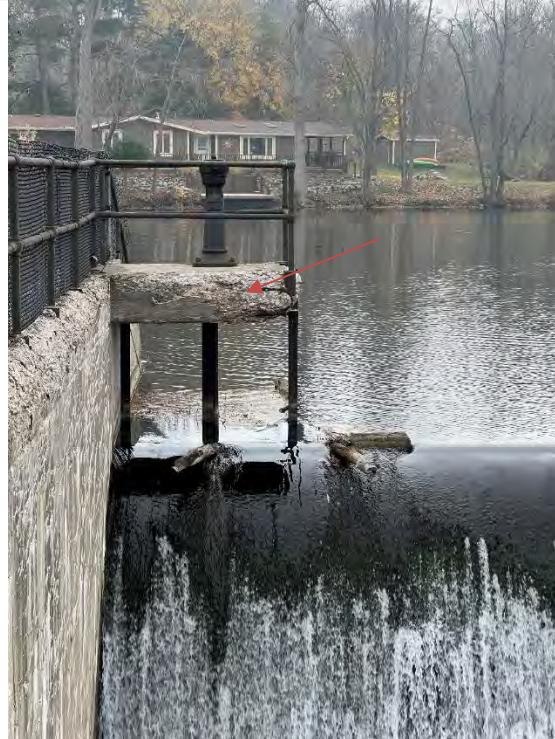
Photo No. 21 – Concrete Deterioration on Downstream Side of Right Operator Deck

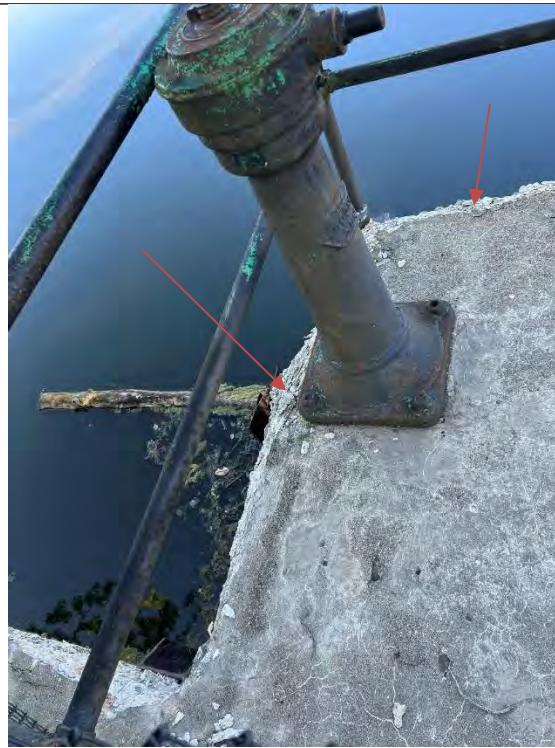
Photo No. 22 – Concrete Deterioration on Left and Upstream Side of Right Operator Deck

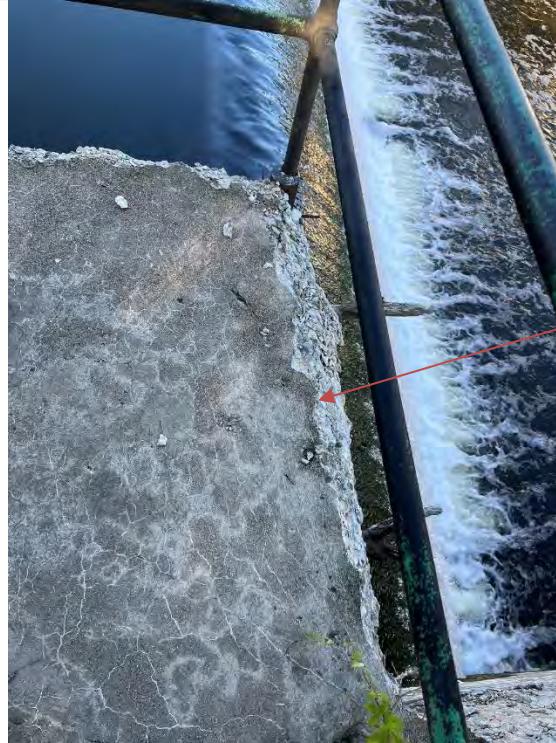
Photo No. 23 – Concrete Deterioration on Downstream Side of Right Operator Deck

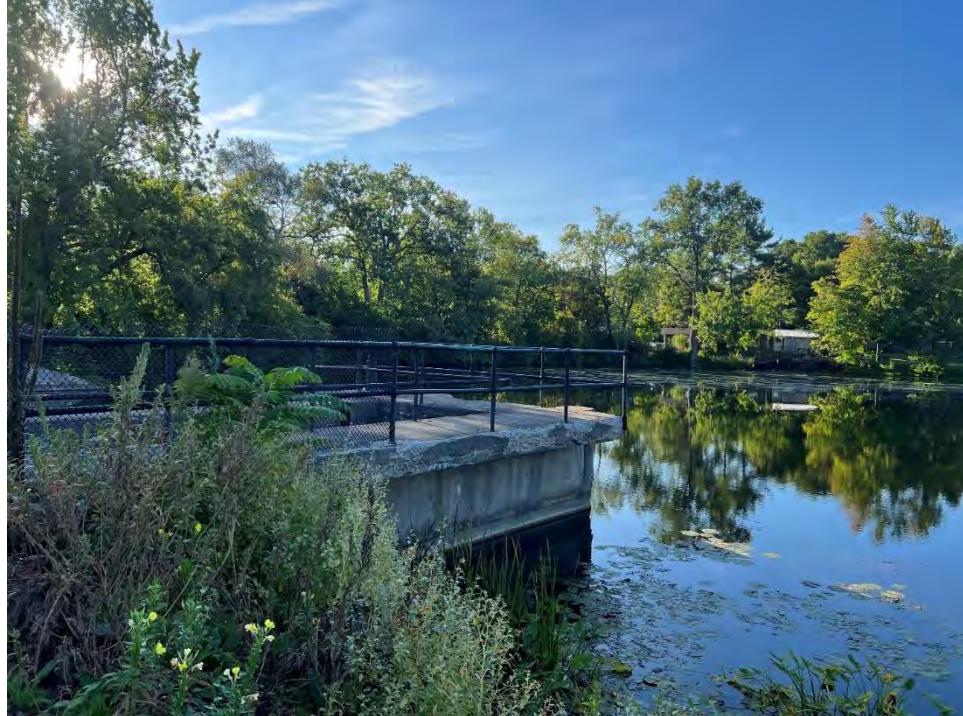
Photo No. 24 – Penstock Intake Looking Right

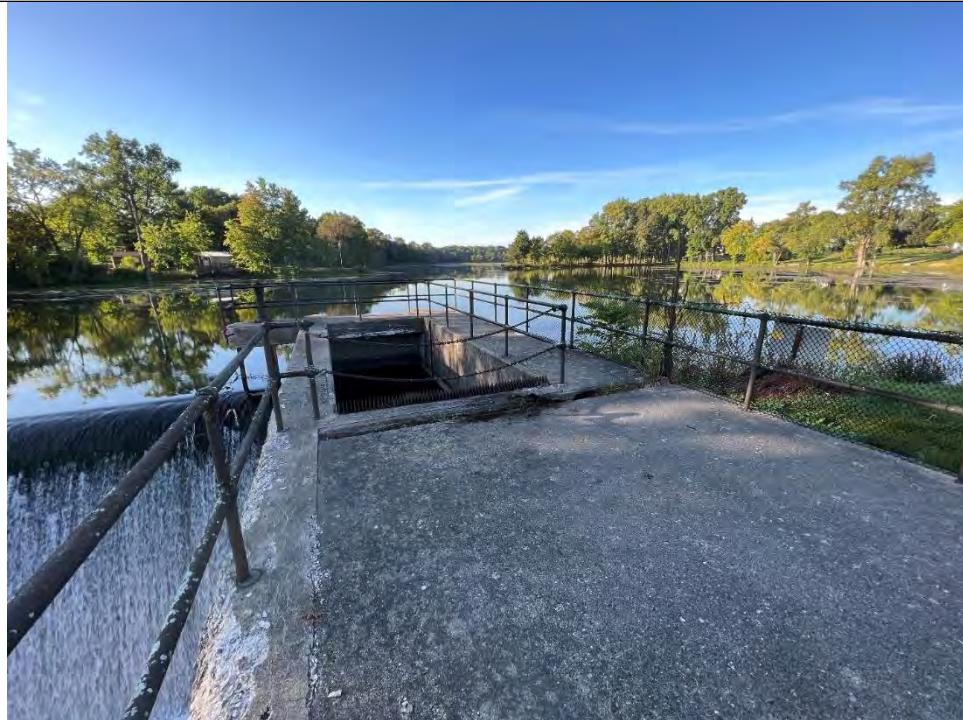
Photo No. 25 – Penstock Intake Deck Looking Upstream
