Inspection, Analysis, and Recommendations Report Ford Manchester Dam

River Raisin
Manchester, Michigan
EGLE Dam ID No. 391

February 14, 2024
GEI Project No. 2204052

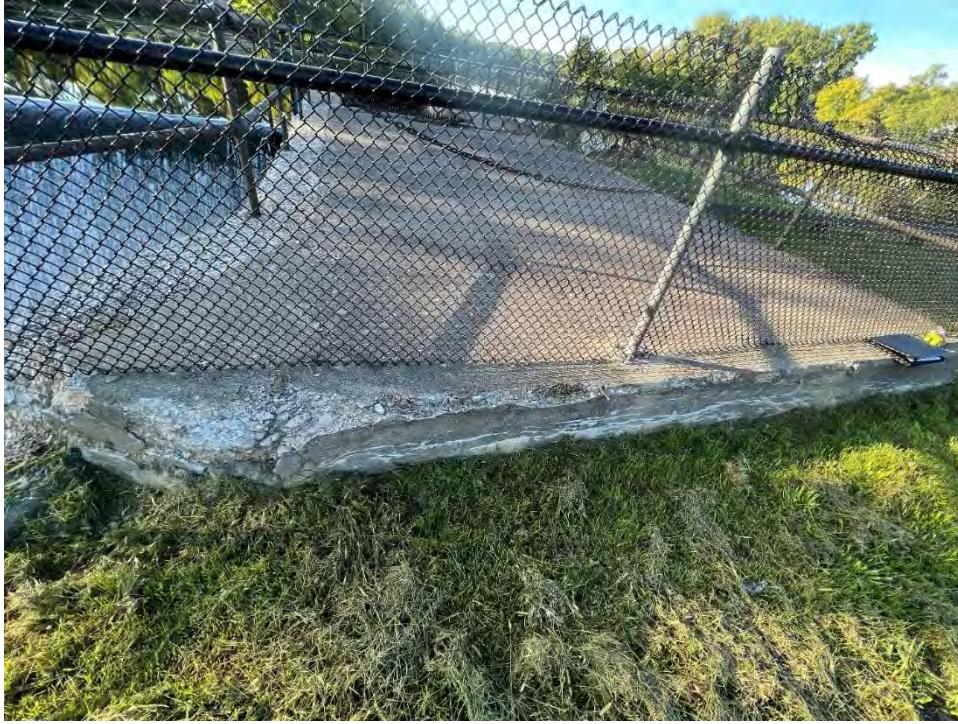
Photo No. 27 – Downstream Side of Penstock Operator Deck Looking Upstream Looking Upstream

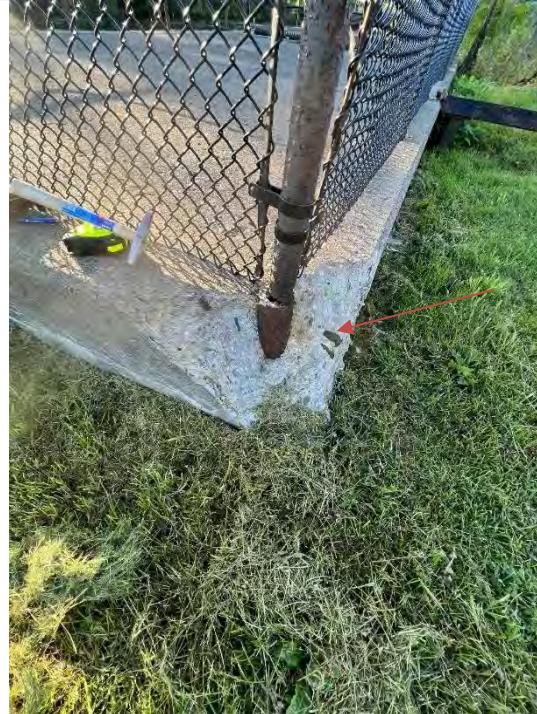
Photo No. 29 – Concrete Deterioration on Downstream Left Corner of Penstock Intake Deck Looking Upstream

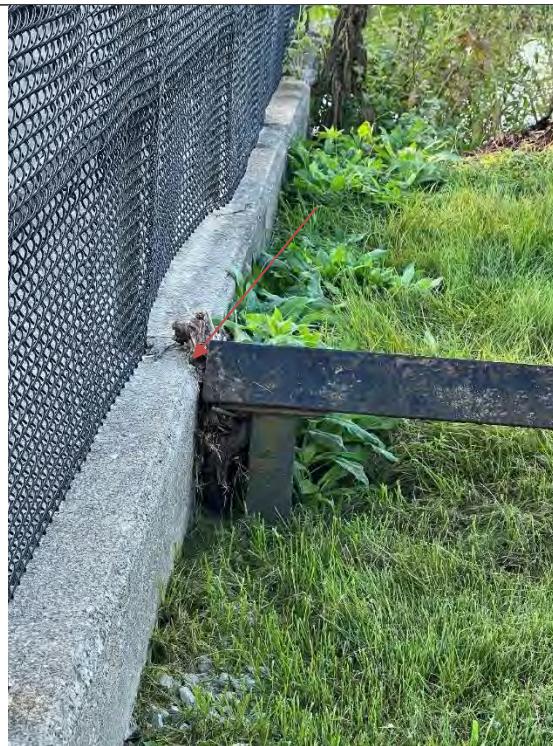
Photo No. 30 – Interface of Guardrail and Left Side of Penstock Intake Deck Looking Upstream

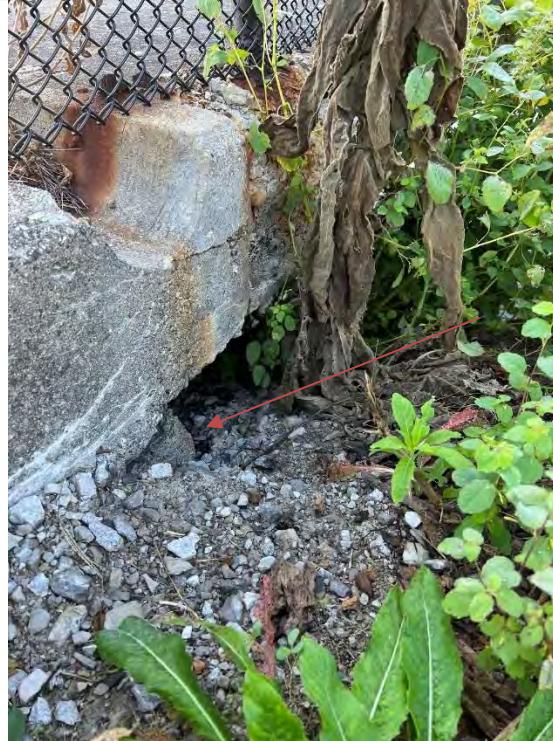
Photo No. 31 – Interface of Left Upstream Face of Penstock Intake and Crest of Left Embankment
Looking Upstream

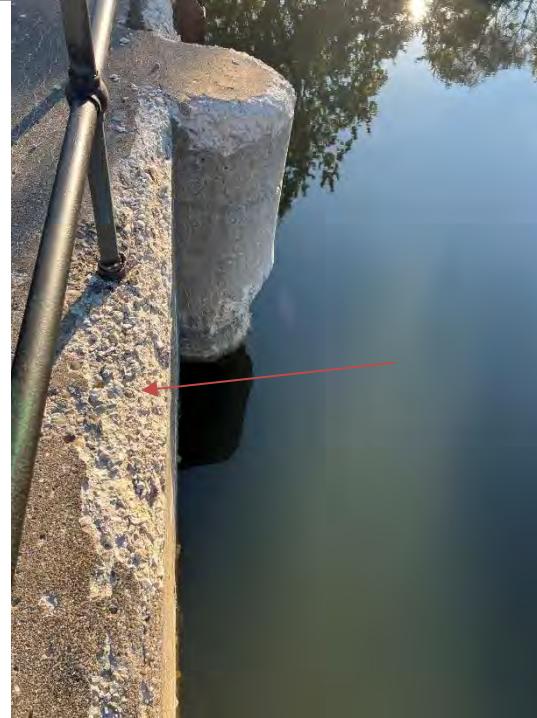
Photo No. 34 – Concrete Deterioration of Upstream Side of Penstock Intake Deck Looking Right

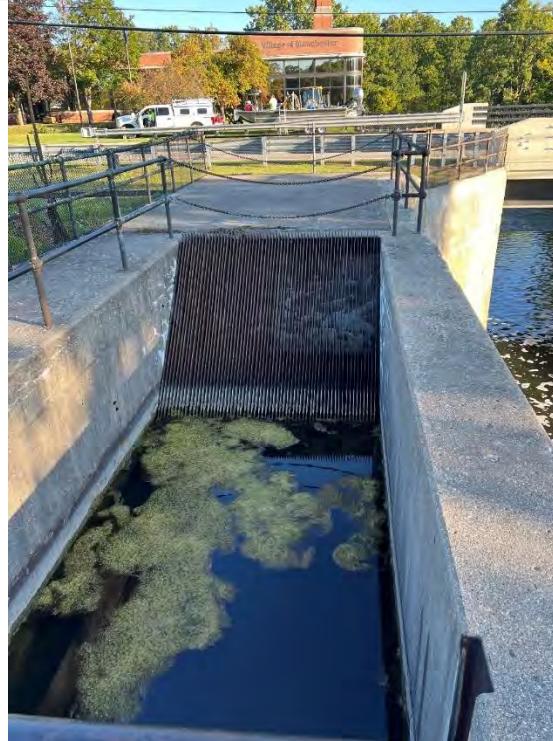
Photo No. 37 – Trashrack Upstream of Penstock Looking Downstream

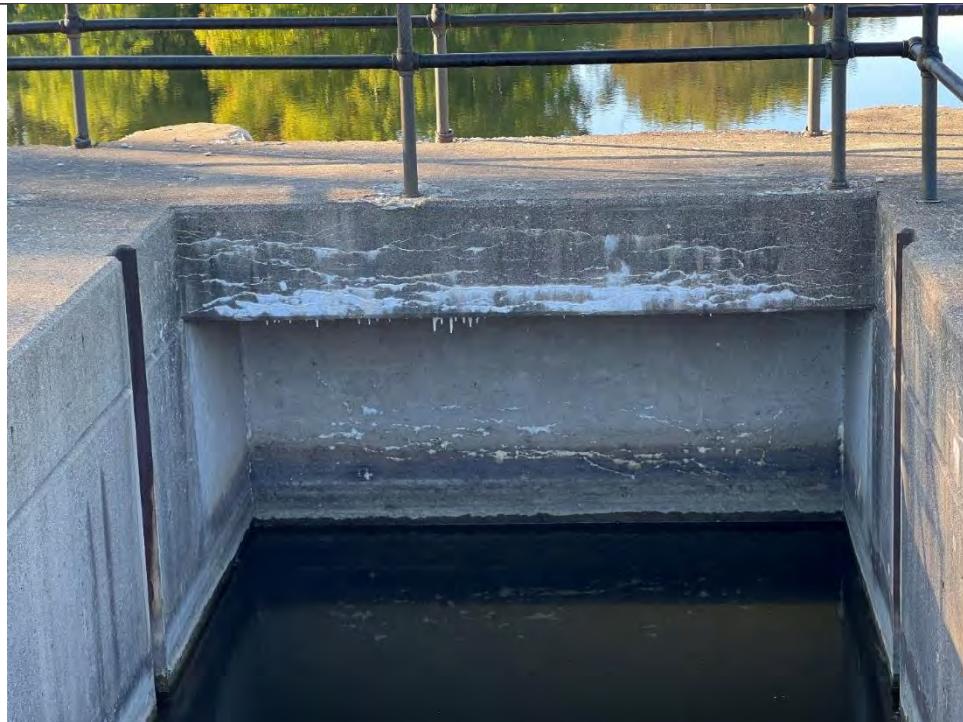
Photo No. 38 – Stoplog Slots in Penstock Intake above Headwater Looking Upstream

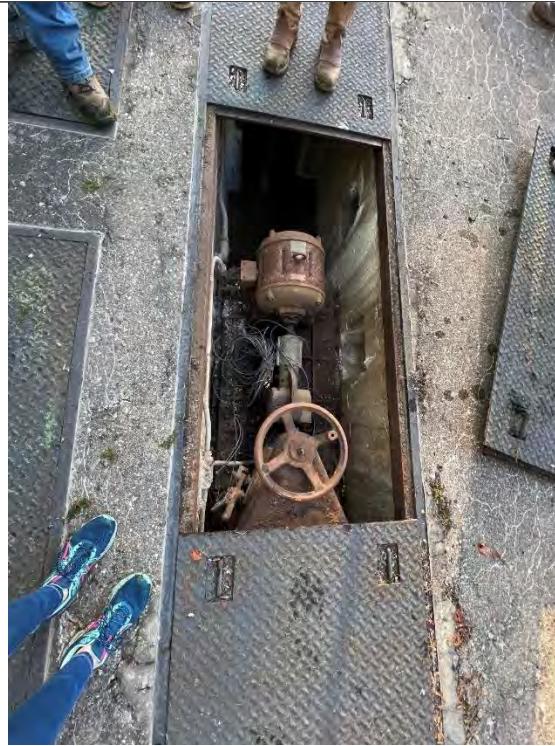
Photo No. 42 – Penstock Access Upstream of Head Gates

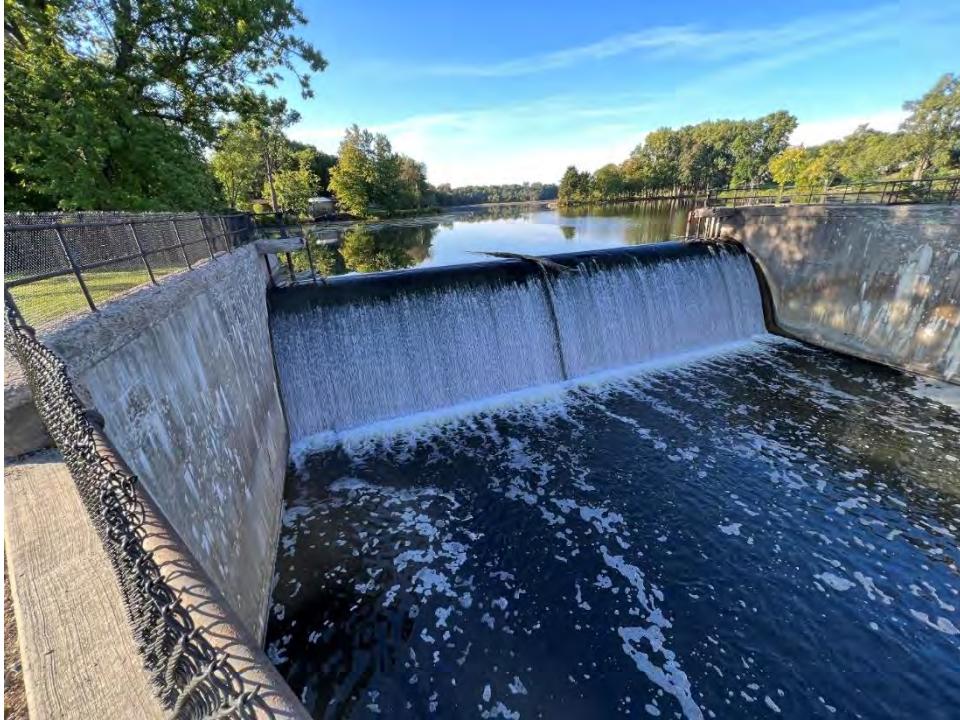
Photo No. 43 – Downstream Left Wall Upstream of M-52 Bridge Looking Left

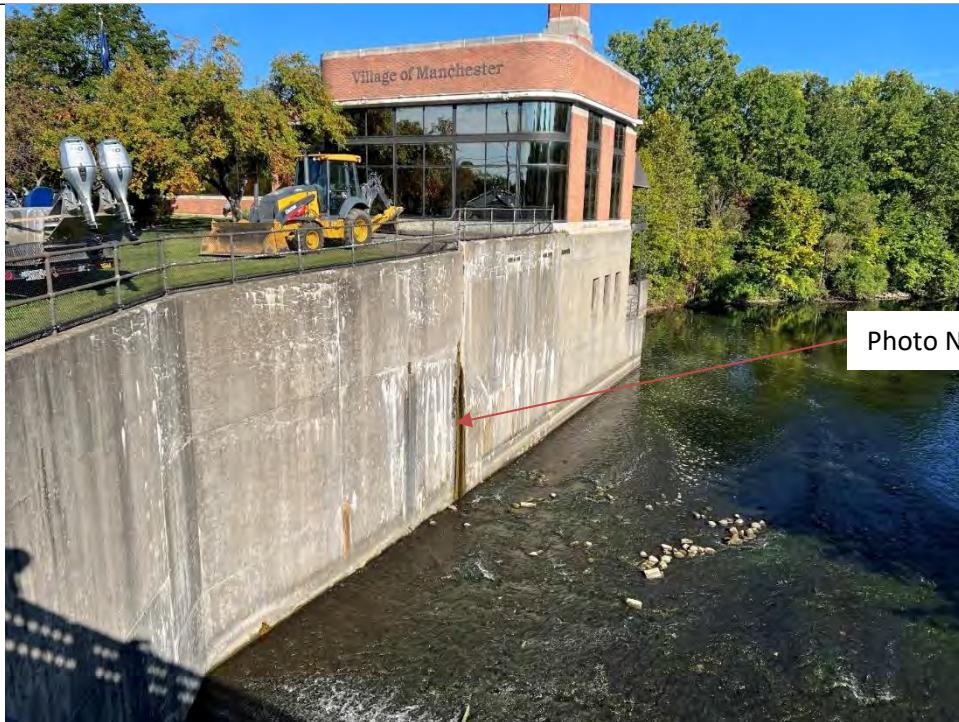
Photo No. 48 – Downstream Left Wall Downstream of M-52 Bridge Looking Downstream

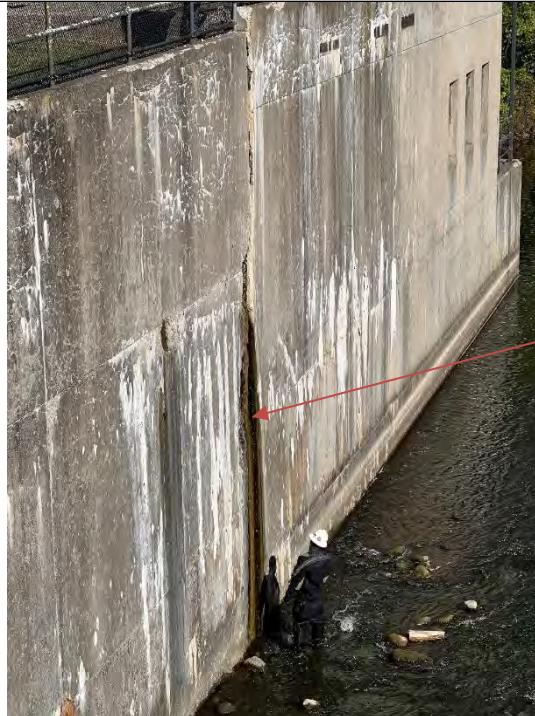
Photo No. 49 – Concrete Deterioration and Leaking at Construction Joint on Downstream Left Wall
Downstream of M-52 Bridge

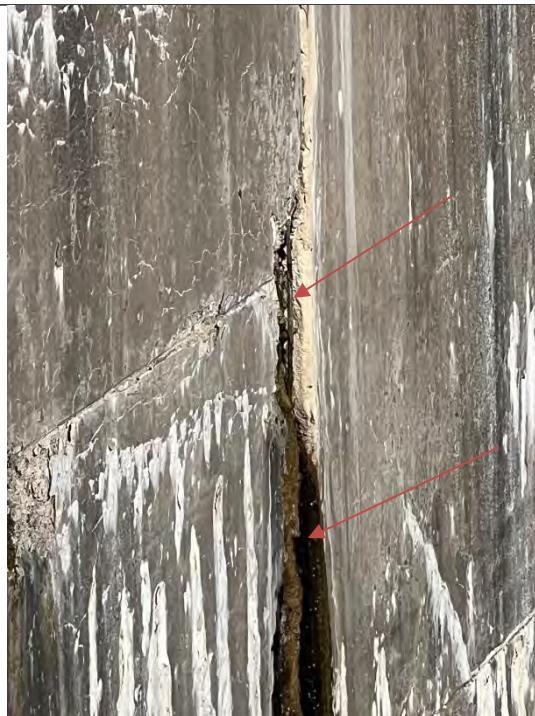
Photo No. 50 – Concrete Deterioration and Leaking at Construction Joint on Downstream Left Wall
Downstream of M-52 Bridge

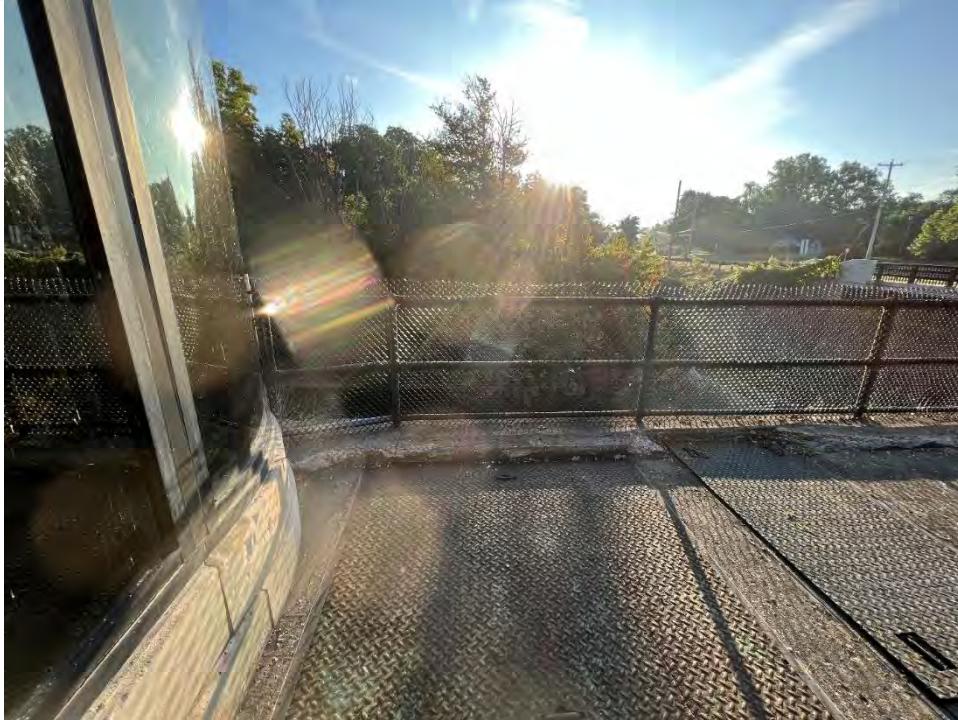
Photo No. 51 – Top of Downstream Left Wall Upstream of Powerhouse Looking Right

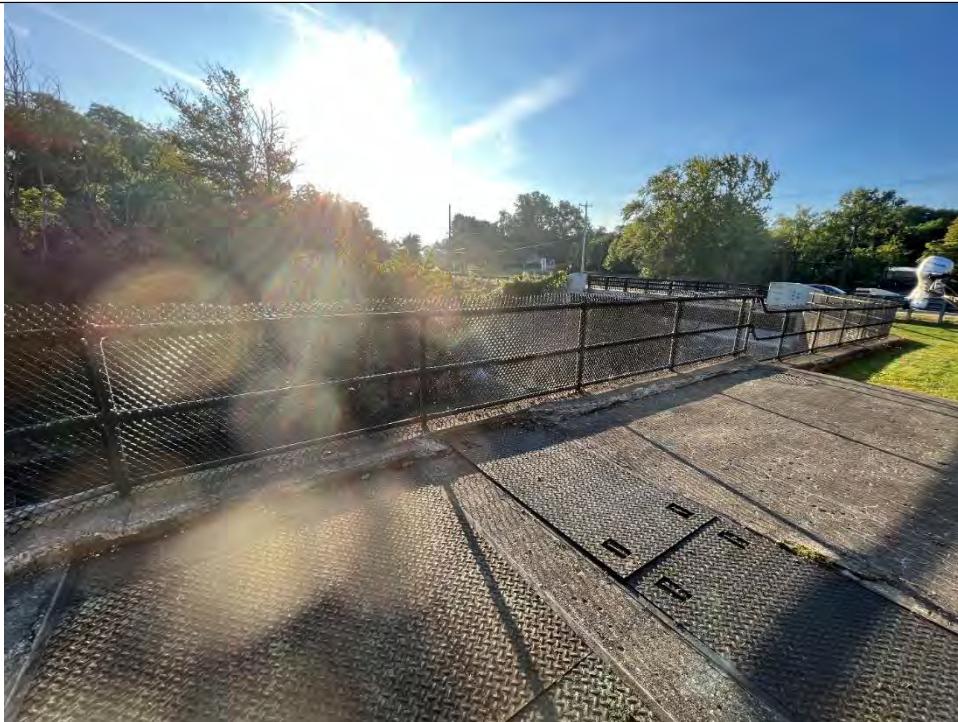
Photo No. 52 – Top of Downstream Left Wall Upstream of Powerhouse Looking Upstream

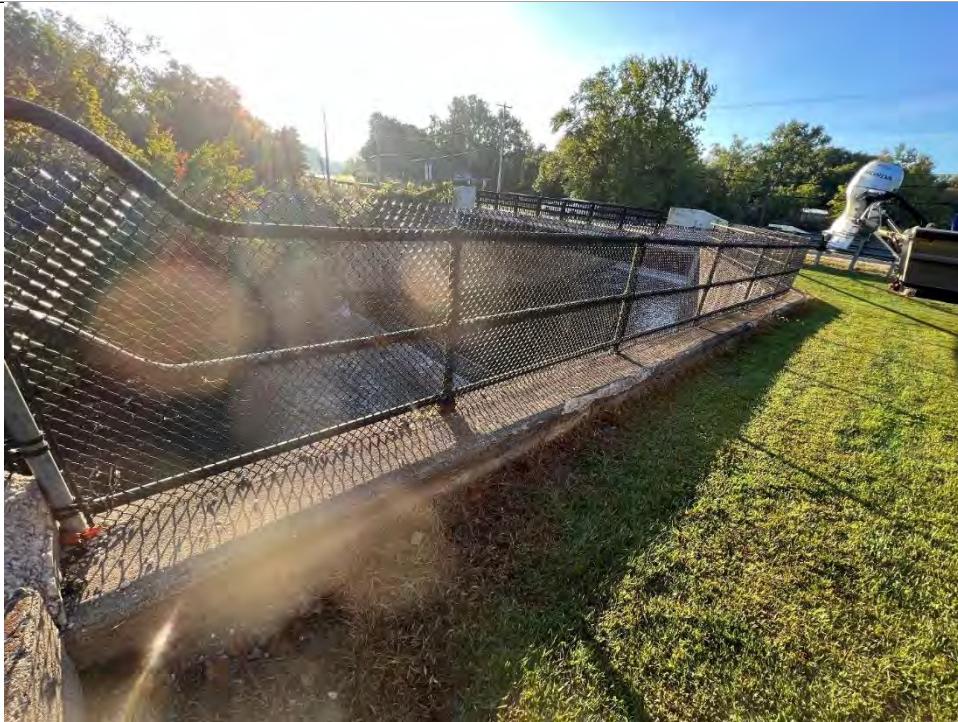
Photo No. 54 – Top of Downstream Left Wall Downstream of M-52 Bridge Looking Upstream

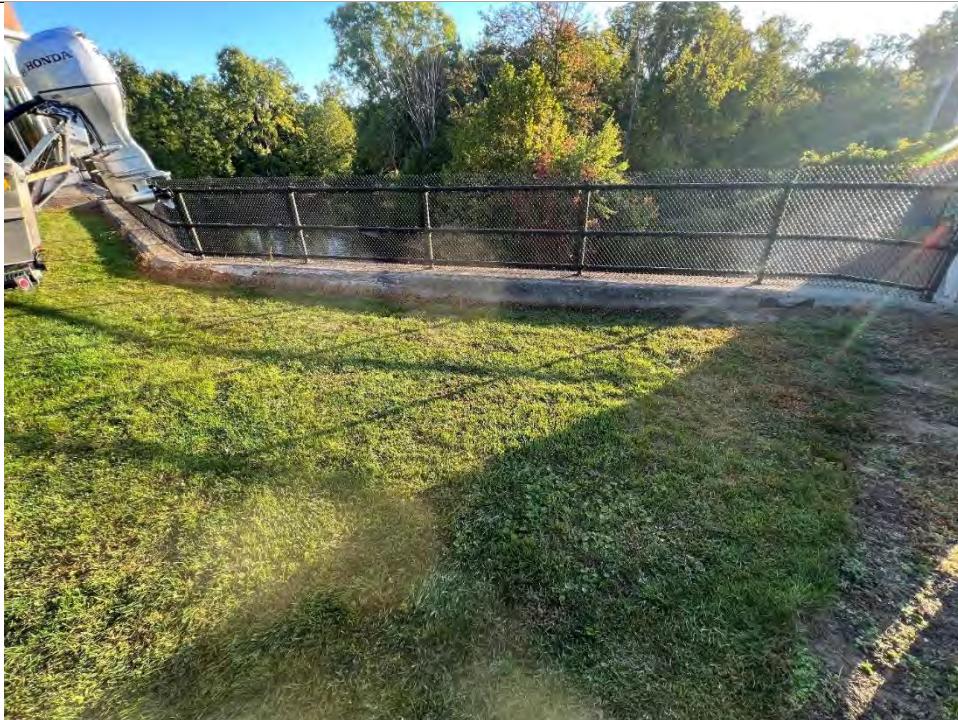
Photo No. 56 – Top of Downstream Left Wall Downstream of M-52 Bridge Looking Right

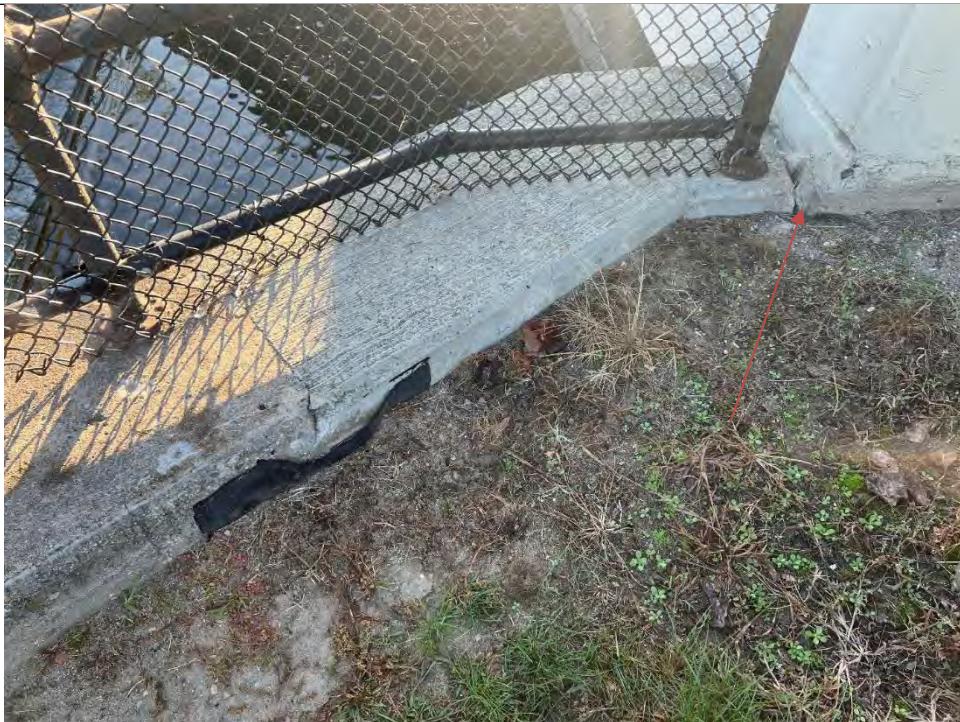
Photo No. 58 – Downstream Interface of Downstream Left Wall and M-52 Bridge

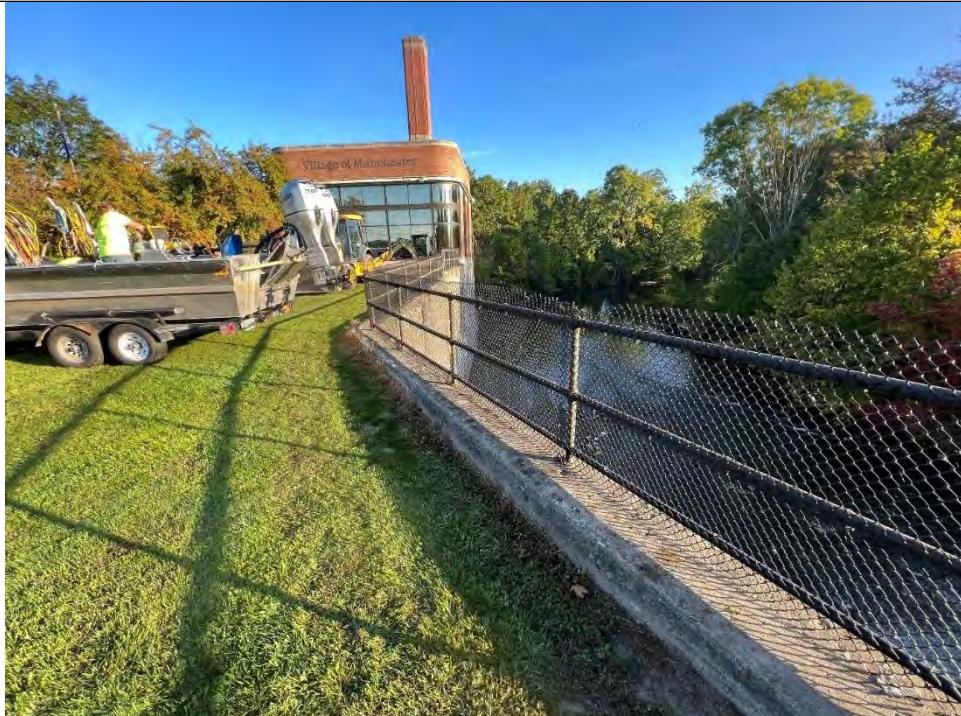
Photo No. 59 – Top of Downstream Left Wall Downstream of M-52 Bridge Looking Downstream

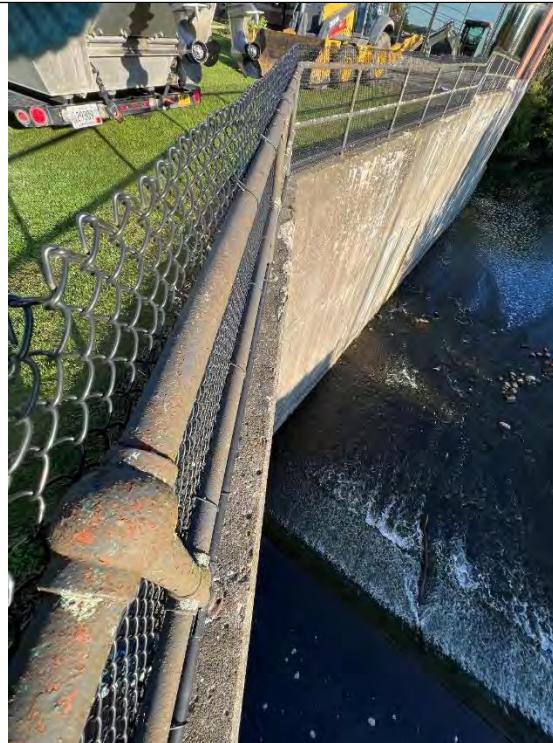
Photo No. 60 – Top of Downstream Left Wall Downstream of M-52 Bridge Looking Downstream

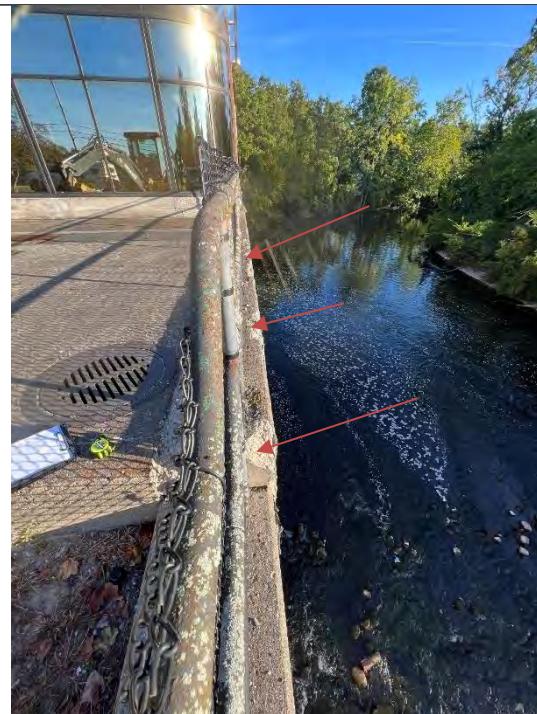
Photo No. 62 – Concrete Deterioration on Top of Downstream Left Wall Downstream of M-52 Bridge
Looking Downstream

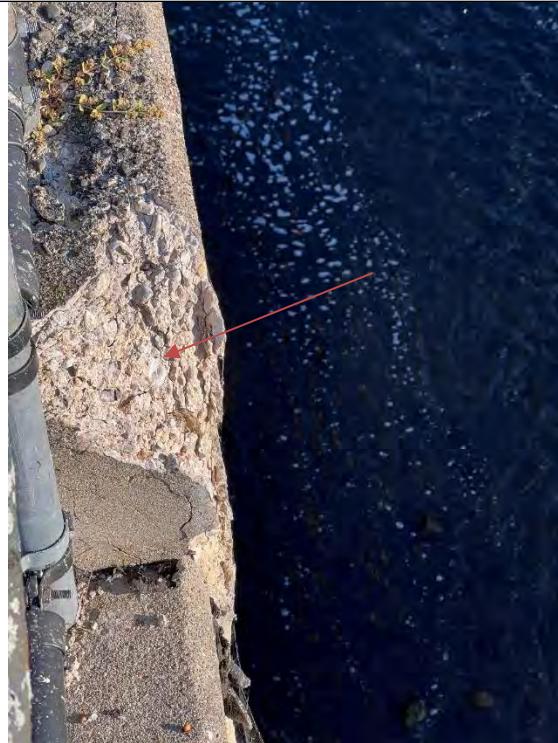
Photo No. 63 – Concrete Deterioration on Top of Downstream Left Wall Upstream of Powerhouse
Looking Downstream

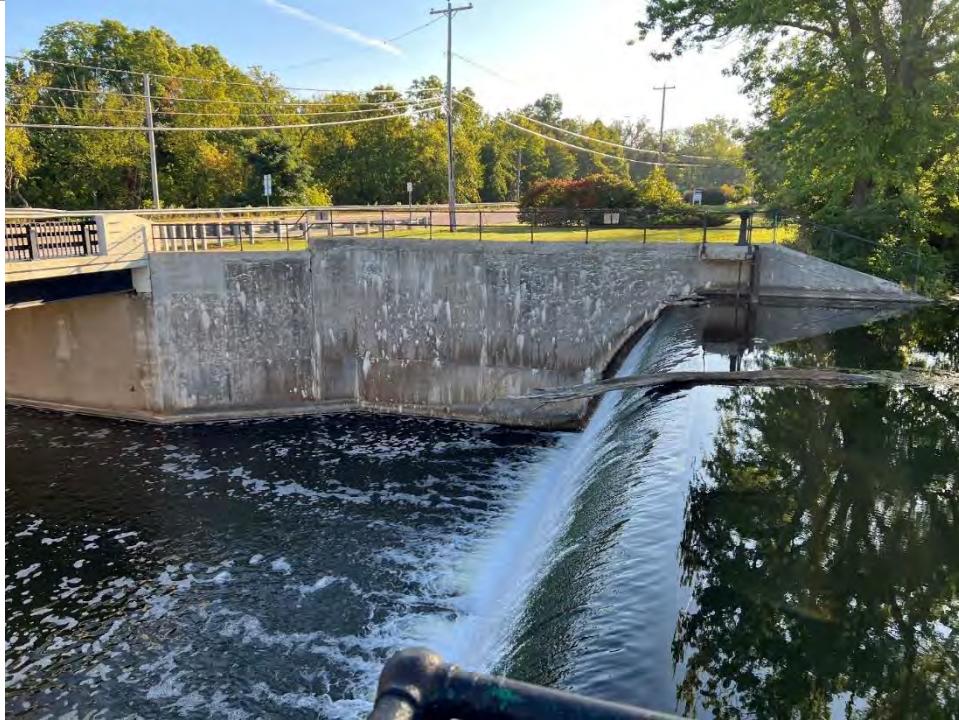
Photo No. 64 – Downstream Right Wall Upstream of M-52 Bridge Looking Right

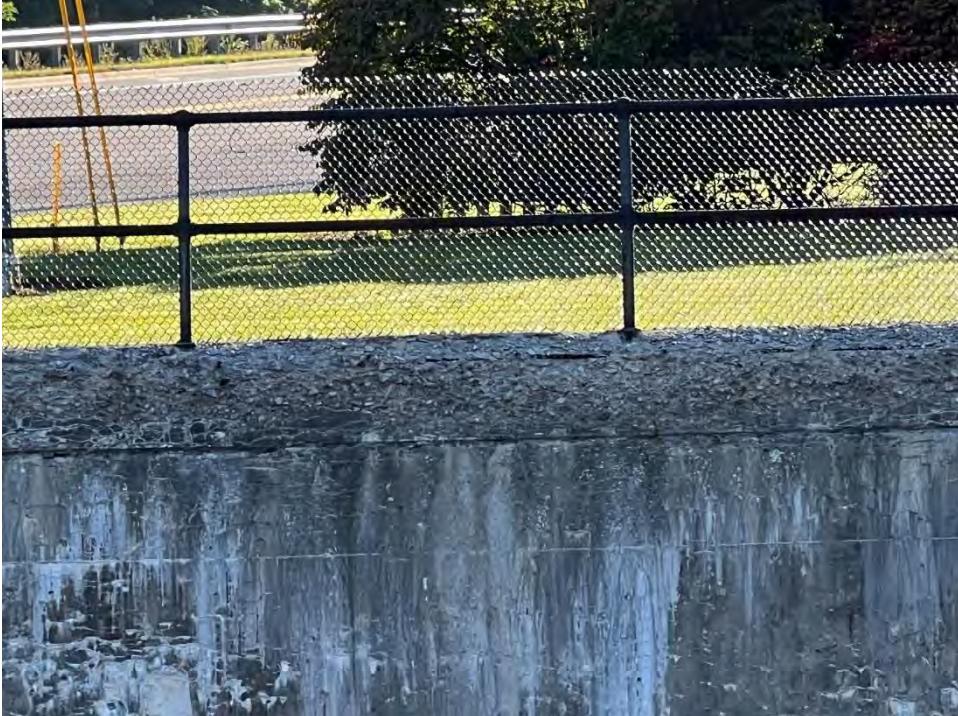
Photo No. 66 – Concrete Deterioration at Top of Downstream Right Wall Upstream of M-52 Bridge
Looking Right

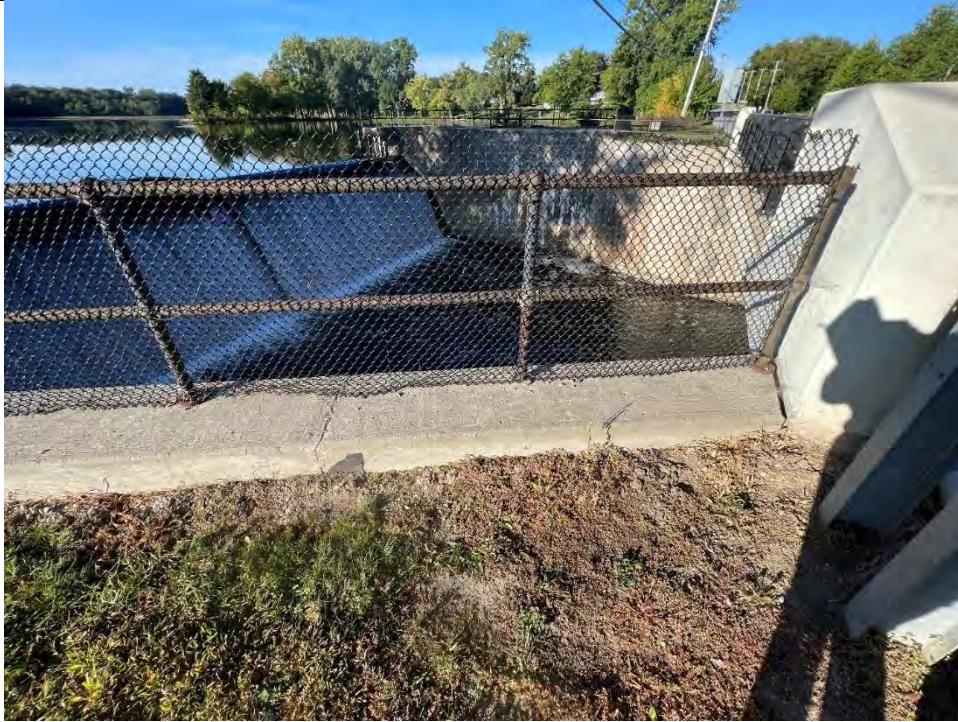
Photo No. 68 –Top of Downstream Right Wall Upstream of M-52 Bridge Looking Left

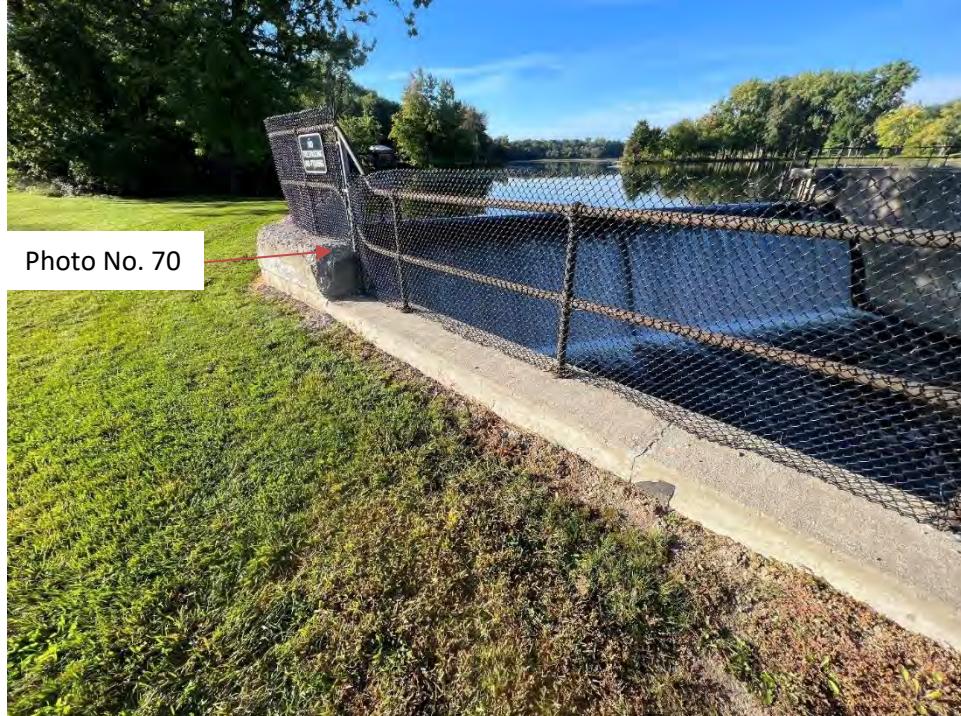
Photo No. 69 – Top of Downstream Right Wall Upstream of M-52 Bridge Looking Upstream

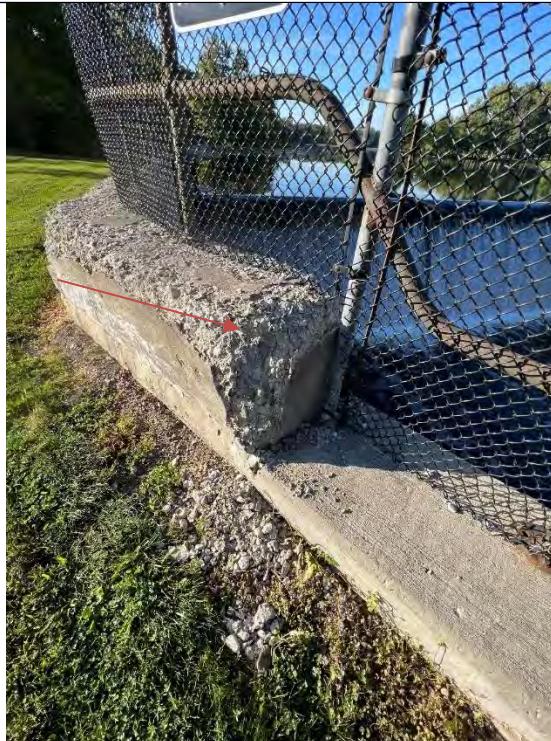
Photo No. 70 – Concrete Deterioration Top of Downstream Right Wall Upstream of M-52 Bridge
Looking Upstream

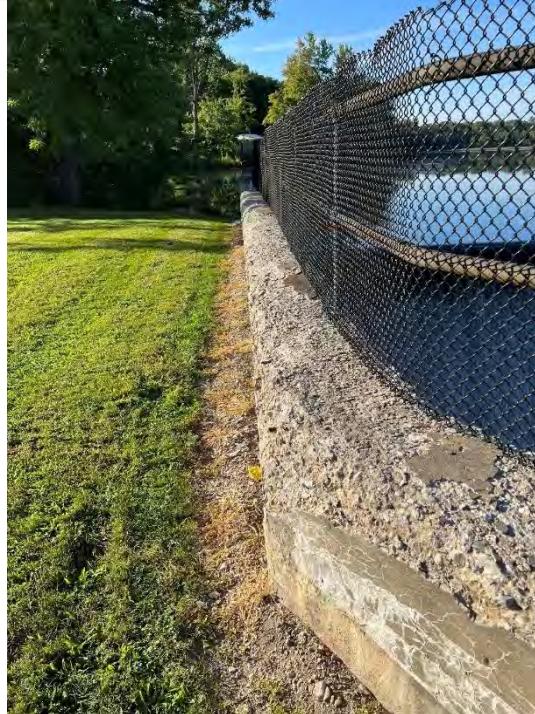
Photo No. 71 – Concrete Deterioration Top of Downstream Right Wall Upstream of M-52 Bridge
Looking Upstream

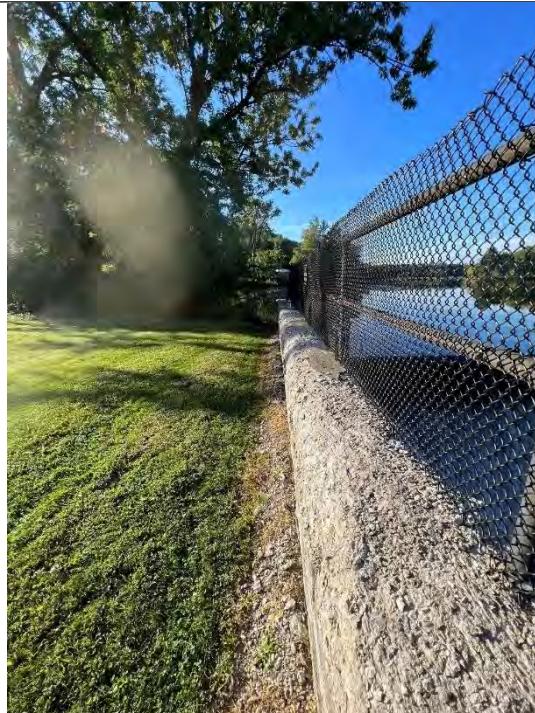
Photo No. 72 – Concrete Deterioration Top of Downstream Right Wall Upstream of M-52 Bridge
Looking Upstream

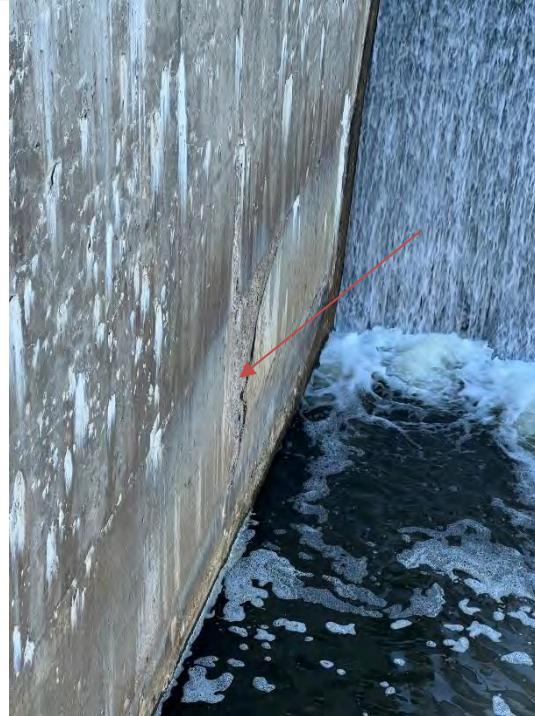
Photo No. 75 – Concrete Deterioration on Face of Downstream Right Wall Upstream of M-52 Bridge
Looking Upstream

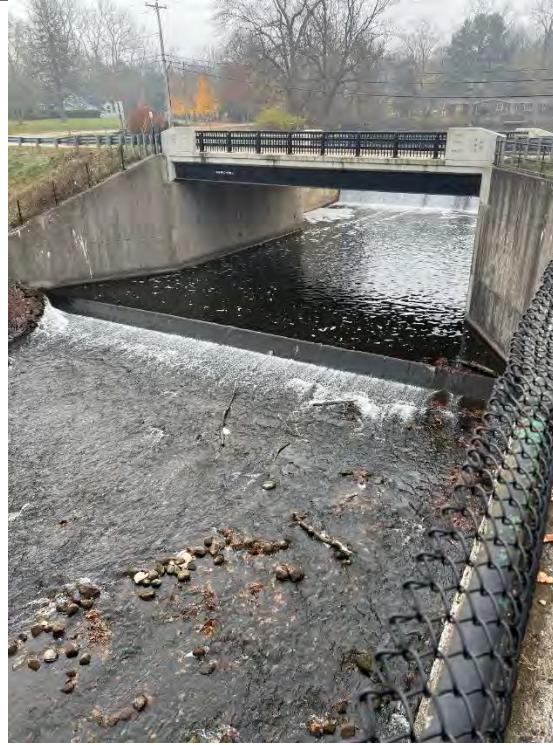
Photo No. 76 – Downstream Right Abutment and Wing Wall Looking Upstream

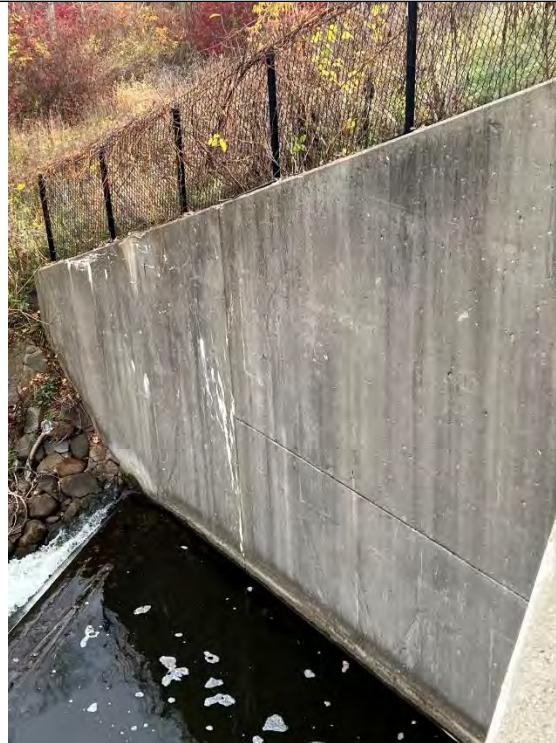
Photo No. 77 – Downstream Right Wing Wall Looking Right

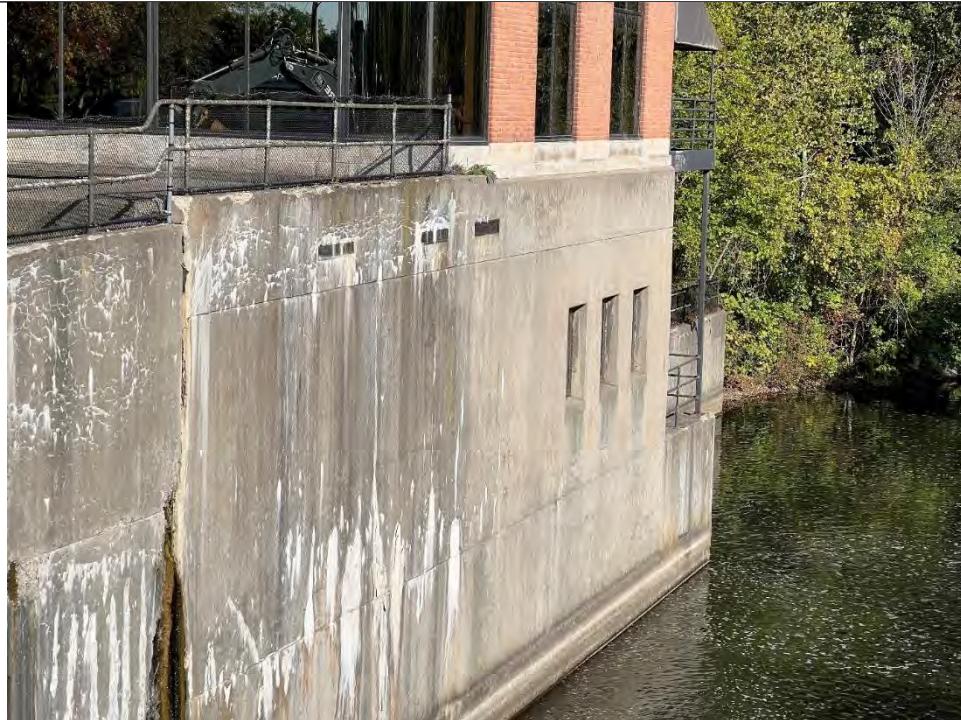
Photo No. 78 – Powerhouse Right Exterior Wall Looking Downstream

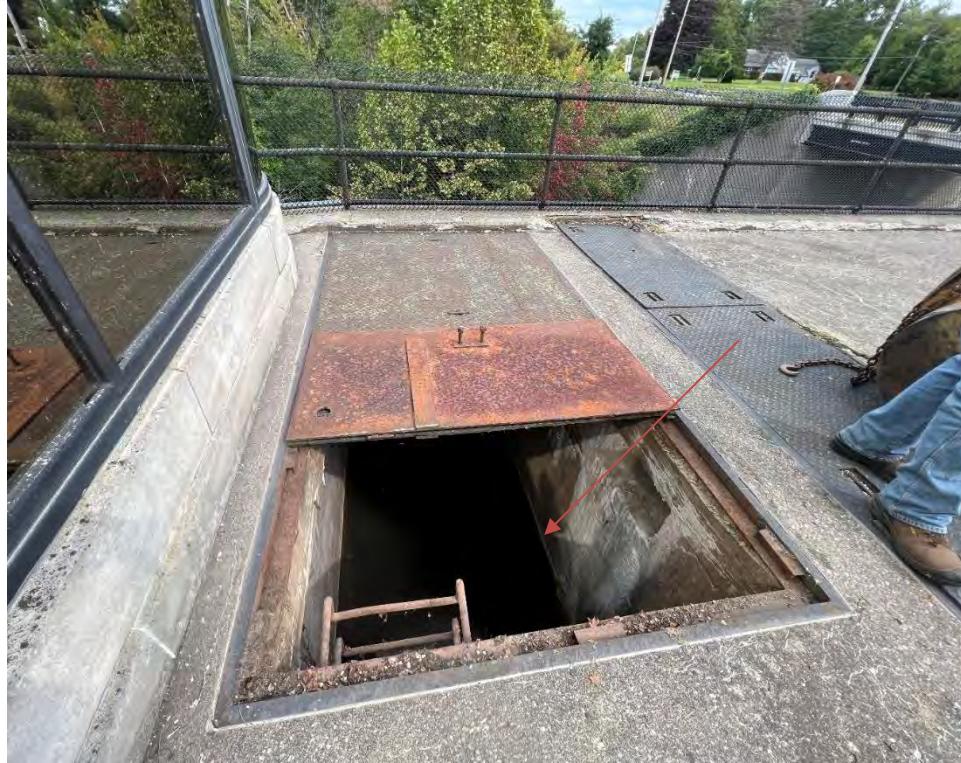
Photo No. 79 – Access to Turbine Vaults Upstream of Powerhouse

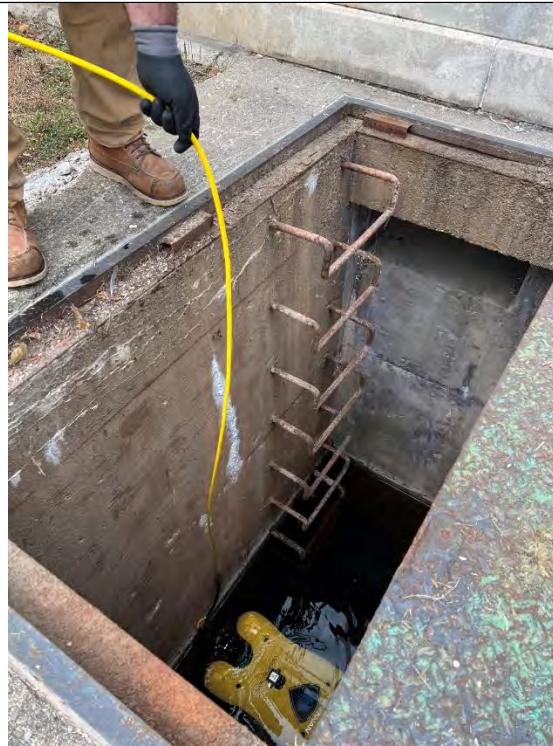
Photo No. 80 – Access to Turbine Vaults Upstream of Powerhouse

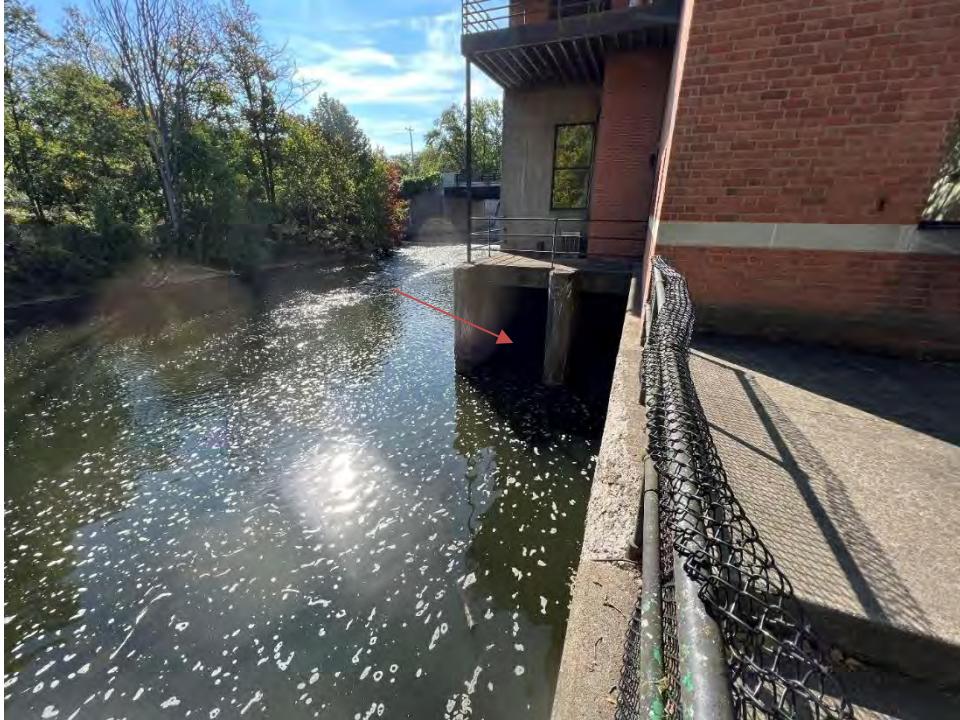
Photo No. 81 – Outlet of Draft Bay Looking Upstream

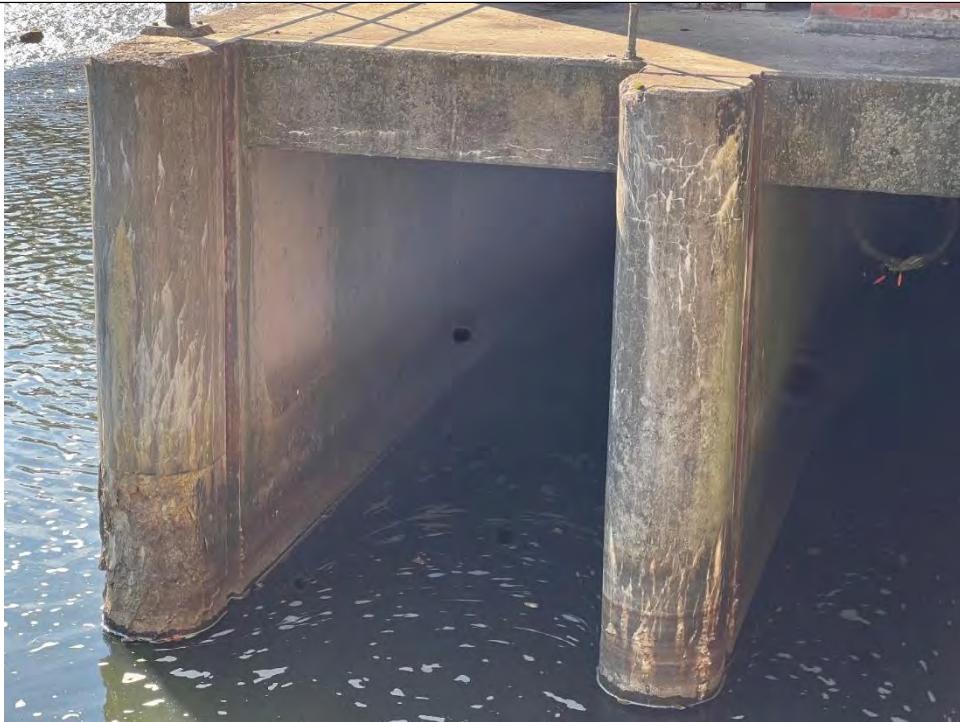
Photo No. 82 – Outlet of Draft Bay Looking Upstream

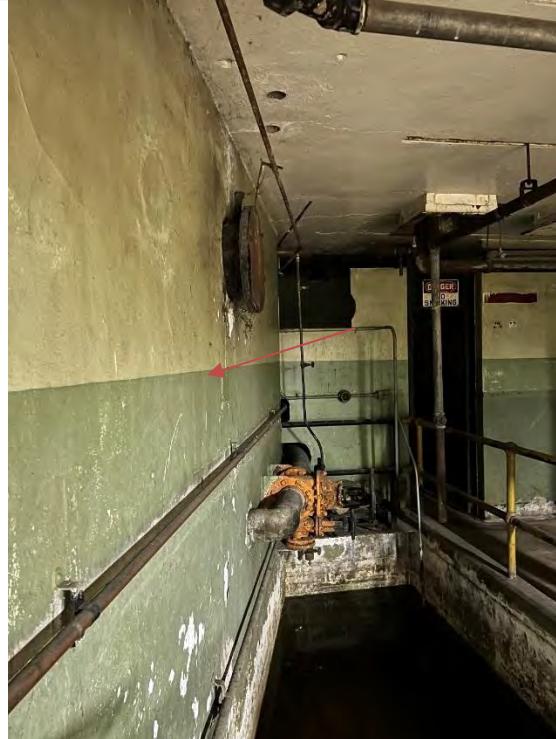
Photo No. 83 – Basement Wall and Right Draft Bay Wall Looking Upstream

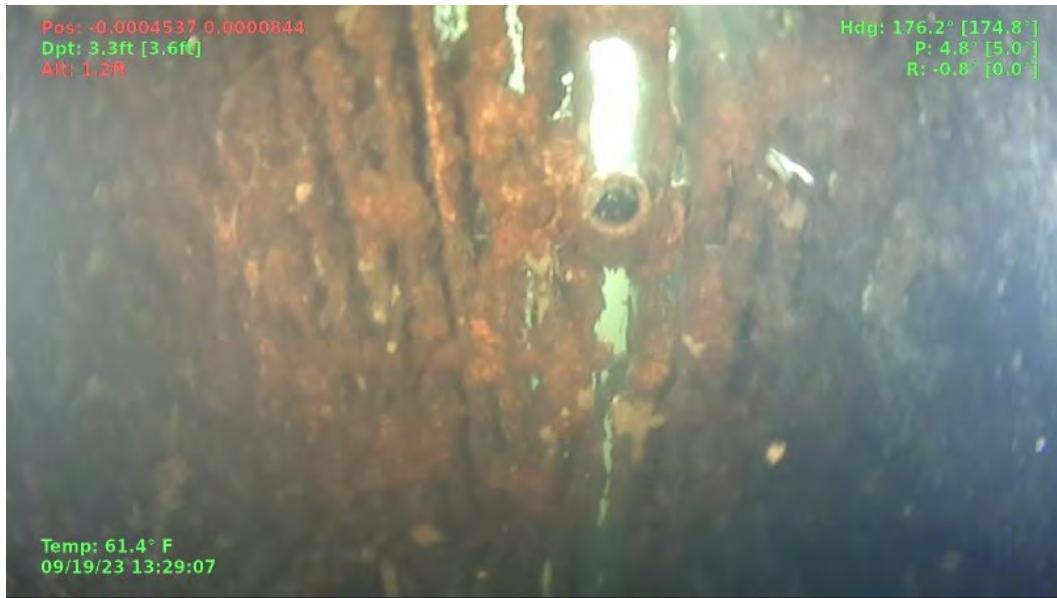
- Trash Rack: The trash rack experienced moderate to heavy marine growth with 80 to 90% coverage (See '[Appendix A, Figure 19](#)').
- West Wall: The concrete was in satisfactory condition.
- Two gates were present on the downstream end of the tunnel (See '[Appendix A, Figures 20-21](#)').
 - The gates experienced light to moderate rust throughout.

Figure 19 – Upstream, Intake Tunnels: Trash Rack

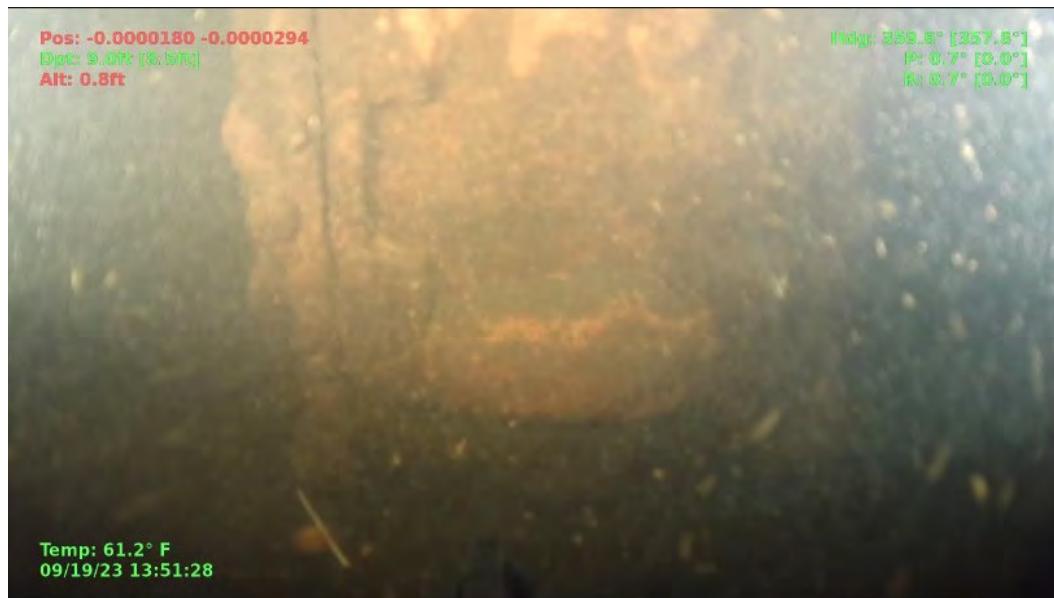
Figure 20 – Upstream, Intake Tunnels: Gate 2

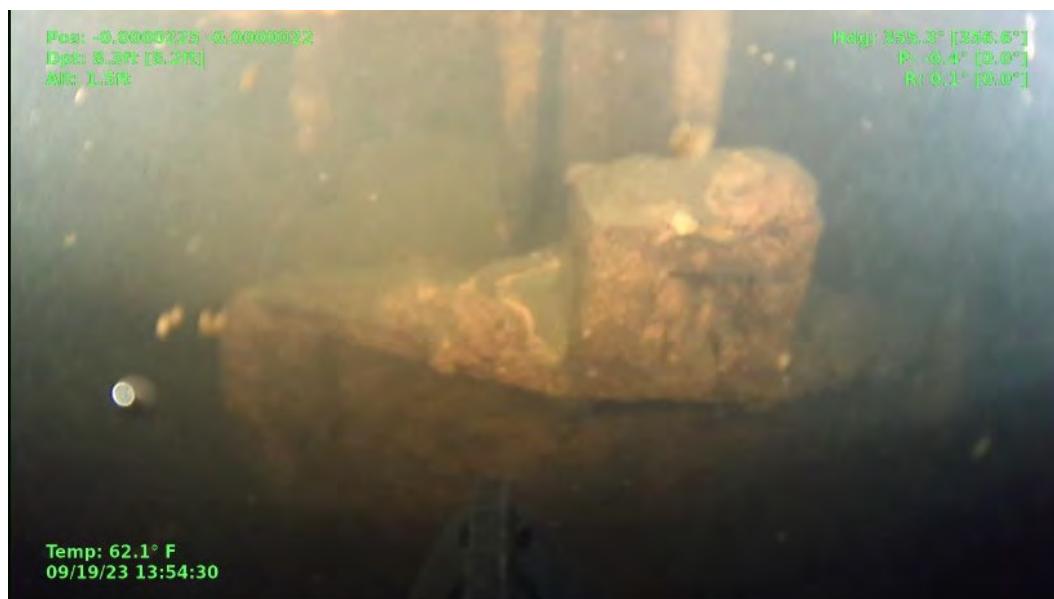
Figure 21 – Upstream, Intake Tunnels: Gate 1
