Inspection, Analysis, and Recommendations Report Ford Manchester Dam

River Raisin
Manchester, Michigan
EGLE Dam ID No. 391

February 14, 2024
GEI Project No. 2204052

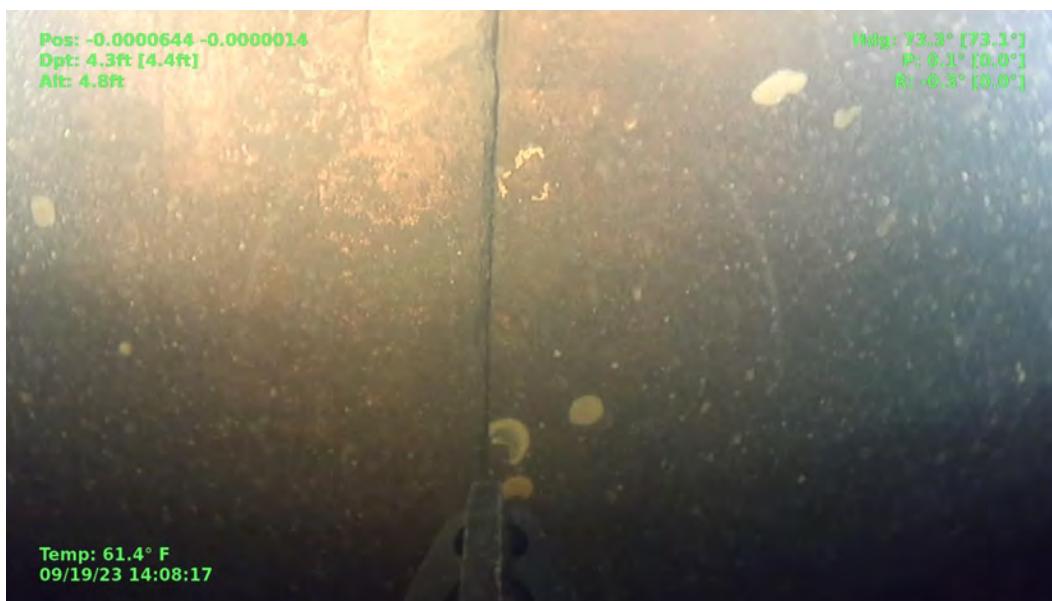
- East Wall:
 - **Station 7:** A construction joint that was the source of the leaking water at Station 6 was present 15-feet upstream of the gates (See '[Appendix A, Figures 22-23](#)').
 - An area of spalling was present on the ceiling (See '[Appendix A, Figures 24-25](#)').
 - **Station 8:** A hairline crack was present on the east wall approximately 27-feet upstream of the gates (See '[Appendix A, Figure 26](#)').
 - The crack extended from the bottom to the top of the wall.
 - **Station 9:** A hairline crack was present on the east wall approximately 40-feet upstream of the gates (See '[Appendix A, Figure 27](#)').
 - The crack extended from the bottom to the top of the wall.

Figure 23 – Upstream, Intake Tunnels East Wall: Construction Joint

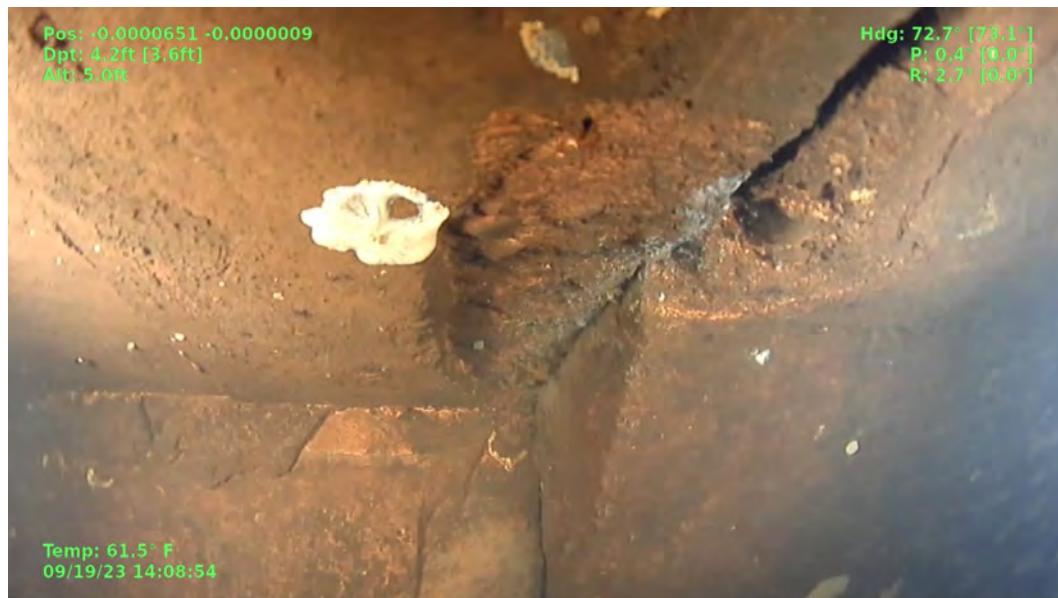
Figure 24 – Upstream, Intake Tunnels East Wall: Spalling on Ceiling

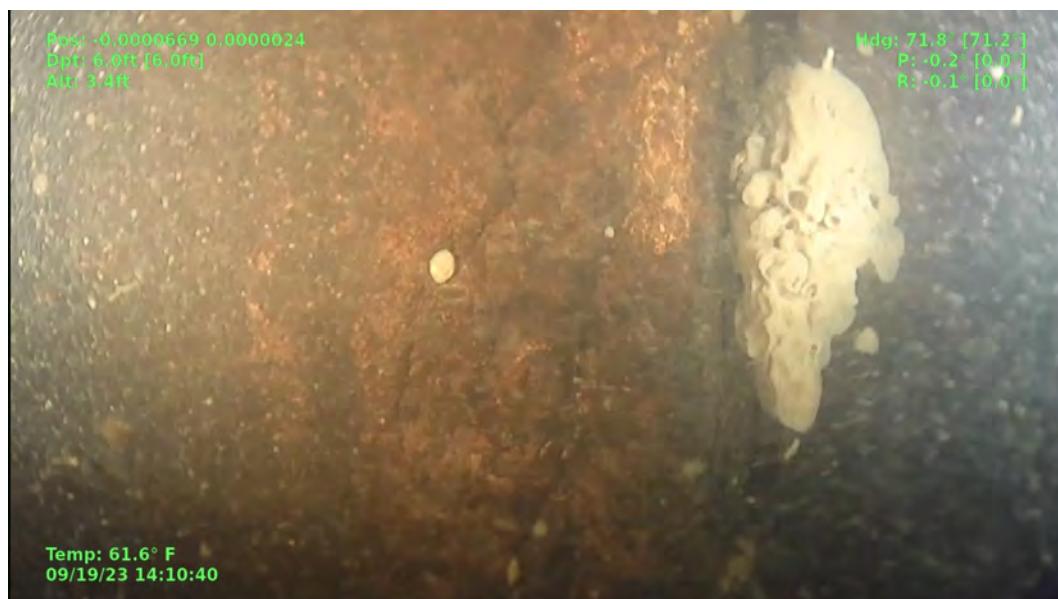
Figure 25 – Upstream, Intake Tunnels East Wall: Spalling on Ceiling

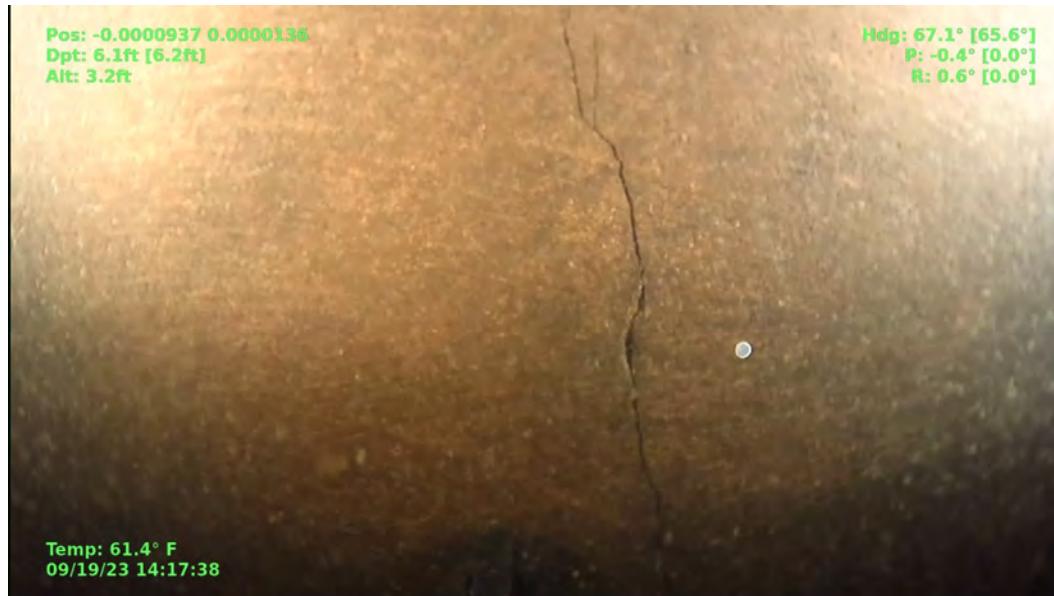
Figure 26 –Upstream, Intake Tunnels East Wall: Hairline Crack

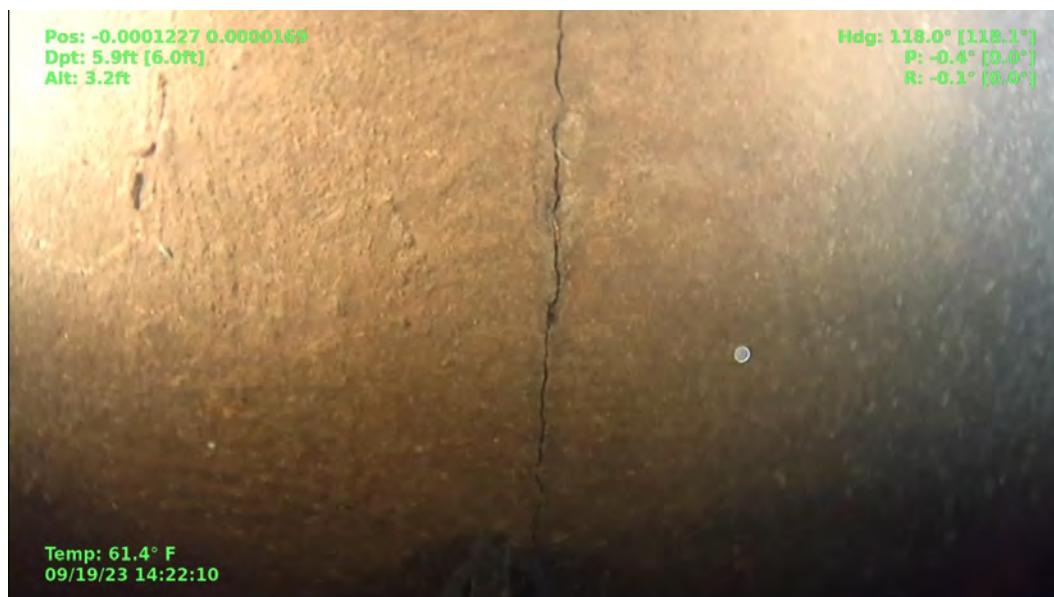
Figure 27 –Upstream, Intake Tunnels East Wall: Hairline Crack

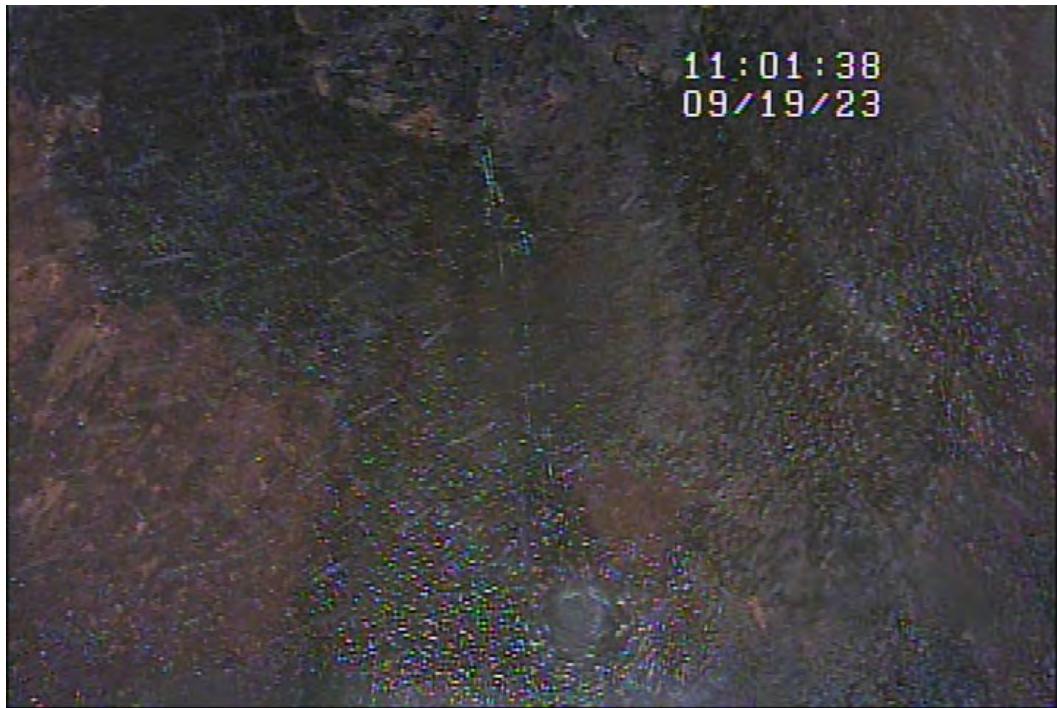
- A broken timber was present on bottom.
 - Draft Tube: The draft tube experienced heavy rust and light delamination (See '[Appendix A, Figure 30](#)').

Figure 30 – Downstream, Bay 1 Draft Tube

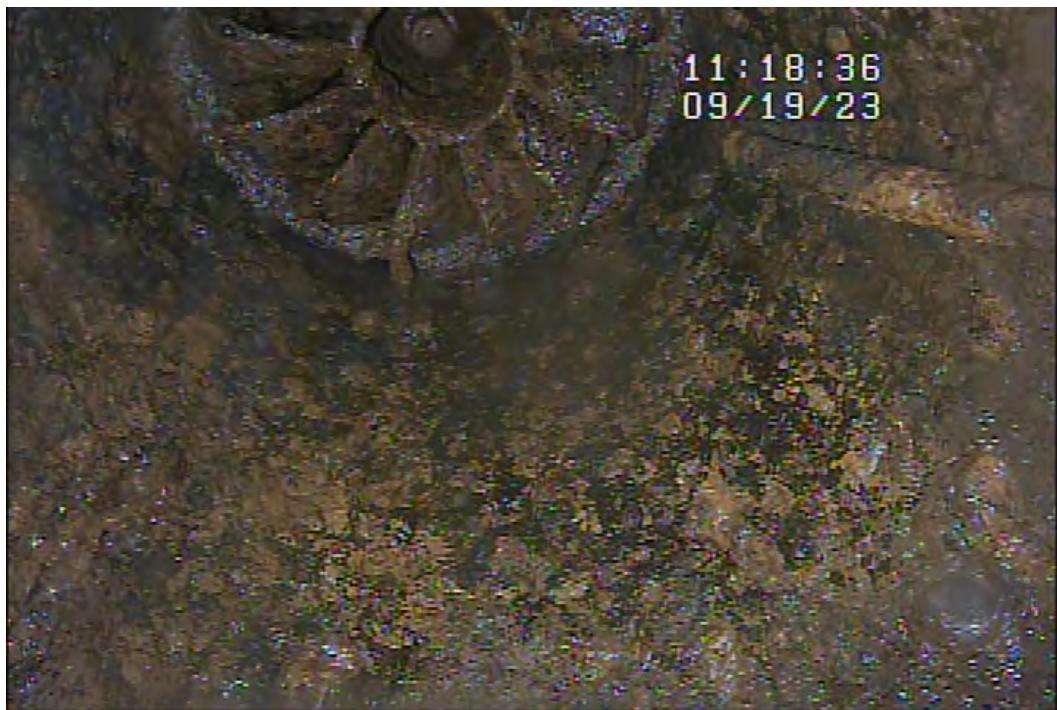
- A broken timber was present on bottom.
 - Right Stoplog Groove: The concrete was in satisfactory condition.
 - A broken timber was present on bottom.
 - Draft Tube: The draft tube experienced heavy rust and light delamination (See '[Appendix A, Figure 31](#)').

Figure 31 – Downstream, Bay 2 Draft Tube

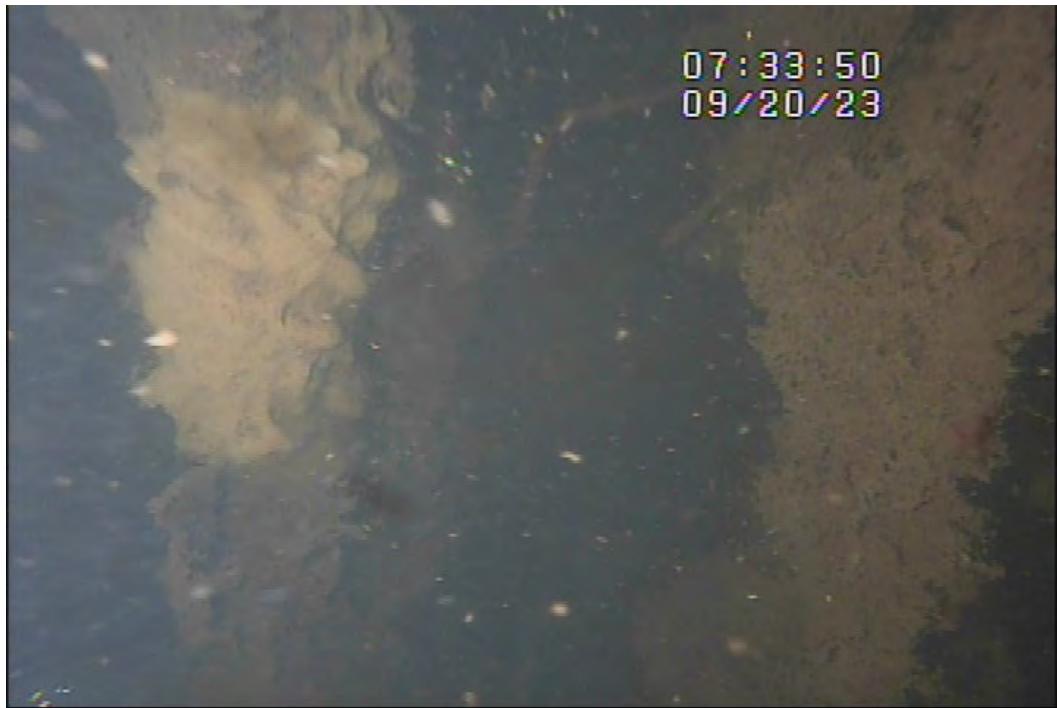
- East Wingwall: The concrete was in satisfactory condition with light scaling present throughout.
- East Sluice Gate: The trash rack was present with heavy rust present (See '[Appendix A, Figure 32](#)').
 - The guides were in place and experienced heavy rust.
- Spillway: The concrete was in satisfactory condition with light scaling present throughout.
 - Moderate marine growth was present throughout.
 - No areas of undermining were found.
- West Sluice Gate: The trash rack was present with heavy rust present (See '[Appendix A, Figure 33](#)').
 - The guides were in place and experienced heavy rust.

Figure 32 – Upstream, East Sluice Gate: Trash Rack

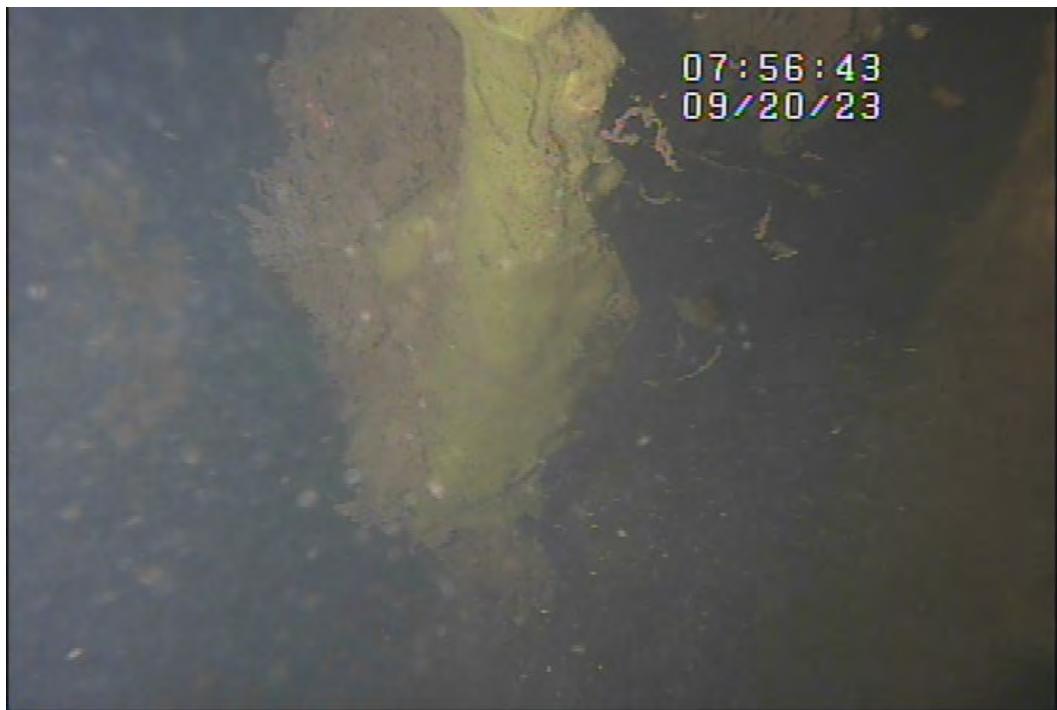
Figure 33 – Upstream, West Sluice Gate: Trash Rack

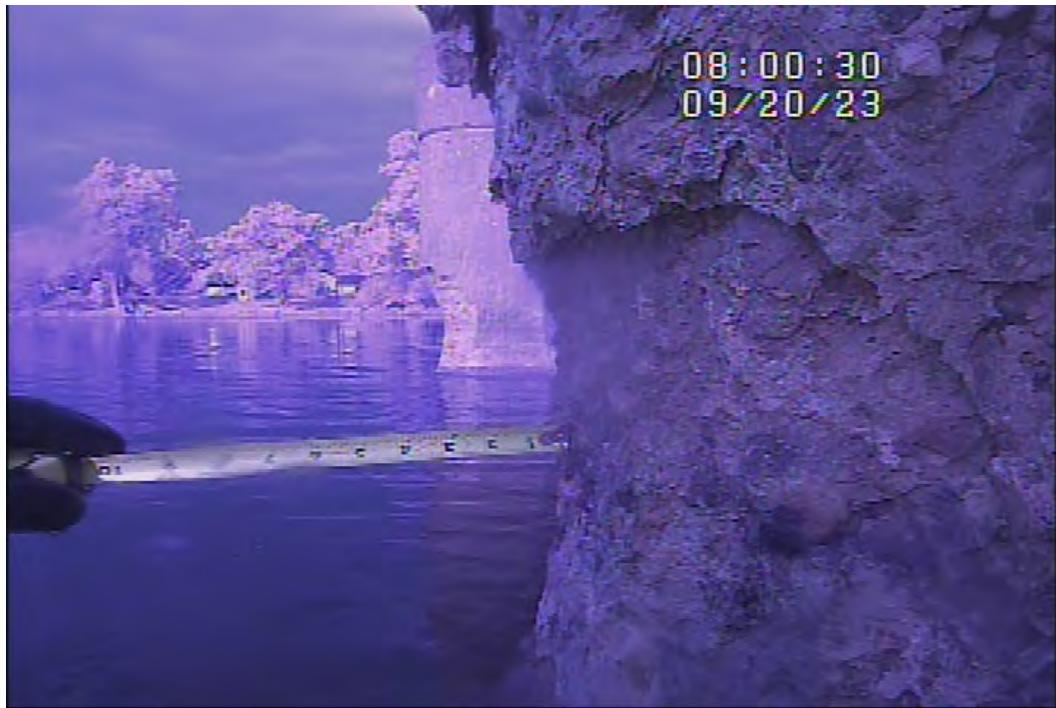
- Bullnose 1, **Station 10:** An area of spalling was present at the freeze/thaw line (See '[Appendix A, Figure 34](#)').
 - The spalling measured 36-inches wide by 27-inches tall with 4-inches of loss.

Figure 34 – Upstream, Intake Tunnel, Bullnose 1: Concrete Loss

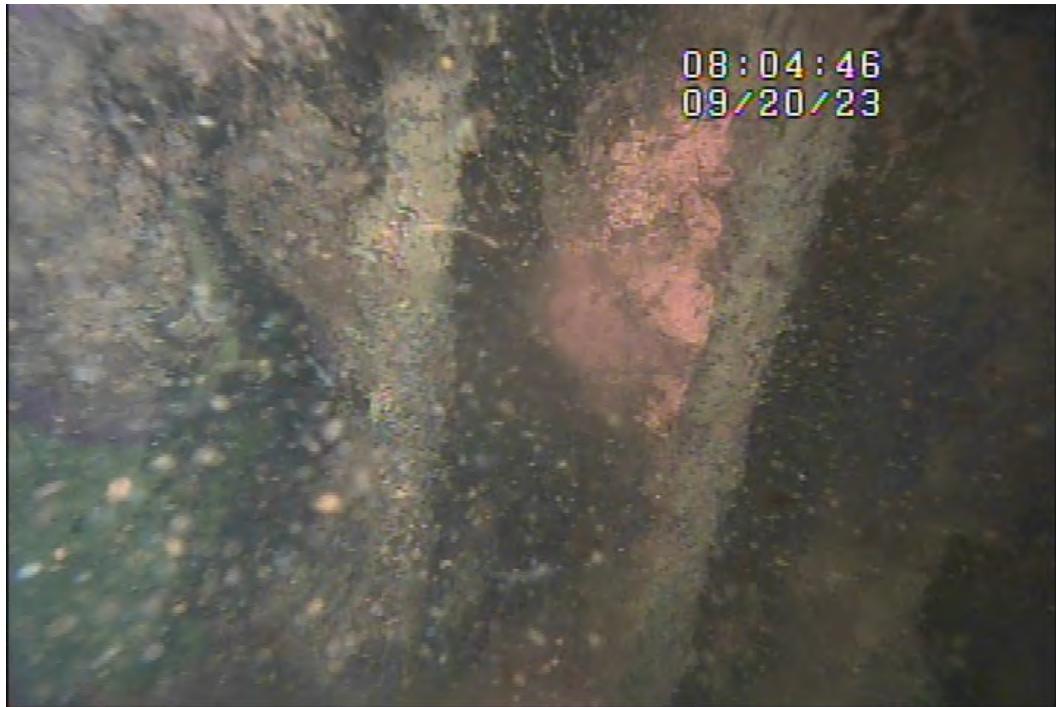
Station	Deficiency Type	Width	Height	Loss	Comments
10	Spalling	36"	27"	4"	At waterline, Bullnose 1
11	Spalling	36"	22"	6"	At waterline, Bullnose 2
12	Scaling	10"	16"	2"	7-inches below waterline, Bullnose 2

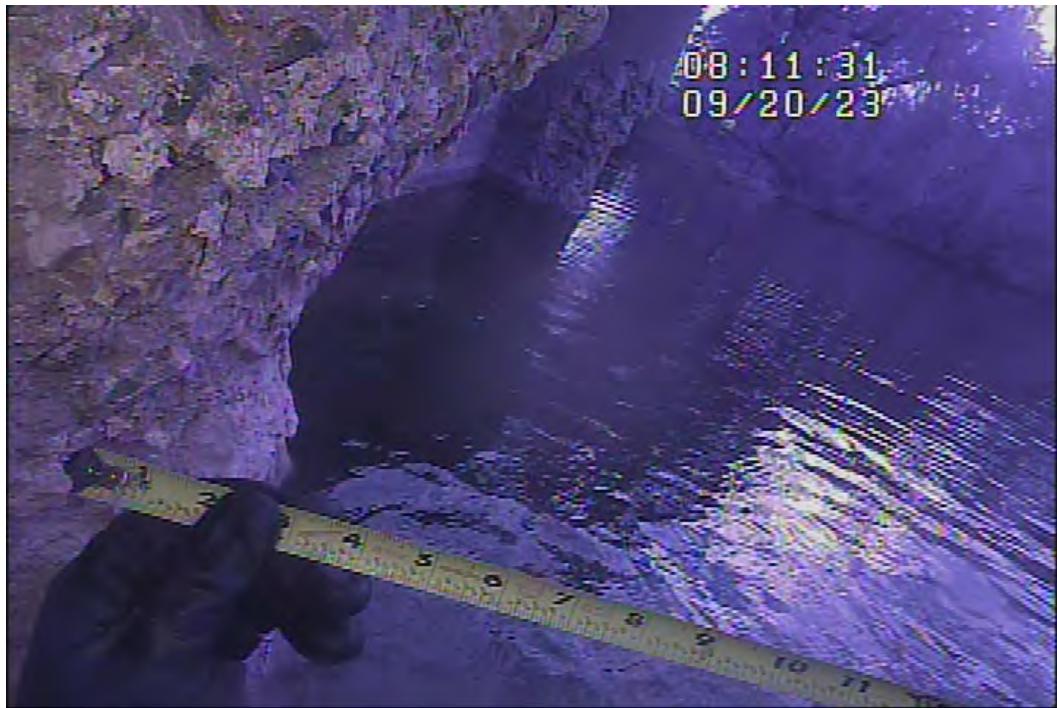
Figure 35 – Upstream, Intake Tunnel: Trash Rack

- Right Stoplog Groove: The concrete was in satisfactory condition.
- Trash Rack: The trash rack experienced moderate to heavy marine growth with 80 to 90% coverage (See '[Appendix A, Figure 35](#)').

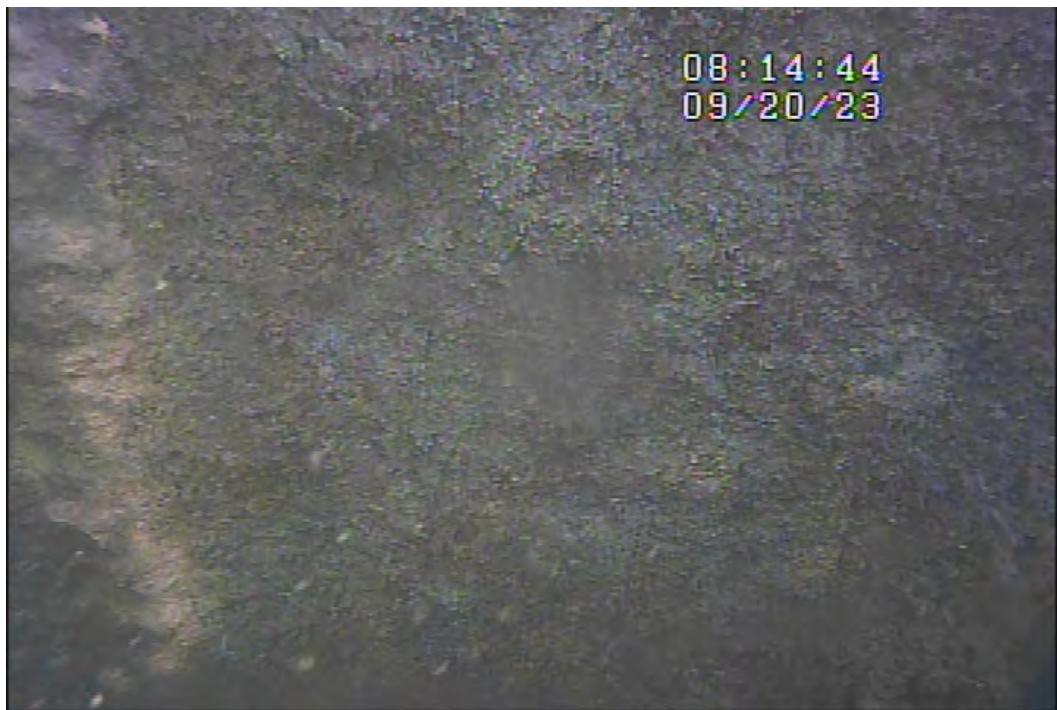
Figure 36 – Upstream, Intake Tunnel Bullnose 2: Concrete Loss

- Left Stoplog Groove: The concrete was in satisfactory condition.
 - A large amount of debris was present in the bottom of the groove.
- Bullnose 2, **Station 11:** An area of spalling was present at the freeze/thaw line (See '[Appendix A, Figure 36](#)').

- The spalling measured 36-inches wide by 22-inches tall with 6-inches of loss.
 - **Station 12:** An area of scaling was present 7-inches below waterline (See '[Appendix A, Figure 37](#)').
